Arboricultural Constraints Appraisal

in Relation to Residential Development Proposal at

**Land off Preston Road, Ribchester,
Lancashire, PR3 3XL**

July 2020

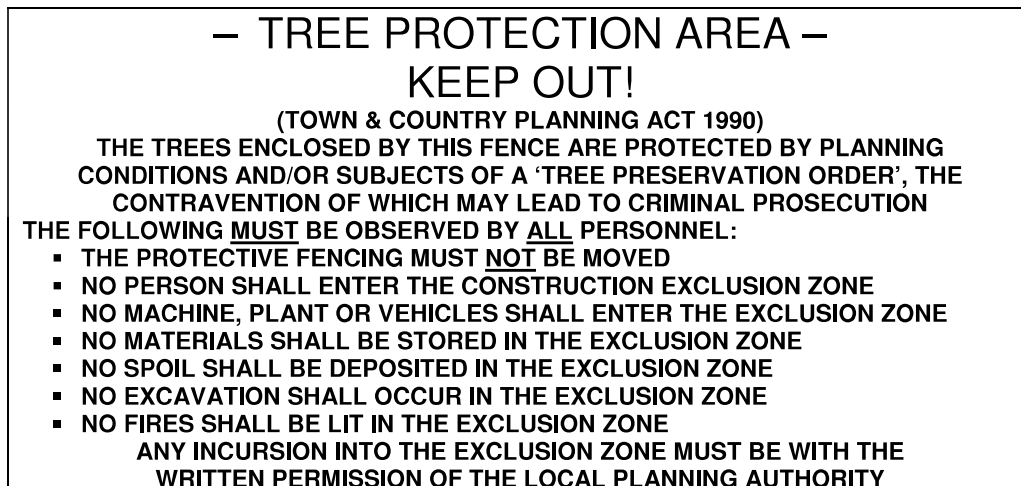
Figure 1: CEZ Warning Sign

6. No fixing shall be made to any tree and all possible precautions shall be taken to prevent damage to tree roots when locating posts.
7. A 600mm x 300mm warning sign reading "TREE PROTECTION AREA KEEP OUT" (see Figure 1, below) shall be fixed to every 10.0 metre length of protective fencing.

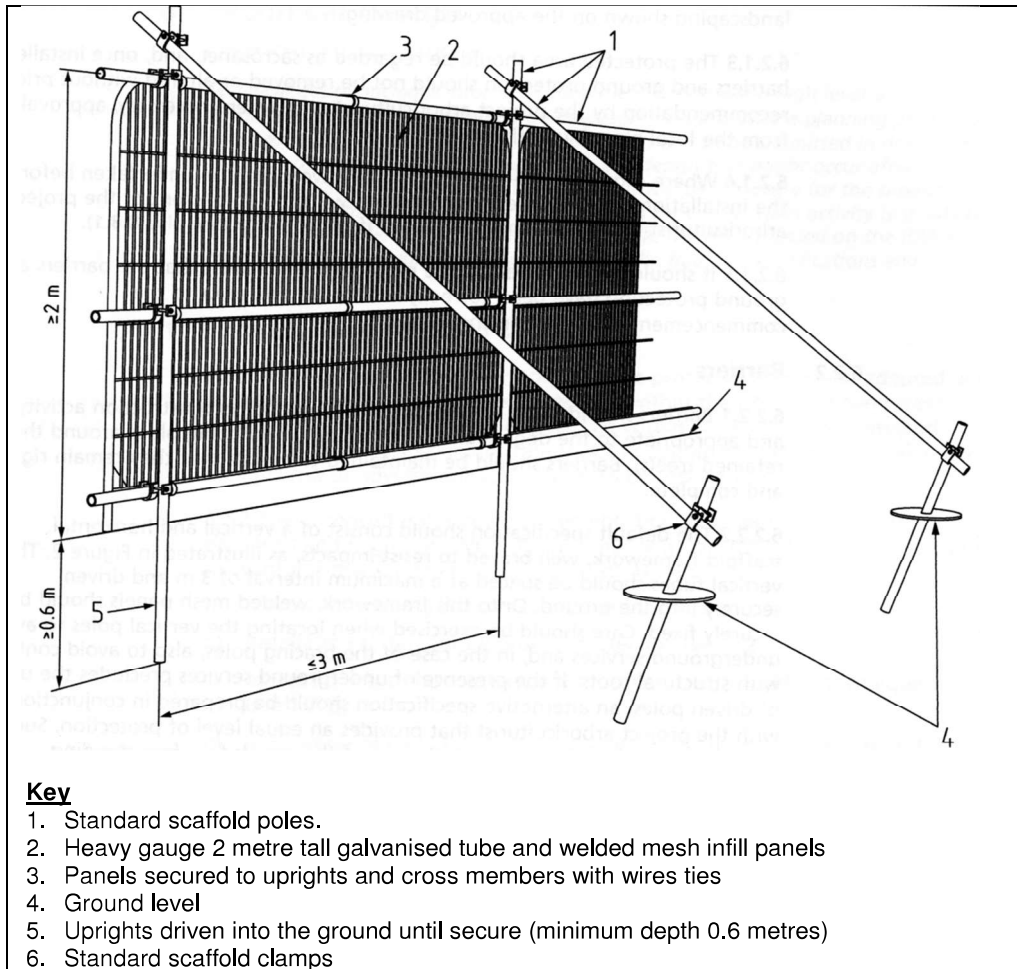
Figure 2: BS5837:2012 Default specification for protective barrier

1. Temporary protective fencing panels shall be weldmesh "Heras" panels of at least 2.0 metres in height.
2. The panels shall butt together and be securely fixed to a scaffold framework, as per 3 to 5 below.

3. The scaffold framework shall comprise of upright poles of at least 3.0 metres in length driven no less than 0.6 metres into the ground at maximum 3.0 metre centres with horizontal and diagonal poles fixed to the uprights, as per 4 to 5 below.

4. The two horizontal rail poles shall be attached to the uprights at heights of 0.6 and 1.8 metres with 3 no. clamps to each joint.
5. The diagonal scaffold pole struts be clamped to the top rail of the scaffold framework at a 45° angle and extend back into the CEZ and clamped to a 0.7 metre length of scaffold tube that shall be driven no less than 0.5m into the ground.

1. be retained in place throughout the development process, as specified in the 'Temporary Protective Fencing Construction' section below and detailed in BS5837:2012 Figure 2 (overleaf);

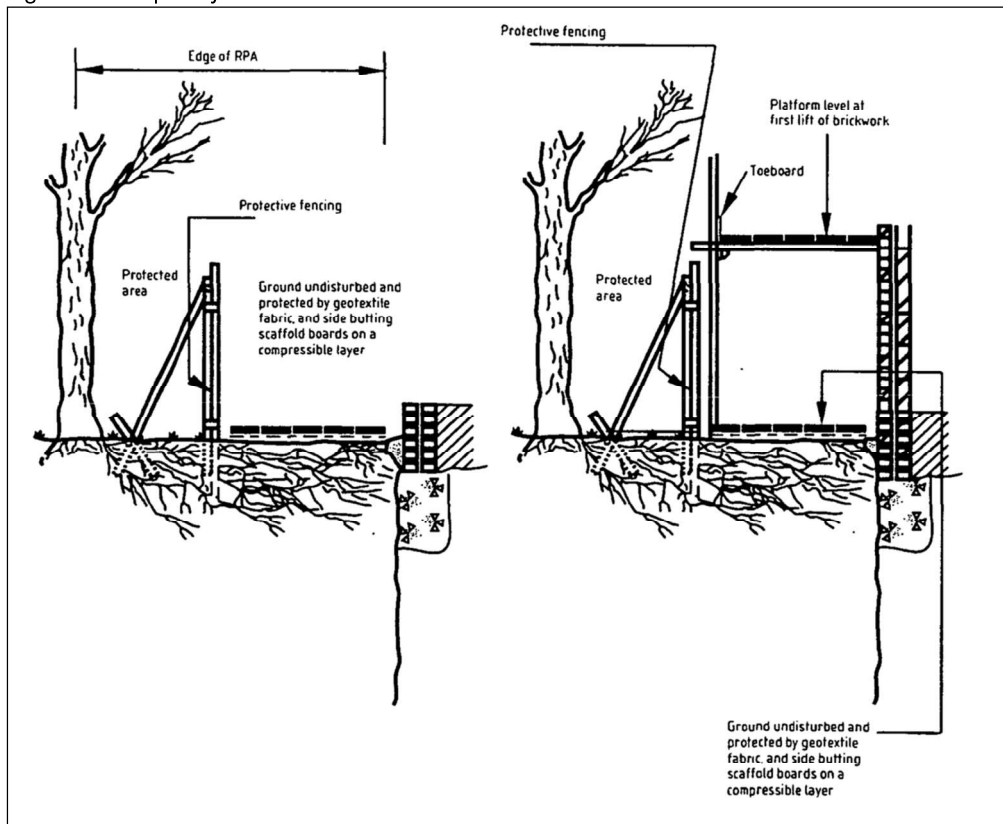
Figure 3: Temporary Ground Protection – Recommended Construction

1. Any necessary Temporary Ground Protection areas shall conform to Figure 3, below, unless otherwise agreed with the LPA.
2. The Ground Protection Area shall be left undisturbed and covered by a semi-permeable geotextile membrane which shall, in turn, be covered by a compressible layer consisting of a material such as woodchip.
3. Side-butting scaffold boards shall then be fitted to cover the Ground Protection Area.
4. On completion of installation, and prior to any demolition or construction works, site preparation, excavation or delivery of plant and materials, the Consulting Arboriculturist or the LPA Tree Officer, as agreed, shall inspect the Temporary Ground Protection.
5. The Temporary Ground Protection shall remain in place until completion of the project and only removed following receipt of written permission from the LPA.
