Existing Elevations

Site Address	63 Hillcrest Road, Langho, BB6 8EN
Client Name	Mr and Mrs Worden
Date	Sept 2020
Scale	1:100 @ A3

Proposed Elevations

Site Address	63 Hillcrest Road, Langho, BB6 8EN
Client Name	Mr and Mrs Worden
Date	Sept 2020
Scale	1:100 @A3
Amendment 20/11/2020 – Rev02

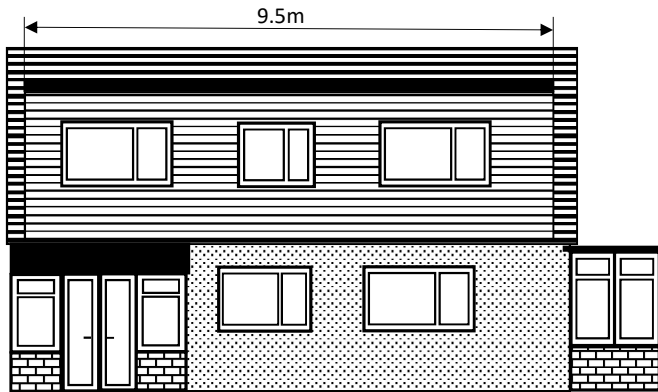
Proposed Side Elevation

- Cladding on dormers to match existing at front of house or matching render to the front
- White UPVC windows to compliment existing
- New slate grey roof tiles
- All new drainage to run into existing drain pipes
- Rubber roof membrane to new dormer
- Existing driveway parking for 5 vehicles
- Width of dormer is to wall to gain enough headroom for the stairs to be moved. Currently stairs are in the lounge and for a better fire escape route the stairs are proposed to move to their own hallway with clearer exit route (please see *)

- Roof Lights added to elevation
- Second dormer removed
