LH1-let-08

**Expanded Heritage Statement**

**Re-roofing the building and creating one en-suite shower room at :  
Lovely Hall, Lovely Hall Lane, Salesbury, Blackburn, BB1 9EQ**

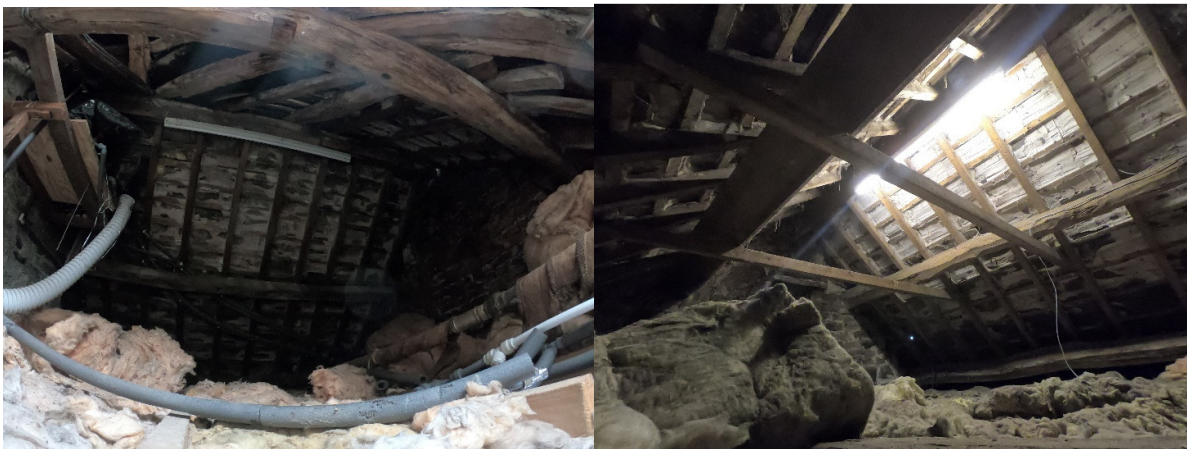
**Bare tiles with deteriorating lime mortar application above bedrooms 3 and 4**

Viewed from the inside, approximately 50% of the underside of the roof coverings are bare tiles with a deteriorating lime mortar application, the remainder a traditional bitumen underfelt.

All roof coverings, tile battens and lead flashings are to be removed and replaced along with a traditional bitumen underfelt as recommended by our ecologist due to the presence of bats.

The replacement stone roof tile and tile battens will be to the written satisfaction of the Local Planning Authority.

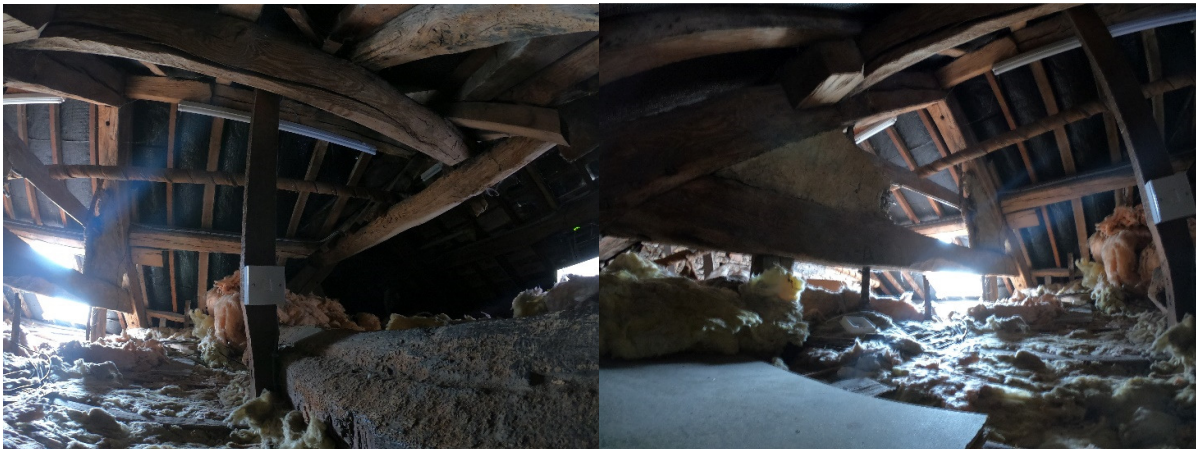
**Traditional bitumen underfelt above bathroom 1 and the adjacent corridor**

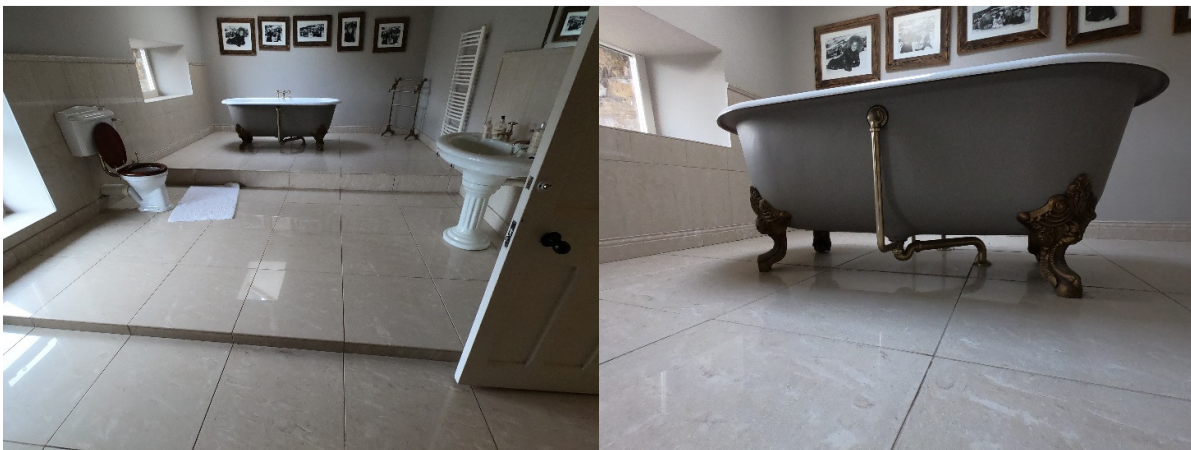
Above the original floor, two steps have been introduced to create a floor void through which to run pipework to and from sanitary fittings.

**Main bathroom with raised floor to conceal pipework**

Our intention is to use the same service void through which to run waste and supply pipes to a new en-suite located just across the adjacent corridor.

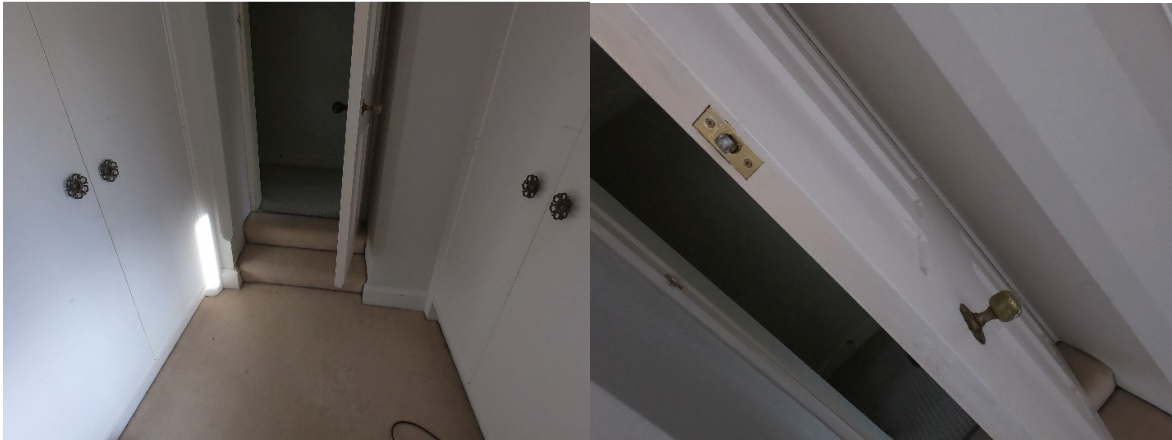
Steven describe the door as having unusual panel shapes reminiscent of the early 20<sup>th</sup> Century and cannot be considered to have much significance.

He further elaborated that earlier doors tended to have the large lock on the exterior around the handle, which this particular door does not have.

Steps introduced to access raised part of the floor

Ball catch on light weight door

Our original intention was to retain as much as possible of the original fabric, however as this particular door is not considered to have much significance, we now propose to remove it and infill the opening with partition wall construction.

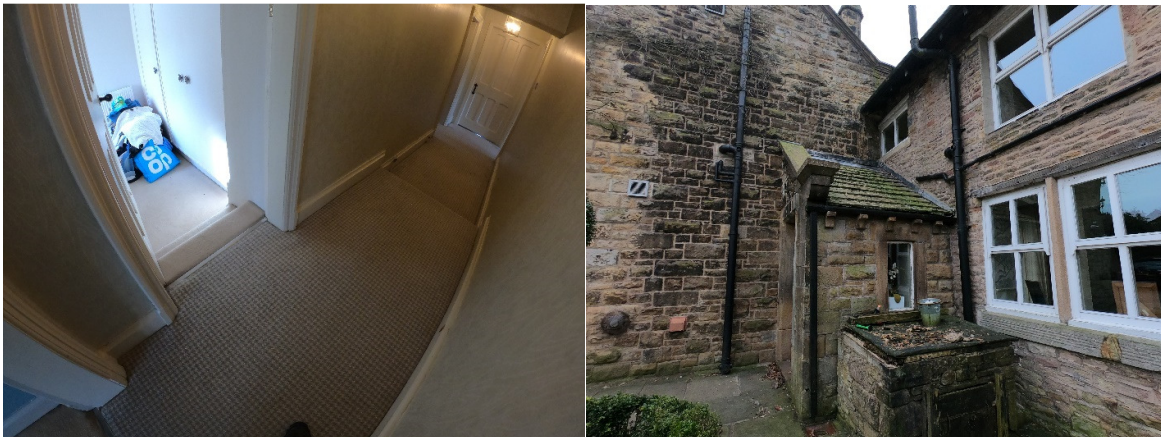
Steps over the floor void extend into the corridor

Existing black upvc soil pipes

Our intention is also to remove the steps, allowing direct access for incoming and waste water pipework.

All services will be concealed, so everyday upvc fittings are proposed, solvent welded at the joints.

Of the final connection to the existing soil and vent pipe, only the last 600mm length of waste pipe will be visible extending from the side wall of the rear porch to the waste pipe, and will be black upvc to match the existing.

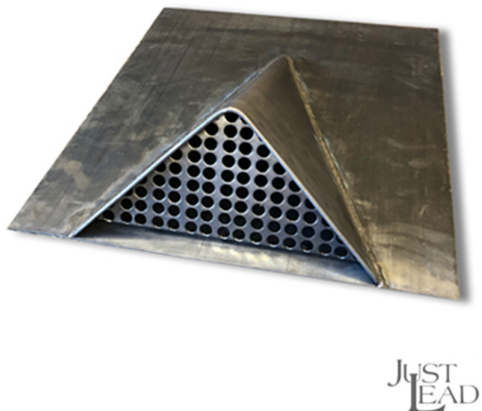
The roof cowl we are proposing to connect to, is a heritage type lead vent for pitched roofs, fabricated using sheet lead by 'Just Lead Workshop' in Edenbridge, Kent.
