**BAT SURVEY AT -**

**THE HAWTHORNS  
RIMINGTON LANE  
RIMINGTON**

**DATE AND TIME OF VISIT  
26<sup>th</sup> Nov 2020 1.00pm**

**REFERENCE NO. 6179**

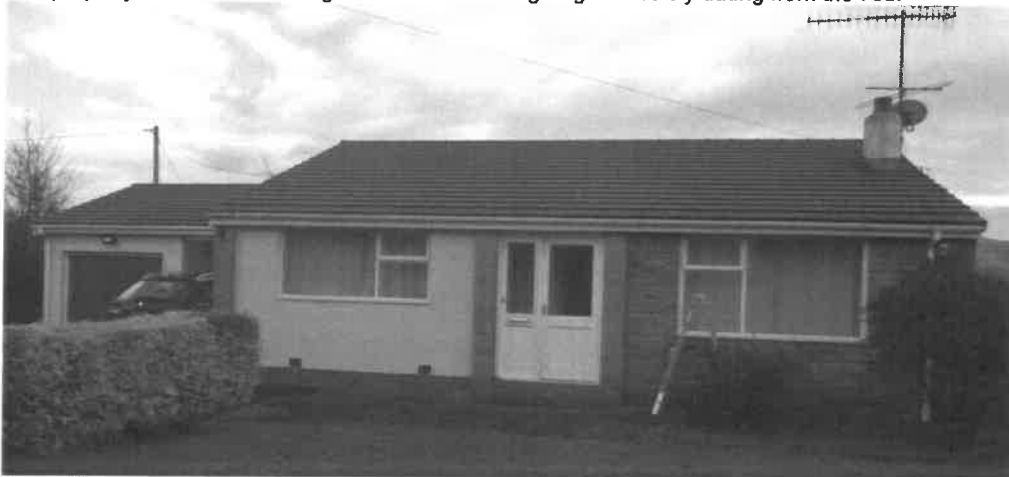
Front elevation

The property is a detached Bungalow with attached garage. Possibly dating from the 70s.

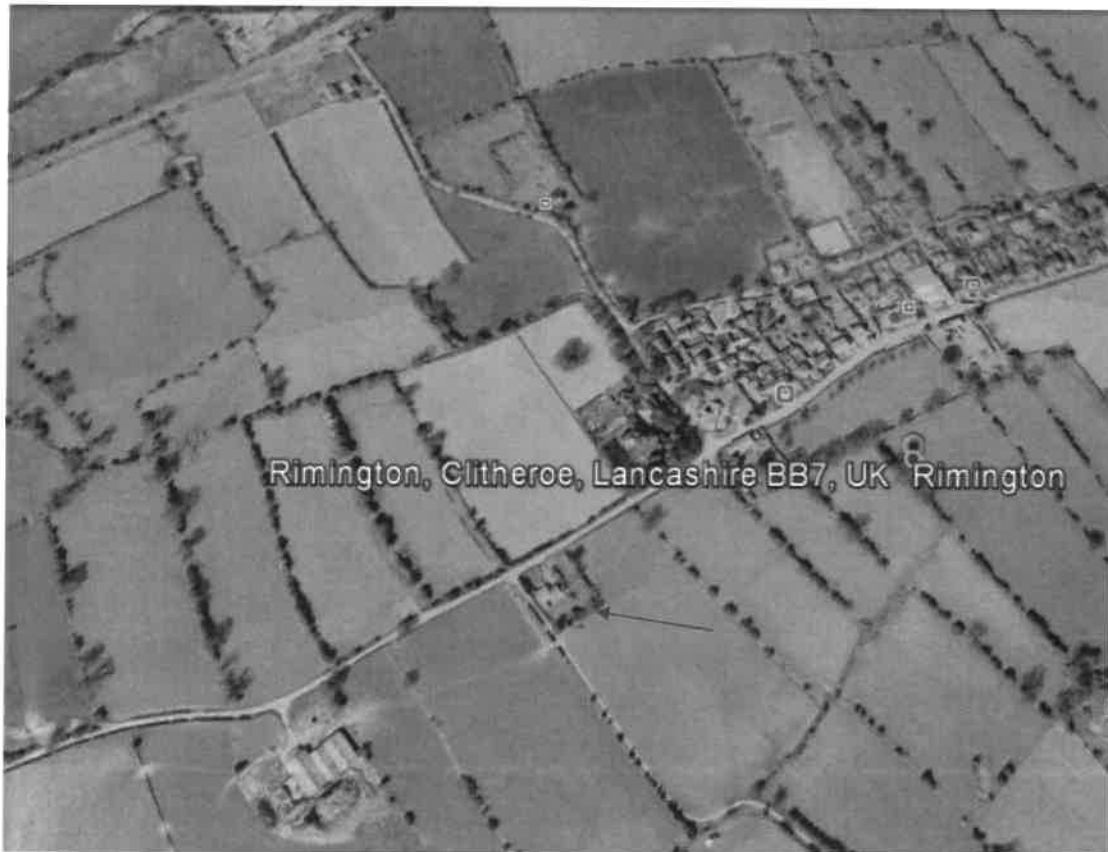
## **LOCATION SD 802455 151m elevation**

The house is located adjacent to Rimington Lane surrounded by garden and agricultural land on the outskirts of the village.

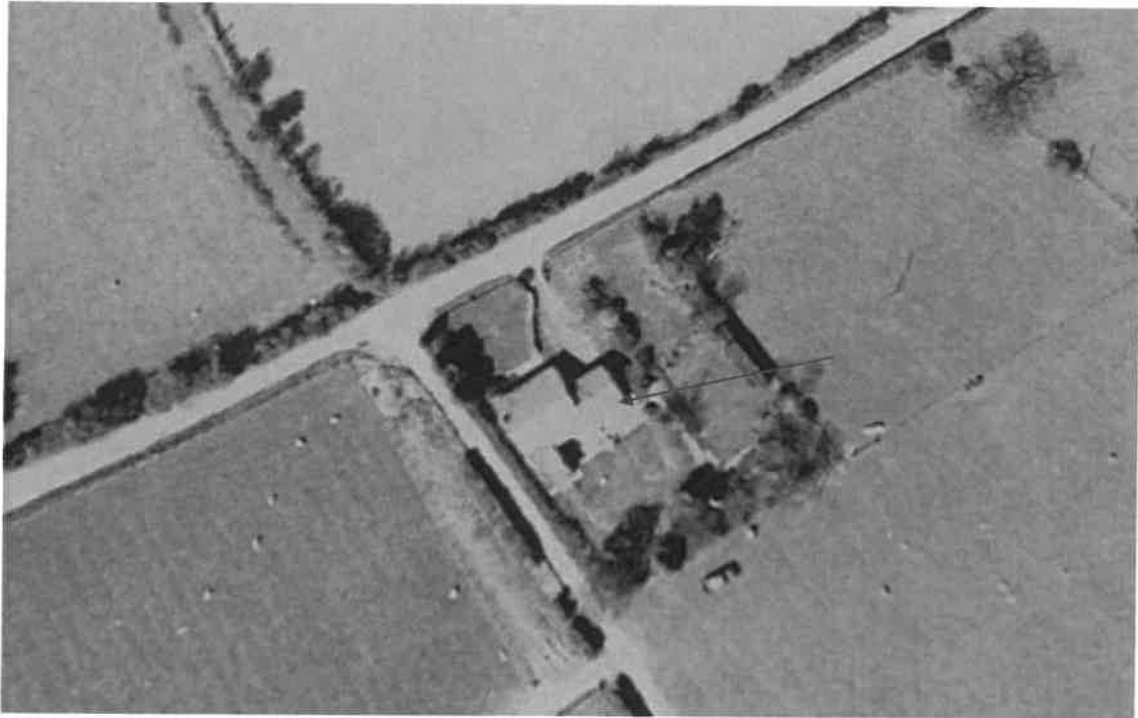
The garden boundaries to the side are Beech hedge the south west being approx 2m from the building, and there are mature trees lining the other boundaries.

The large acreage pastureland surrounding the property is bound by hedgerow and trees

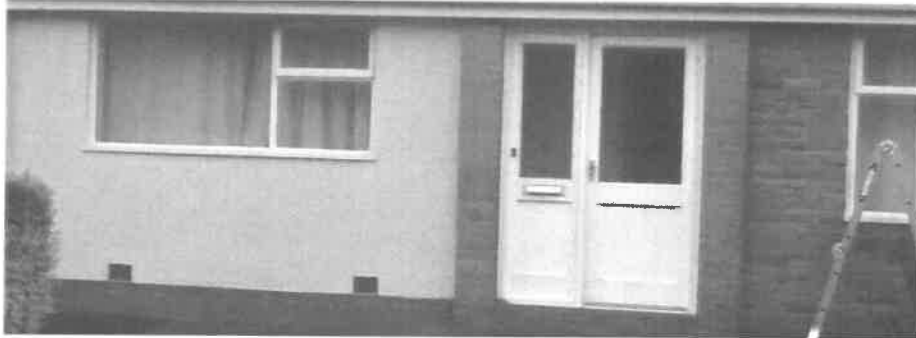
The Bungalow has a painted render finish with stone quoins and a small section of stone to the front elevation. The walls are in excellent condition.

There are no access points in the walls and no signs of grease marks or staining indicating bat entry.

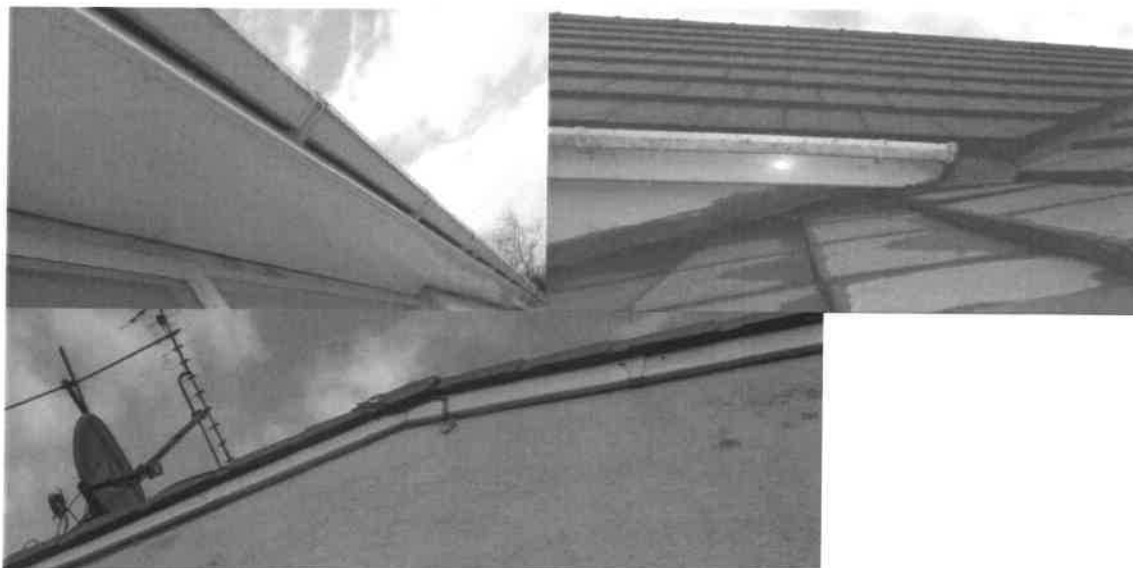
The Bungalow was re-roofed since the previous survey, approx. 3-4 years ago. During the re-roofing work, bats were found nor any signs of previous use. The new roof is in excellent condition with no access points. The upvc fascias, Verge detail and flashings are tight fitting with no gaps suitable as bat access points.

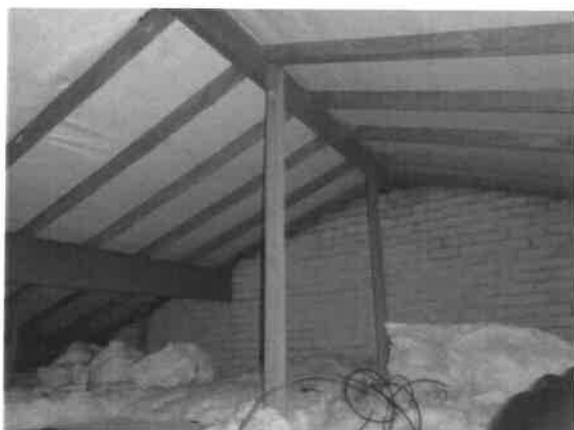
The roof space is used for storage the purlins rafters and felt are in excellent condition with no cracks or crevices suitable for bats.

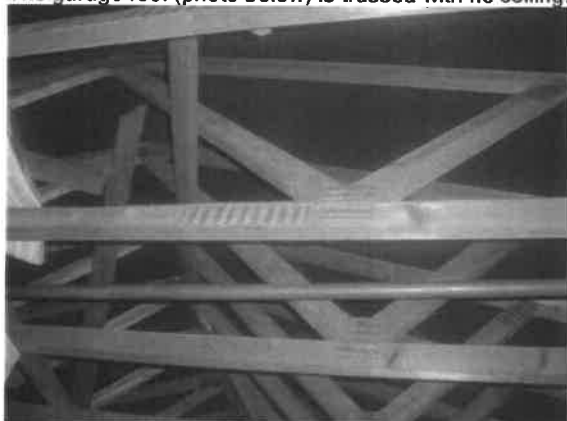
The garage roof (photo below) is trussed with no ceiling.
