**Bat Survey Report (preliminary day-time survey):**

**Highcroft  
Painterwood  
Billington  
Whalley  
BB7 9JD**

**Survey Date: 1/2/19**

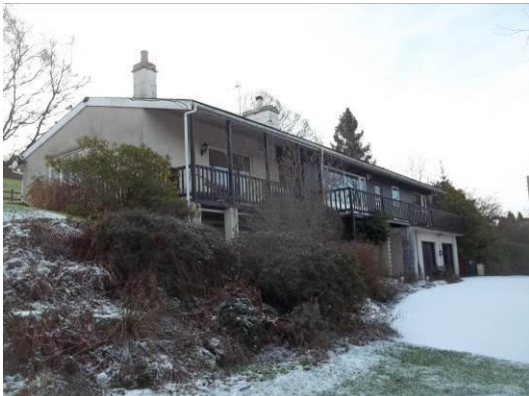
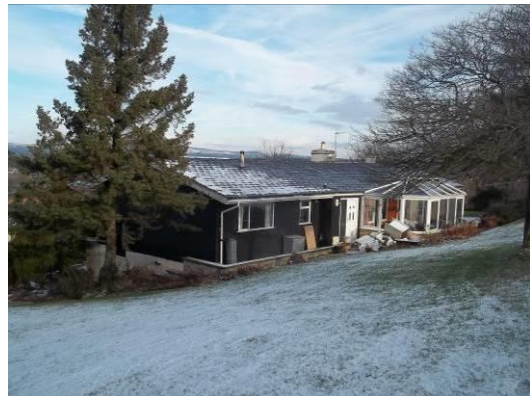
Front (north-western) and rear elevations

This is a large, modern-style, detached house. It is two-stories high at the front and single-storey at the rear:

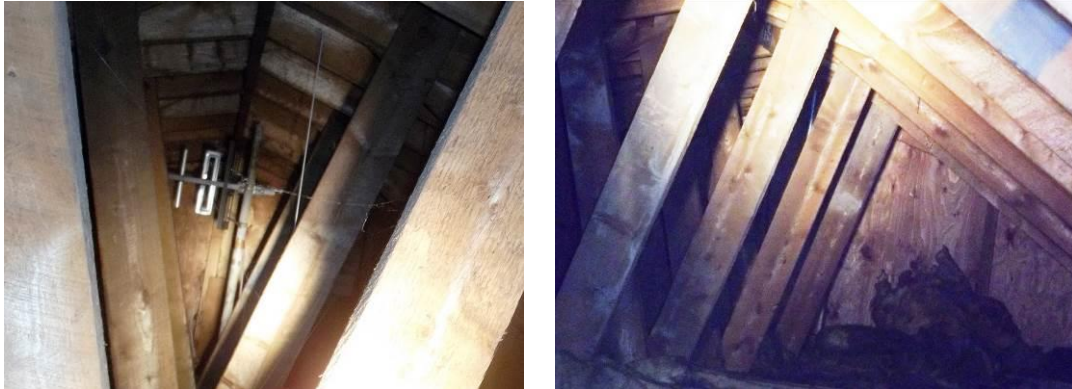
South-western gable end

Given the findings of the survey of the exterior of the property it was not expected that signs of the presence of bats would be found in the loft. This is low in height and congested with trusses, limiting ease of access for inspection. It was however inspected from the loft-hatch, which is towards the south-western end of the building. There did not appear to be any bat access available at the internal gable wall:

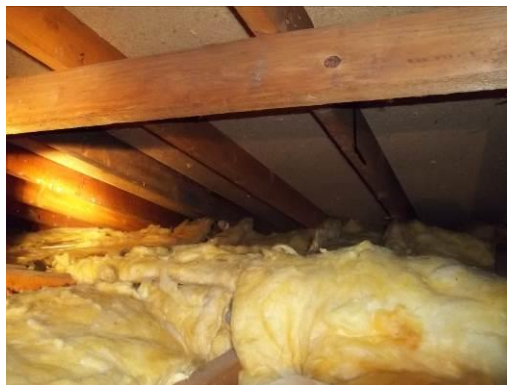
The roof is lined with board and there is insulating material at floor level.

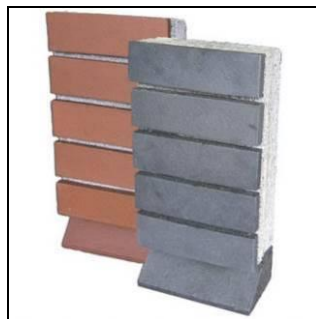
“Designed to be built into an exterior wall and is available in a variety of faces to match the building. Standard facings of red or blue brick - ideal for new builds - are normally available from stock, or boxes can be made to your specific requirements with a face of brick, stone, timber, or plain (for rendering). Supplied unpointed.”

Brick example of Ecosurv Habitat. Can also be faced with stone.

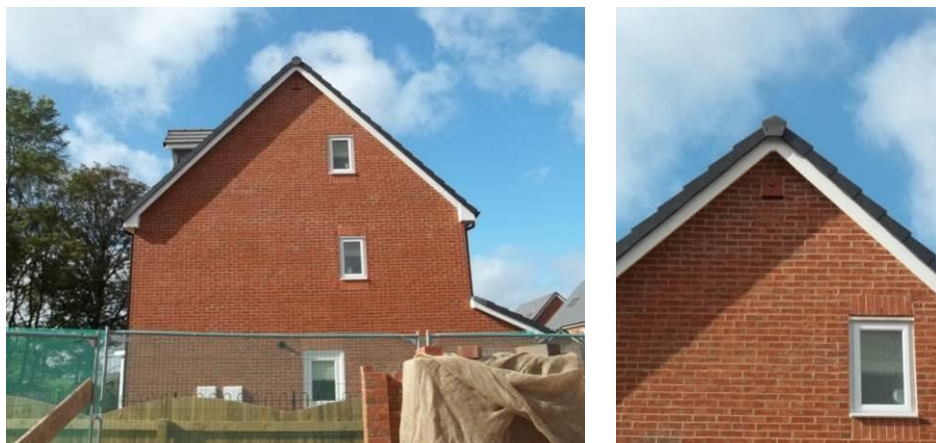
Above: typical unit in situ. Photo © Angela Graham

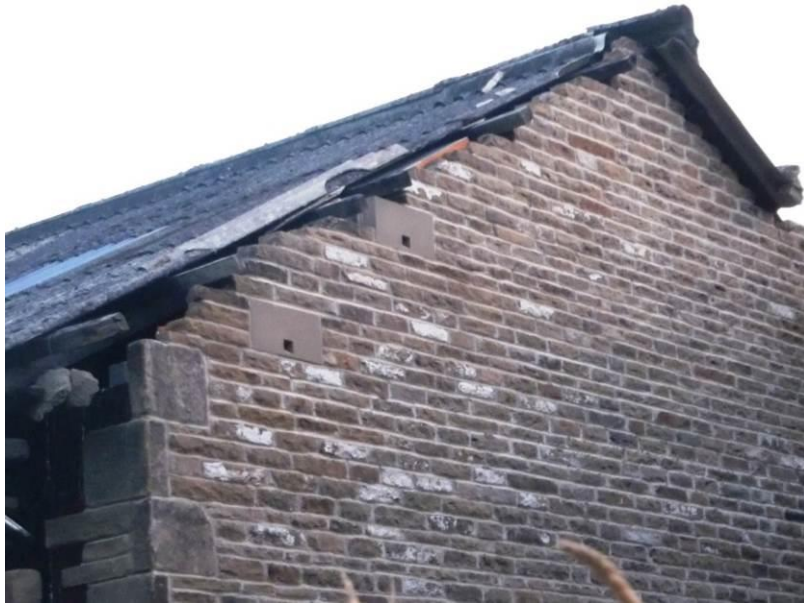
Example of Forticrete boxes in situ

“Forticrete’s boxes have been designed to be fitted to your property easily. Suitable for new build construction or renovation work where there is a requirement to provide a habitat for Pipistrelle bats.”
