Proposed residential development
Land east of Chipping Lane
Longridge, Preston

Ground Investigation Summary Report

**Proposed residential development
Phase 1
Land East of Chipping Lane
Longridge
Preston
PR3 2NA**

GROUND INVESTIGATION SUMMARY REPORT

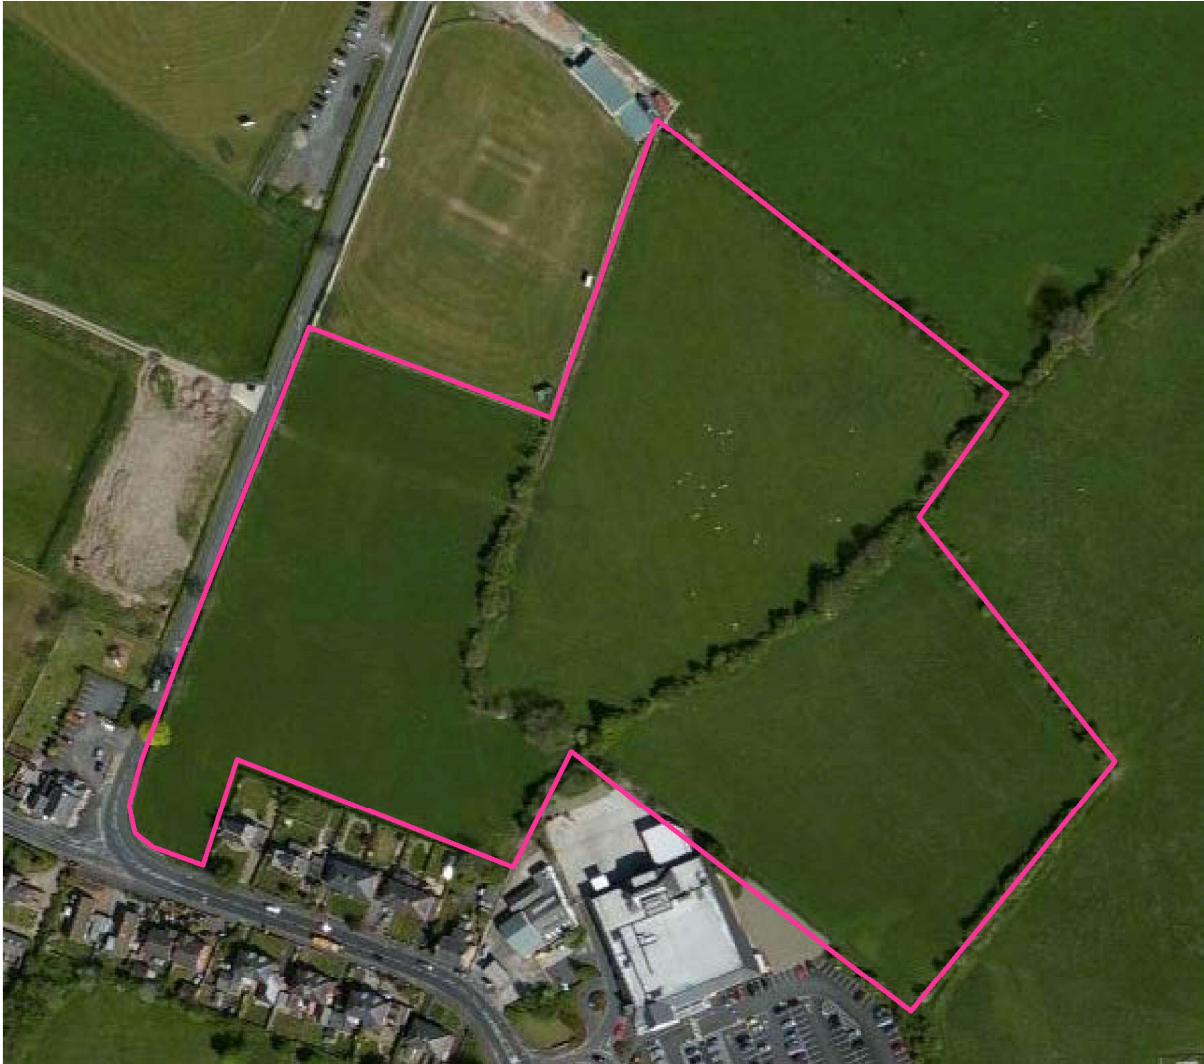
Aerial photograph of site

Approximate Phase 1 site boundaries edged in pink

Proposals	Development of up to 363 homes within what is termed Phases 1 and 2, with associated landscaping, gardens, hardstanding and access roads. This summary report refers to the Phase 1 area only (see aerial image above) in which 118 dwellings are proposed.
Investigations	Review of Phase 1 desk study information produced by Curtins Consulting Ltd (ref EB1355/GI/3692 Rev A Issue 01 dated 14th April 2014) and completion of Phase 2 intrusive ground investigations at the site by Soiltechnics Ltd comprising 20 trial pits and 7 boreholes excavated to depths of up to 4.5m. Installation of 4 gas and groundwater monitoring wells also undertaken as a precaution.
History of the site	<p>Since the earliest historical map dated 1893 the site has been occupied by open fields and farmland. Approx. 50m-100m to the north and north east of the site are a number of small ponds bounded by embankments. The historical maps illustrate no existing buildings or developments and have remained unchanged up until the most recent historical maps.</p> <p>Since 1893 the surrounding area adjacent to the site is bound by Chipping Lane to the east and Higher Lane to the south. Pit street mill is illustrated 20m to the south east of the site and a cluster of residential housing and farm houses, including Berry Farm and Crumpax Farm, are located approximately 50-60m from the site. Adjacent to the south west of the site are several buildings labelled Alston Arms and 50m to the west of the site is an iron and brass foundry. During 1895 the surrounding area illustrates the development of a number of works, mills and factories, including a gas works and a foundry circa 50m south west of the site. From 1913 onwards steady urban expansion continued within Longridge to the south, slowing by 1932. A brook is shown running adjacent to the western boundary from 1932. From 1961 to 1967 the surrounding area expanded significantly, with the closest developments occurring approximately 10-30m from the site (Frey Stocks) and a garage south east of the site. The pattern of redevelopment to the surrounding area continues, however not within close proximity of the site. The site remains predominantly unchanged up to the most recent historical maps.</p>
