**BAT SURVEY AT -  
3 COMMONS LANE  
BALDERSTONE**

DATE AND TIME OF VISIT  
17<sup>th</sup> Dec 2021 3.00 pm

REFERENCE. Mr and Mrs Evans.

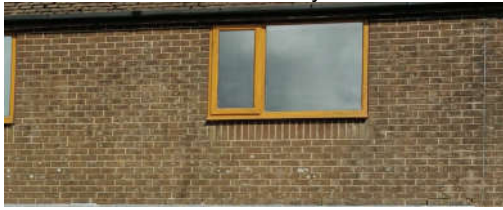
The walls are brickwork cavity construction.

The walls are in good condition and do not provide any access points, cracks or crevices suitable for bat ingress.

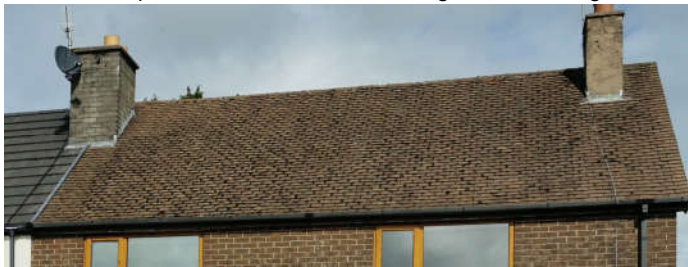
A traditional pitched roof with eaves and gable overhang the roof finish is tile.

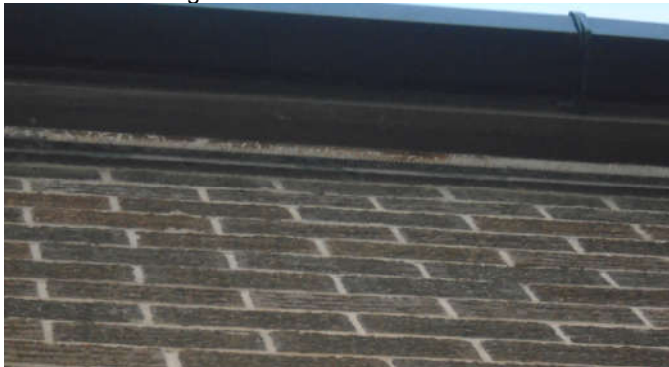
The tiles are in good condition very tight fitting with no obvious access points, the ridge tiles are well pointed and lead flashings are tight fitting. The eaves soffits are tight fitting and do not provide any access points or crevices suitable for bat ingress.

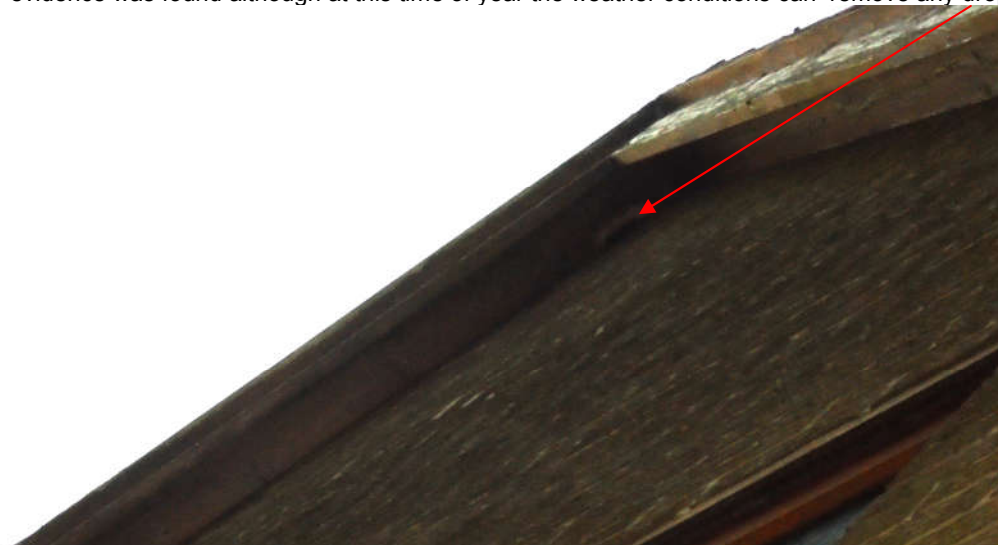
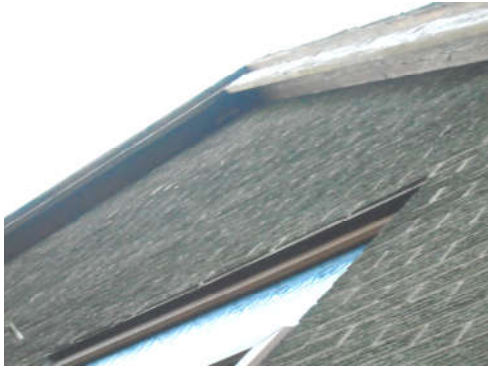
The soffits to the gable are in good condition and very tight fitting with the exception of a gap near the ridge. Close inspection was not possible, binoculars were used, signs of staining around the gap was noted, however no other evidence was found although at this time of year the weather conditions can remove any droppings.

Bats were not present in the roof space at this property however the presence of the gap in the gable soffit could not be discounted as providing potential roost habitat, particularly as a Pipistrelle bat population was historically found to be present in a neighbouring property. It is necessary to undertake an emergence survey during the activity period (April- September) to fully assess if the development at the property will impact on any local bat population.

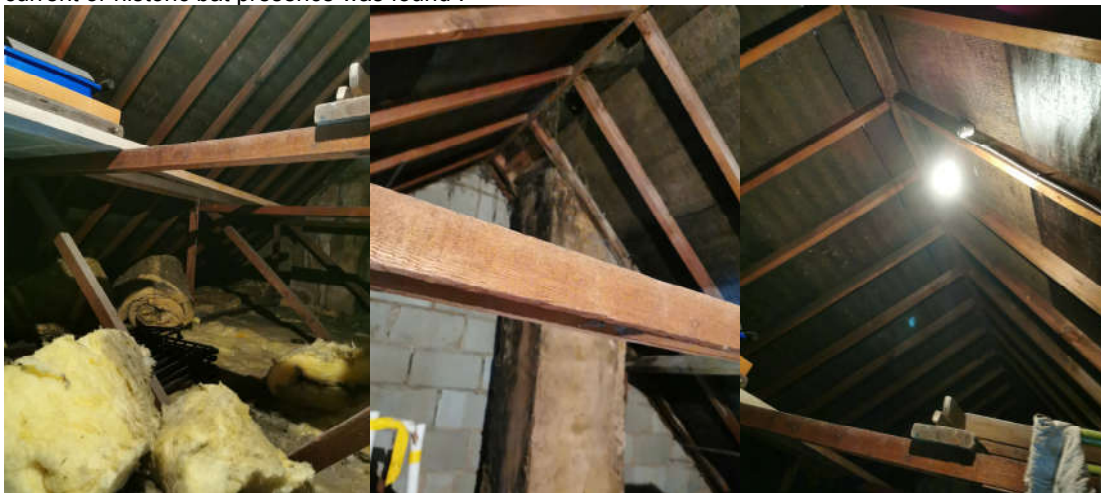
The roof void was accessible from a ceiling hatch. And it was possible to closely examine the timber purlins, rafters and ties all were in excellent condition as was the underlay. The insulation quilt was very clean with no dropping or insect remain evidence. The space did not provide any high value roost habitat and no evidence of current or historic bat presence was found .
