**An assessment for the need of a traditional wall covering**

Application No. 3/2020/0763

Condition No. 8

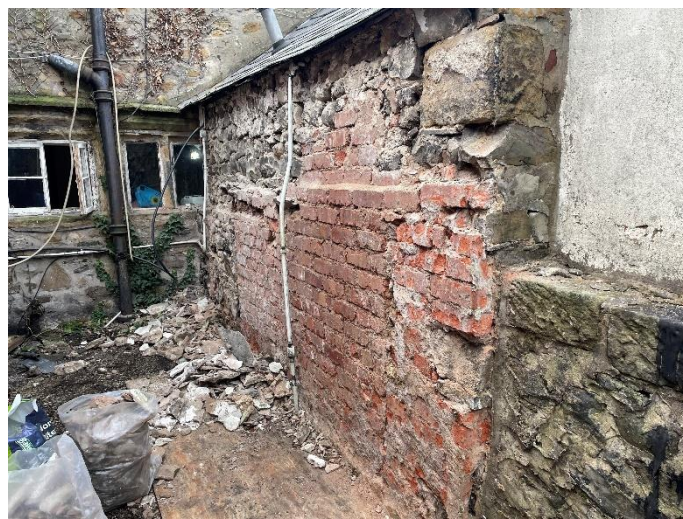
The existing condition following removal of the render is shown in the below figures 1 and 2. The walling likely originally consisted of solely sandstone rubble, with brickwork patching repairs evident since its construction and evidence of further patching/filling with larger stones/pebbles that have clearly been smoothed by erosion. These are likely from the stream adjacent to the property.

The material condition is generally poor throughout, with the wall considerably damp from the previous cement based render. Areas of sandstone have deteriorated and are spalling and the brickwork is uneven and patchy.

Figure 1 – View of exposed wall.

The proposal for replacement is to apply a lime render to the external wall to allow breathability whilst protecting and covering the face of the existing masonry. As the masonry is a mix of many different materials and generally of quite poor build quality, it is not classed as in keeping with the rest of the property and for aesthetic reasons in a commercial setting it would be considered appropriate to cover this with a lime render. The lime render would also provide protection from further deterioration of any stonework/masonry which may continue if left exposed to the elements, whilst providing a breathable covering.

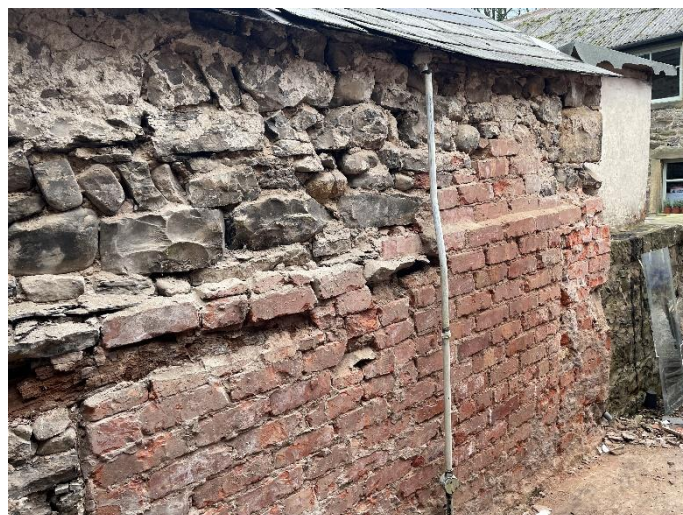
Figure 2 – Alternative view of exposed wall.
