hare hill croft

44 york street clitheroe BB7 2DL		Chartered Practice
t. 01200 444490 e. mail@stantonandrews.co.uk	w. stantonandrews.co.uk	
project	project number	drawing number
moorend	1903	PL 52
name		r L J Z
site sections - additional

status planning

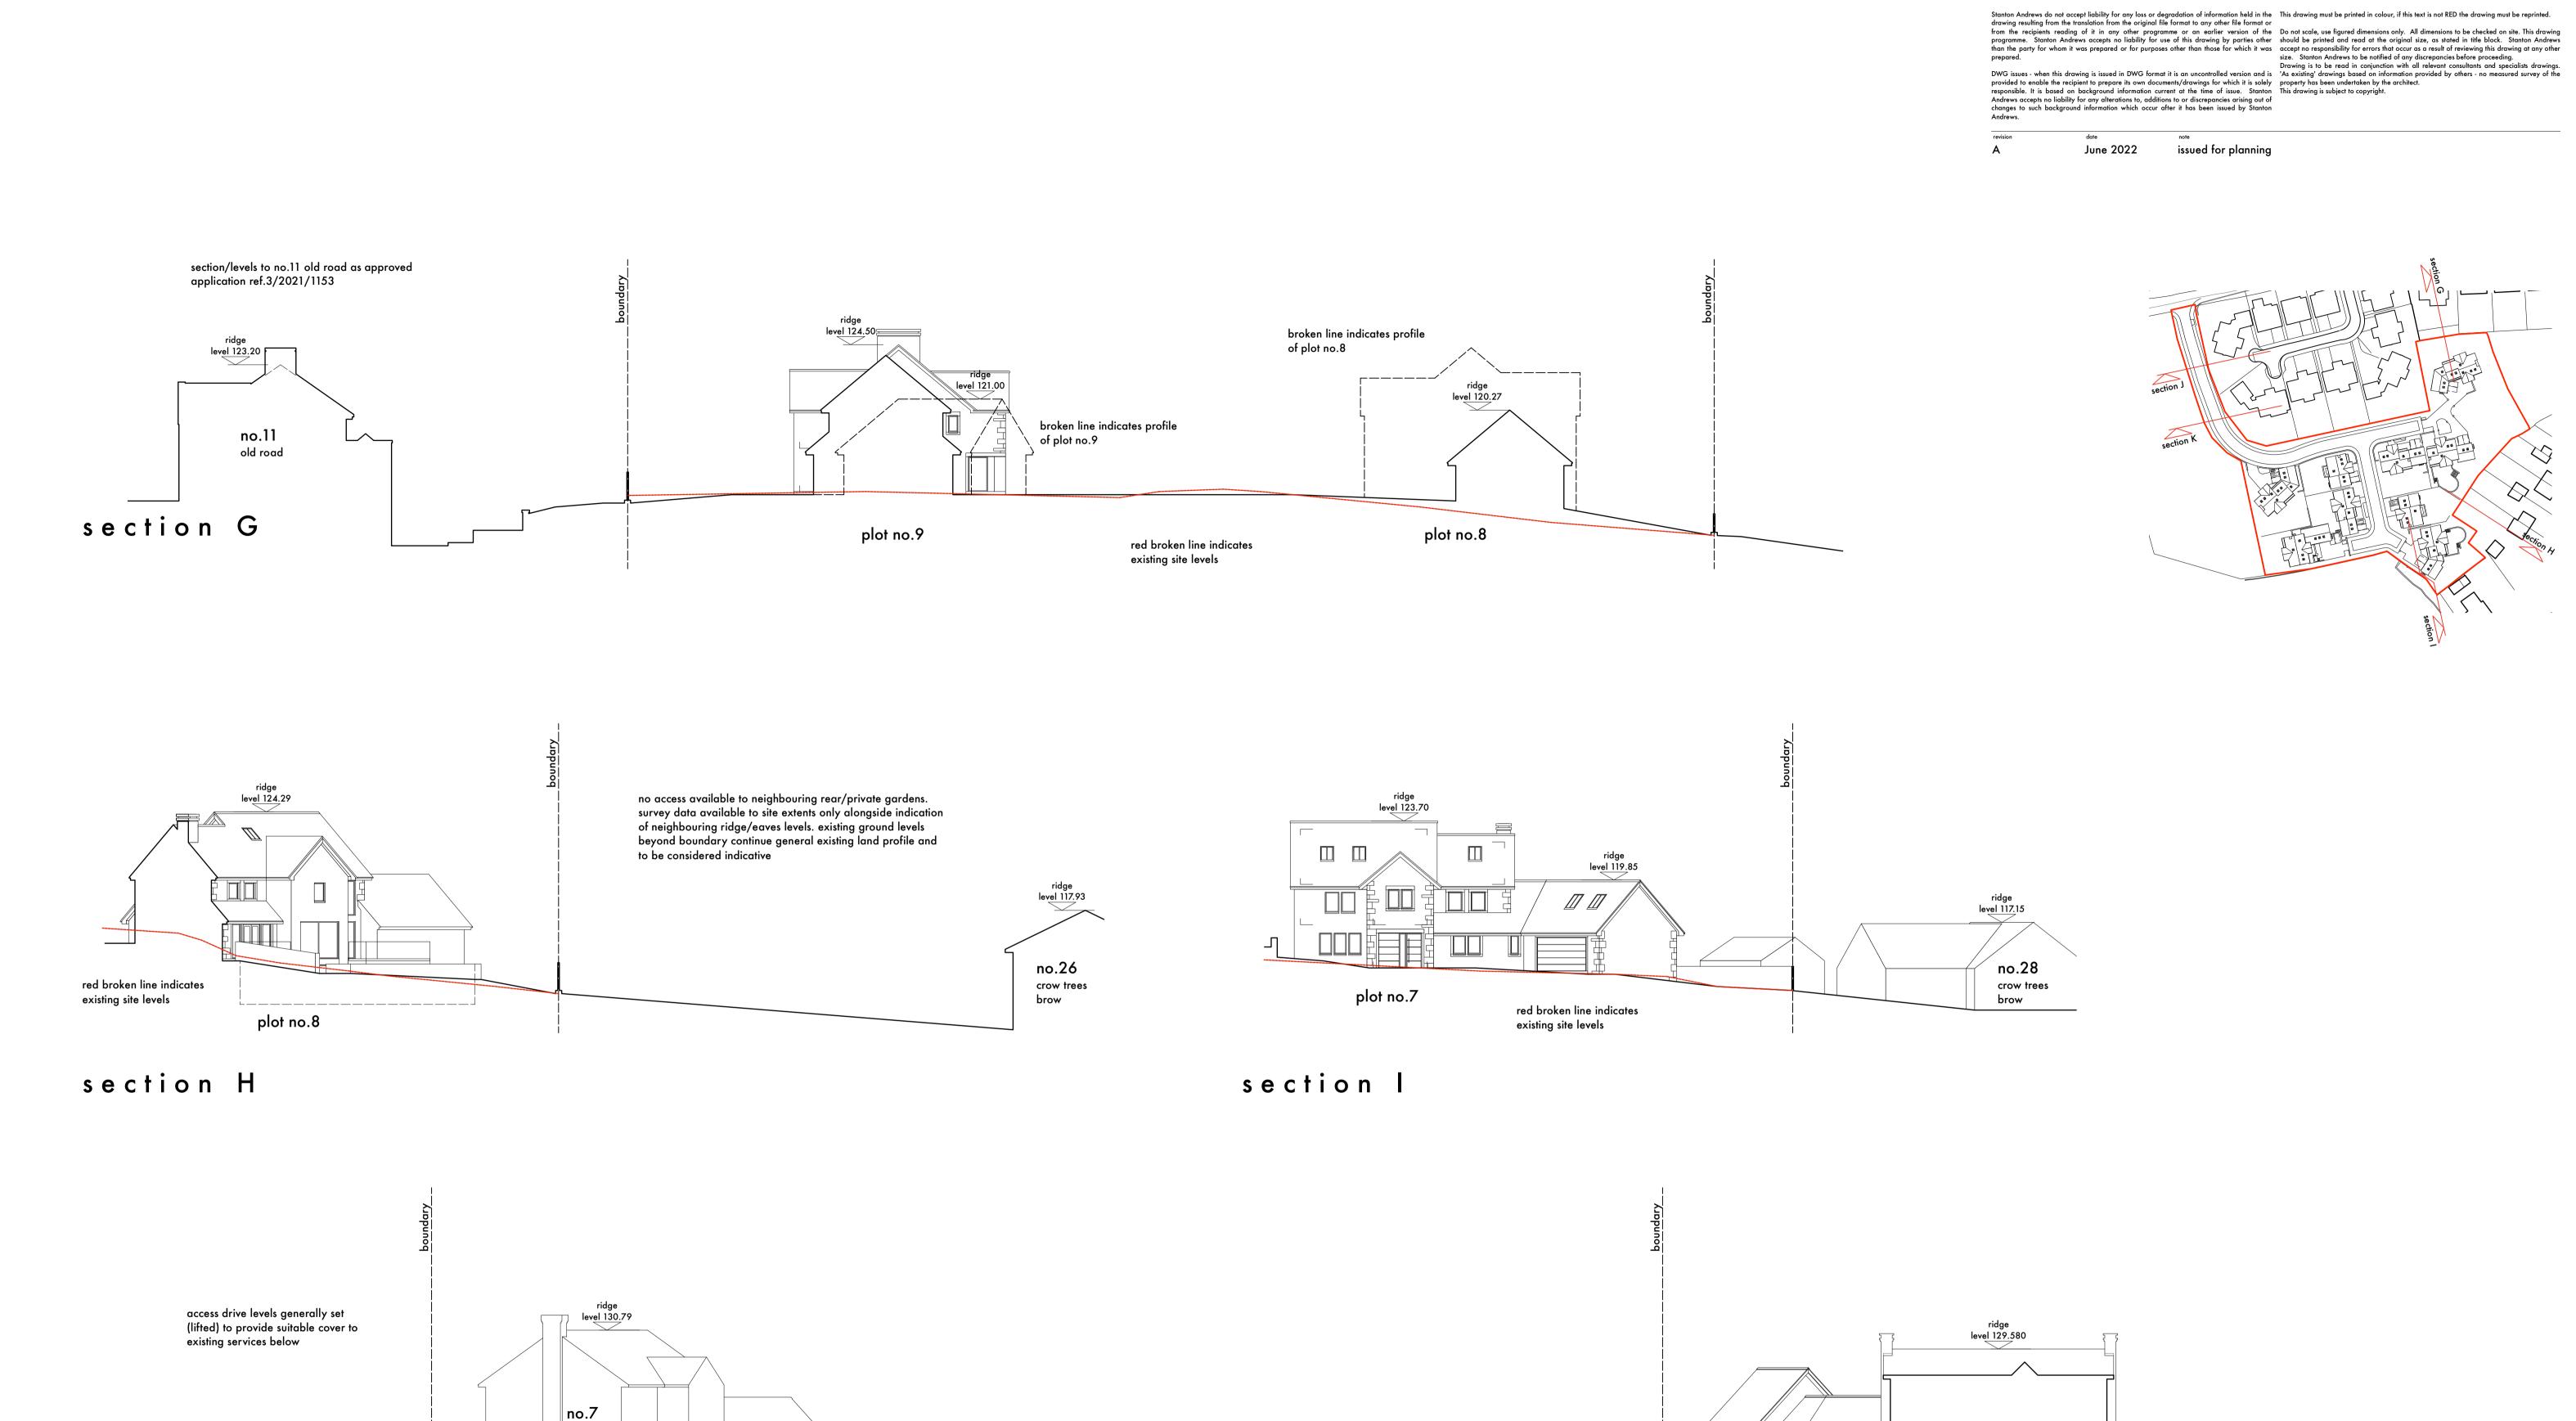
red broken line indicates

section J

taken through access drive (to plot no.7 hare hill croft)

existing site levels

section K
taken through access drive (to plot no.6 hare hill croft)

level 122.25
