# Arboricultural Constraints Appraisal

in Respect of Proposed Residential Development at

# Land off Chatburn Old Road, Chatburn, Lancashire, BB7 4EP

March 2022

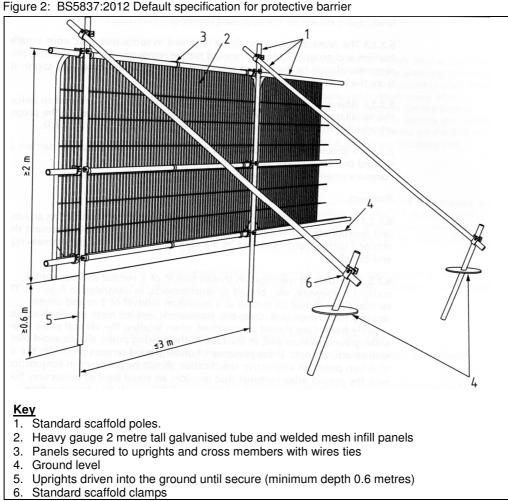
Figure 2: BS5837:2012 Default specification for protective barrier

- 1. Temporary protective fencing panels shall be weldmesh "Heras" panels of at least 2.0 metres in height.
- 2. The panels shall butt together and be securely fixed to a scaffold framework, as per 3 to 5 below.

- 3. The scaffold framework shall comprise of upright poles of at least 3.0 metres in length driven no less than 0.6 metres into the ground at maximum 3.0 metre centres with horizontal and diagonal poles fixed to the uprights, as per 4 to 5 below.

- 4. The two horizontal rail poles shall be attached to the uprights at heights of 0.6 and 1.8 metres with 3 no. clamps to each joint.
- 5. The diagonal scaffold pole struts be clamped to the top rail of the scaffold framework at a 45° angle and extend back into the CEZ and clamped to a 0.7 metre length of scaffold tube that shall be driven no less than 0.5m into the ground.

- 6. No fixing shall be made to any tree and all possible precautions shall be taken to prevent damage to tree roots when locating posts.
- 7. A 600mm x 300mm warning sign reading "TREE PROTECTION AREA KEEP OUT" (see Figure 1, below) shall be fixed to every 10.0 metre length of protective fencing.

- 1. be retained in place throughout the development process, as specified in the 'Temporary Protective Fencing Construction' section below and detailed in BS5837:2012 Figure 2 (overleaf);

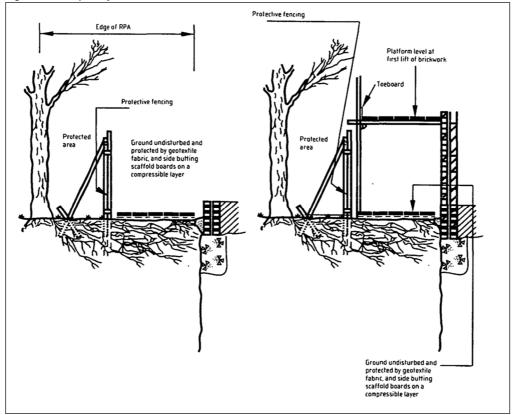
Figure 3: Temporary Ground Protection – Recommended Construction

- 1. Any necessary Temporary Ground Protection areas shall conform to Figure 3, below, unless otherwise agreed with the LPA.
- 2. The Ground Protection Area shall be left undisturbed and covered by a semi-permeable geotextile membrane which shall, in turn, be covered by a compressible layer consisting of a material such as woodchip.
- 3. Side-butting scaffold boards shall then be fitted to cover the Ground Protection Area.
- 4. On completion of installation, and prior to any demolition or construction works, site preparation, excavation or delivery of plant and materials, the Consulting Arboriculturist or the LPA Tree Officer, as agreed, shall inspect the Temporary Ground Protection.
- 5. The Temporary Ground Protection shall remain in place until completion of the project and only removed following receipt of written permission from the LPA.
