# **Arboricultural Impact Assessment**

in Relation to Proposed  
Construction of Detached Garage at

**Plane Tree Cottage,  
Chipping Road, Chaigley,  
Lancashire, BB7 3LT**

# ARBORICULTURAL IMPACT ASSESSMENT PLANE TREE COTTAGE, CHAIGLEY

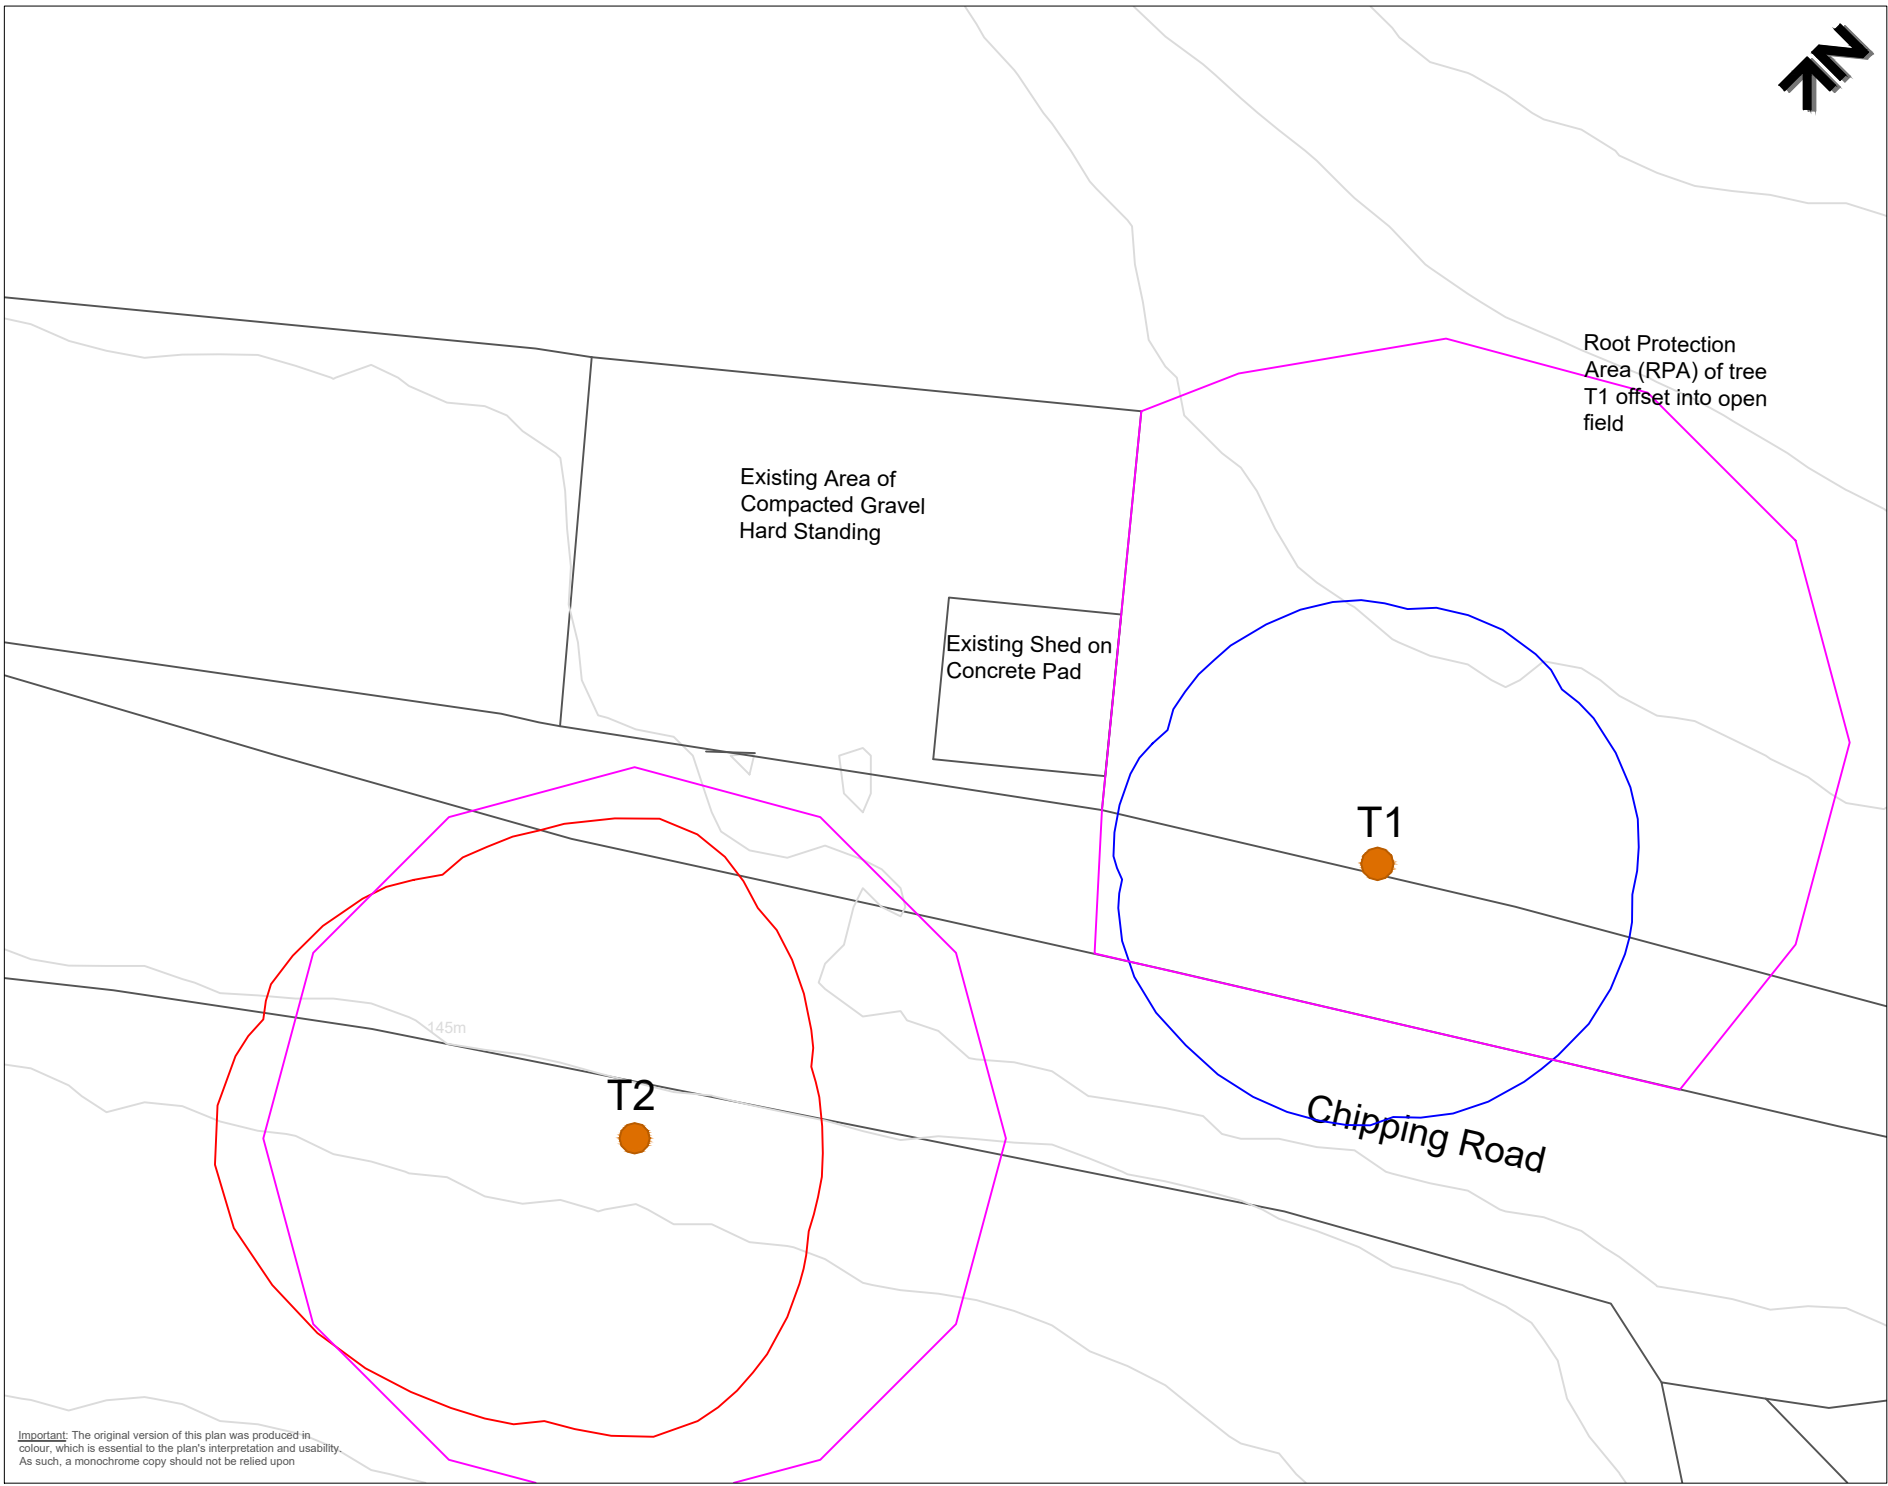
<b>Root Protection Areas (RPAs):</b>	
	RPAs: Area(s) of Ground Around Trees that Should be Protected Throughout Development Works with Protective Fencing to form a Construction Exclusion Zone - see Temporary Protective Fencing Specification
<b>Project:</b> PLANE TREE COTTAGE CHIPPING ROAD CHAIGLEY LANCASHIRE BB7 3LT	
<b>Client:</b> STEVE JACKSON	
<b>Title:</b> <b>TREE CONSTRAINTS PLAN</b> in Relation to Proposed Construction of Detached Garage	
Scale:	1:200@A4
Date:	October 2022
Drawn by:	MM
Checked by:	PH
e: info@bowlandtreeconsultancy.co.uk t: 01772 431150	
Ref: BTC2578-TCP	Rev:
