HERITAGE STATEMENT TO SUPPORT PLANNING & LISTED BUILDING CONSENT APPLICATIONS

FOR INTERNAL ALTERATIONS AND REINSTATEMENT OF TWO ROOFLIGHTS

AT FLAT 3, HODDER COURT, STONYHURST, BB7 9PP

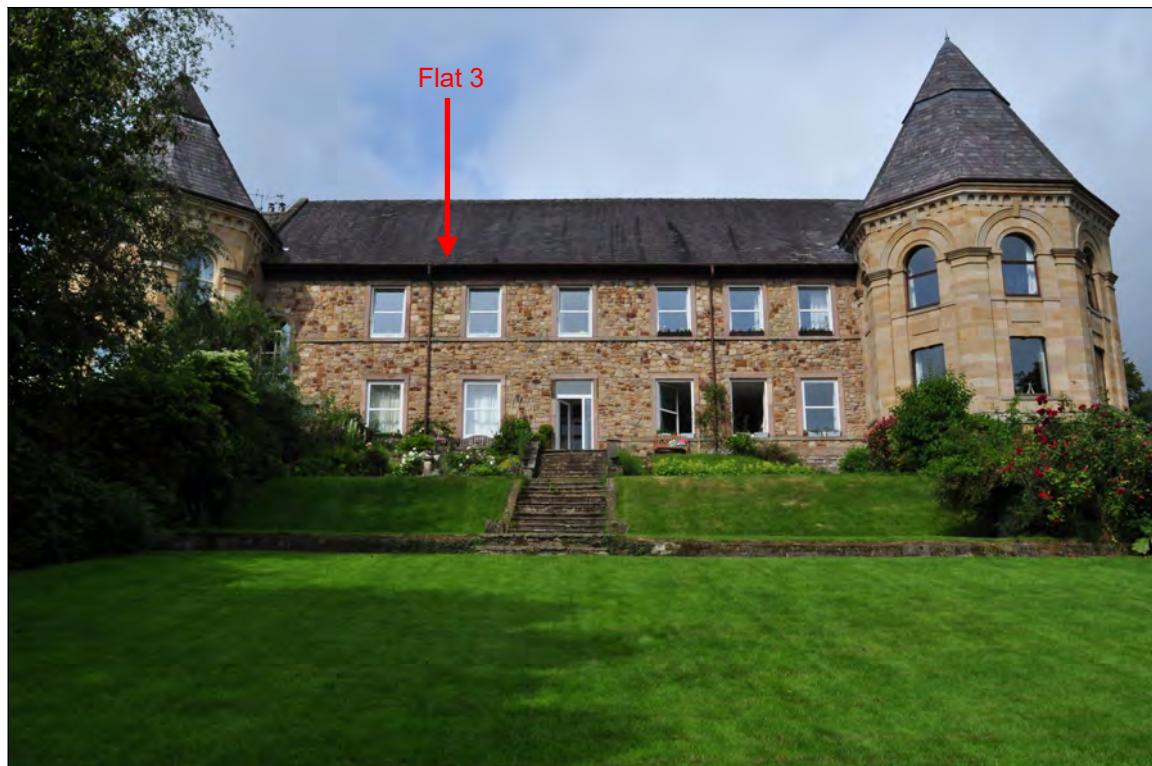
Photo 1: East side of range containing Flat 3: modern rebuilding, between end towers

6.1 The west and east elevations of Flat 3 and its neighbours are of random rubble, which evidently dates from rebuilding carried out as part of the 1980s conversion, although the array of windows in the east, garden front contains some re-used dressings, and is probably close to the previous fenestration pattern (photo 1, below). The windows in the west, courtyard side are however entirely modern in form and detail, and no remnants of the previous openings (as indicated on the 1981 planning application) survive (photo 2). The roof was no doubt likewise re-laid at that time and is of uniform blue slate, with tile ridge.

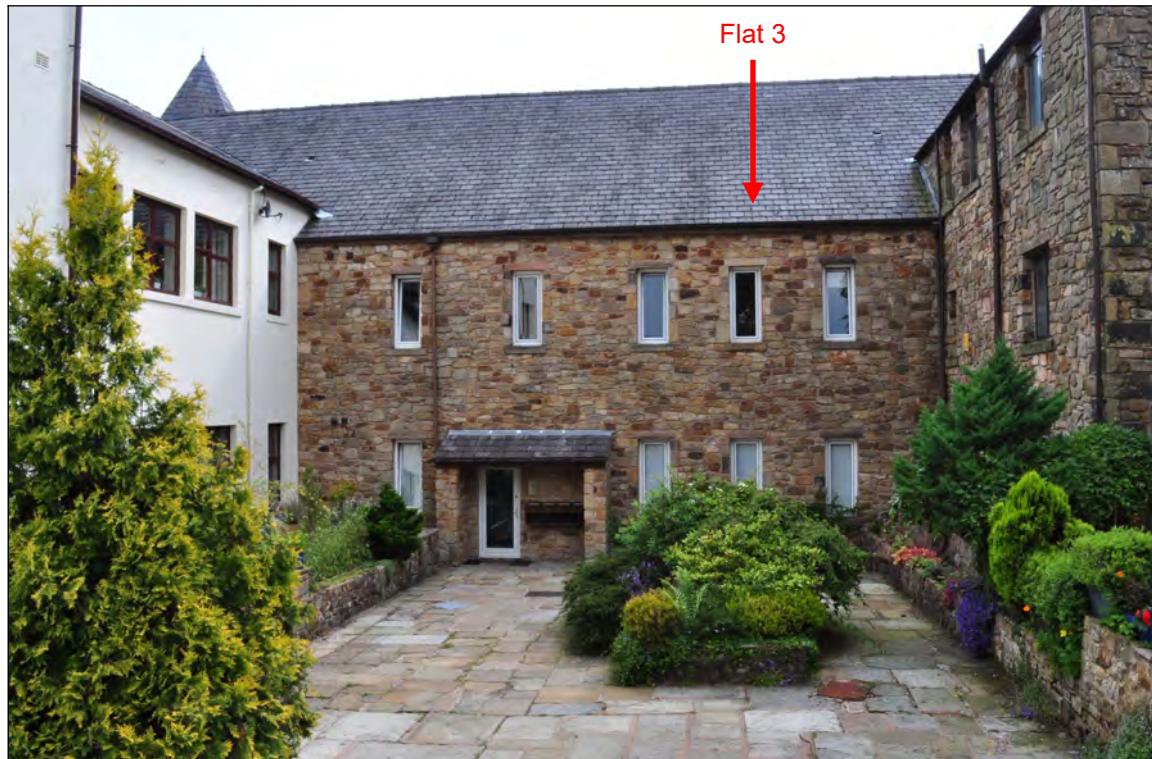
Photo 2: West side of range containing Flat 3: modern rebuilding, set between wings of similarly modern appearance

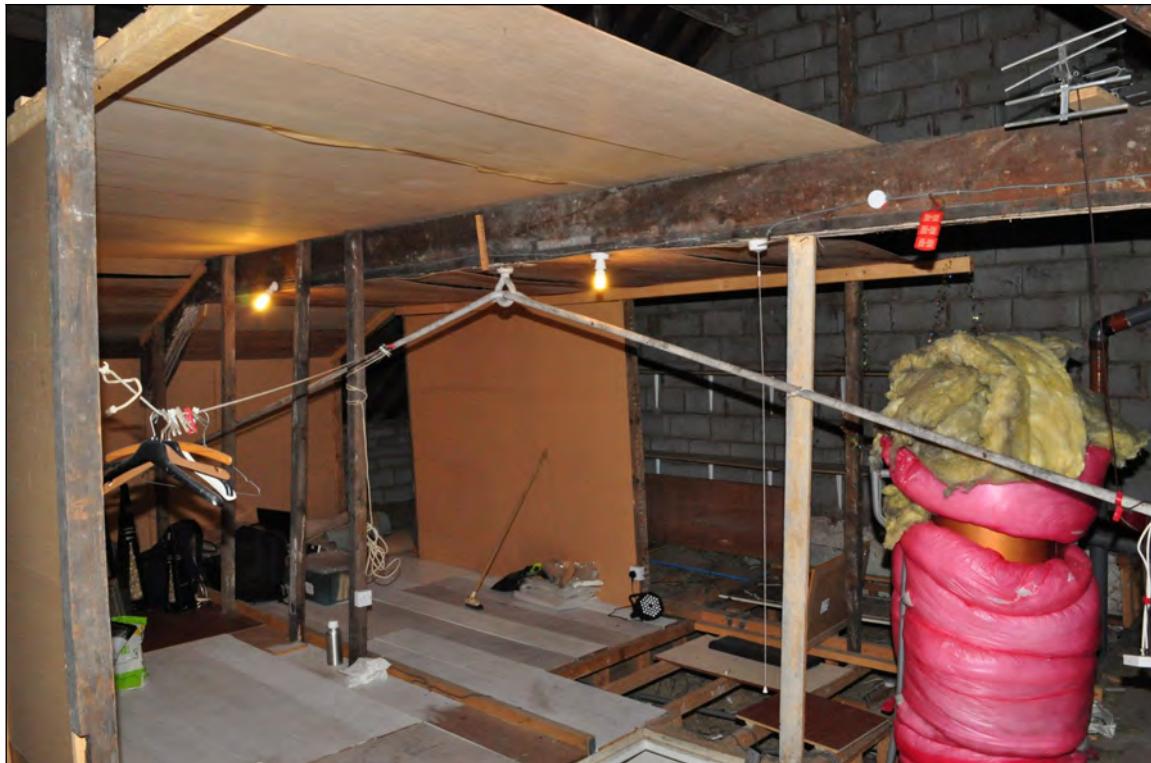
Photo 3: Roof space over Flat 3. Upper storey originally extended up to the collar, which retains traces of lath and plaster.

6.2 Flat 3 is on the first floor and the presently occupied rooms are entirely modern. However it has a large roof space, currently without natural light, and accessible only via a loft ladder. Inspection of the roof space shows that its lower part, below the collars of the trusses, was at one time ceiled over by lath and plaster, and probably formed the upper part of a formerly much taller upper storey within the building (photo 3). In the west side of the roof, above collar height, and central to the bays, there are two very obvious former openings for rooflights, below which would have been lath and plastered sides, to form lightwells down to the space beneath (photo 4).

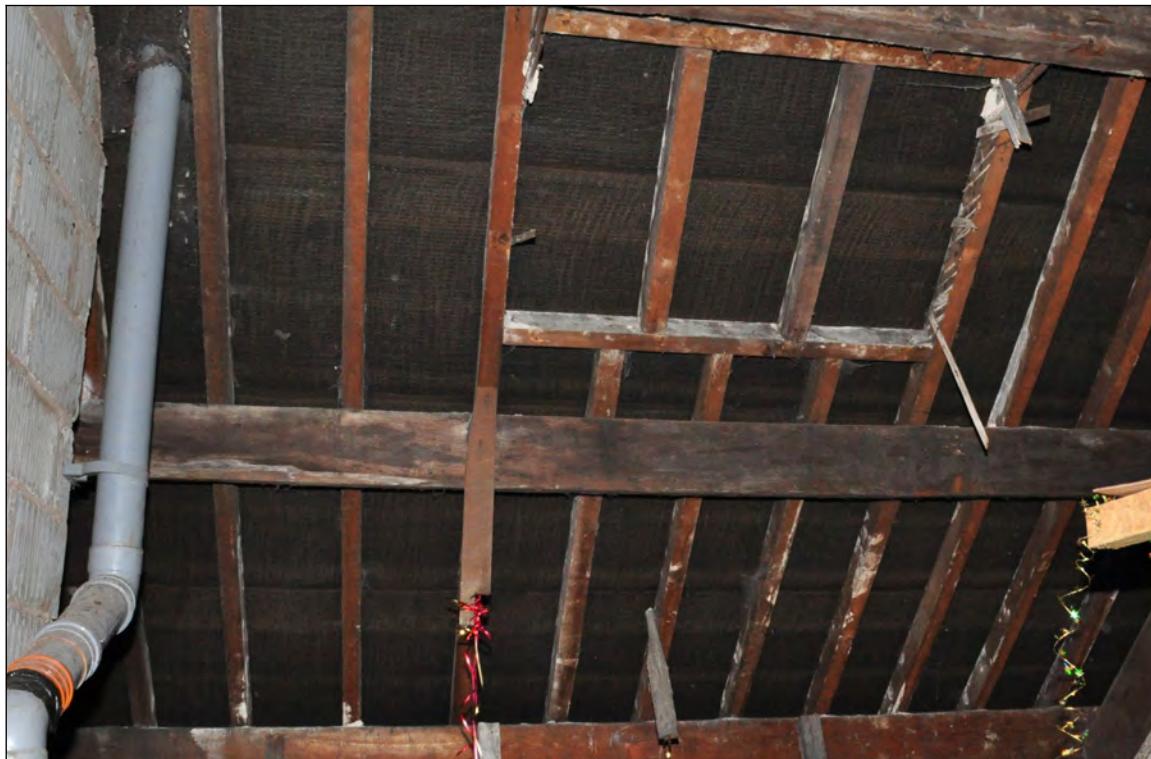
Photo 4: One of two former rooflights in west side, with remnants of lath and plaster lightwell to sides

4.1 It is proposed to alter the roof space over the flat to create additional accommodation, principally another bedroom and en suite bathroom. This would be accompanied by the reinstatement of two former rooflights in the west pitch.
