Arboricultural Impact Assessment

in Relation to Proposed Construction of New Driveway Access
(Planning Application No. 3/2023/0015) and Detached Triple Garage
(Planning Application No. 3/2023/0215) at

**Laneside House, Forest Beck Brow,
Wigglesworth, North Yorkshire,
BD23 4SL**

**ARBORICULTURAL IMPACT ASSESSMENT
LANESIDE HOUSE, FOREST BECK BROW, WIGGLESWORTH**

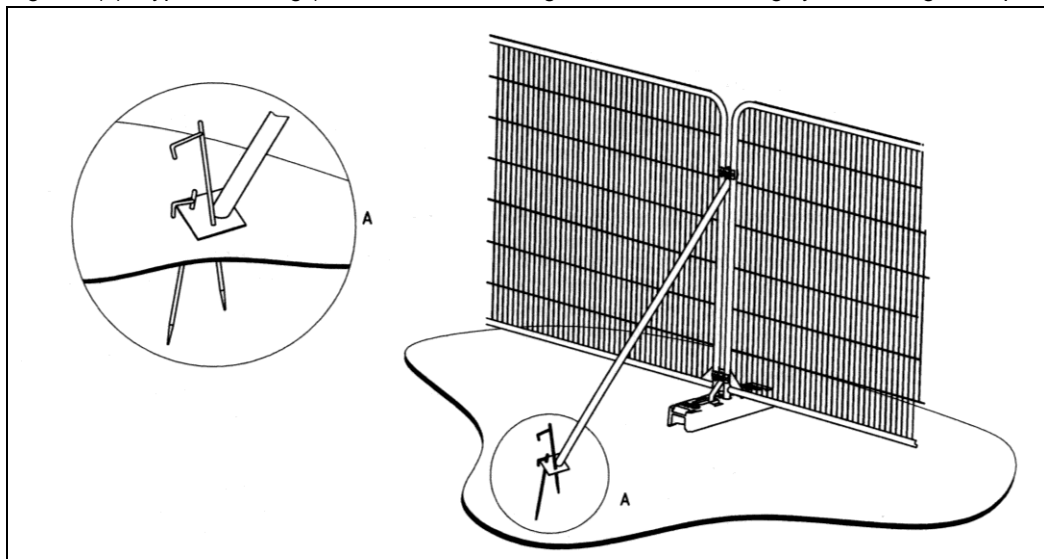
Figure 3(a): Type 2 Fencing (BS5837:2012 above-ground strut stabilising system with ground pins)

1. Temporary protective fencing panels shall be weldmesh "Heras" panels of at least 2.0 metres in height.
2. The panels shall stand on rubber or concrete feet.

3. The panels shall butt together, and be joined together using a minimum of two anti-tamper couplers, installed so that they can only be removed from inside the fence.

4. The distance between the fence couplers shall be at least 1.0 metre, and shall be uniform throughout the fence.
5. The panels shall be supported on the inner side by stabiliser struts, which shall be clamped to the scaffold framework at a 45° angle and extend back into the CEZ and shall be attached to a base plate, which shall be secured to the ground with pins (Figure 3a).

Type 2 Temporary Protective Fencing Construction (see Figure 3(a), below)
