Tree Protection Scheme

In Respect of Proposed Construction of Detached Garage at

**The Glebe Barn, Main Street,
Gisburn, Lancashire, BB7 4HR**

TREE PROTECTION SCHEME THE GLEBE BARN, MAIN STREET, GISBURN

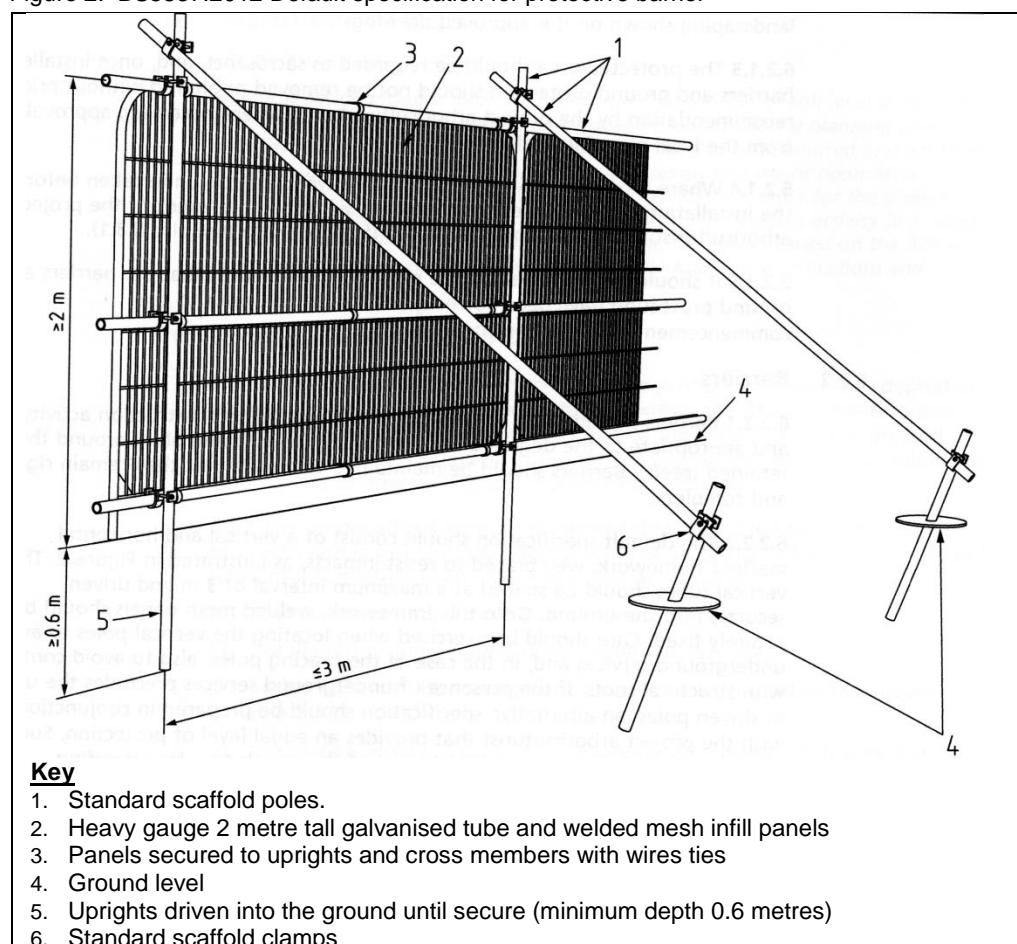
Figure 2: BS5837:2012 Default specification for protective barrier

Type 1 (i.e. 'Default') Temporary Protective Fencing Construction (see Figure 2, below)

1. Temporary protective fencing panels shall be weldmesh "Heras" panels of at least 2.0 metres in height.
2. The panels shall butt together and be securely fixed to a scaffold framework, as per points 3 to 5 of Figure 2, overleaf.

3. The scaffold framework shall comprise of upright poles of at least 3.0 metres in length driven no less than 0.6 metres into the ground at maximum 3.0 metre centres with horizontal and diagonal poles fixed to the uprights, as per points 4 to 5.

4. The two horizontal rail poles shall be attached to the uprights at heights of 0.6 and 1.8 metres with 3 no. clamps to each joint.
5. The diagonal scaffold pole struts be clamped to the top rail of the scaffold framework at a 45° angle and extend back into the CEZ and clamped to a 0.7 metre length of scaffold tube that shall be driven no less than 0.5m into the ground.

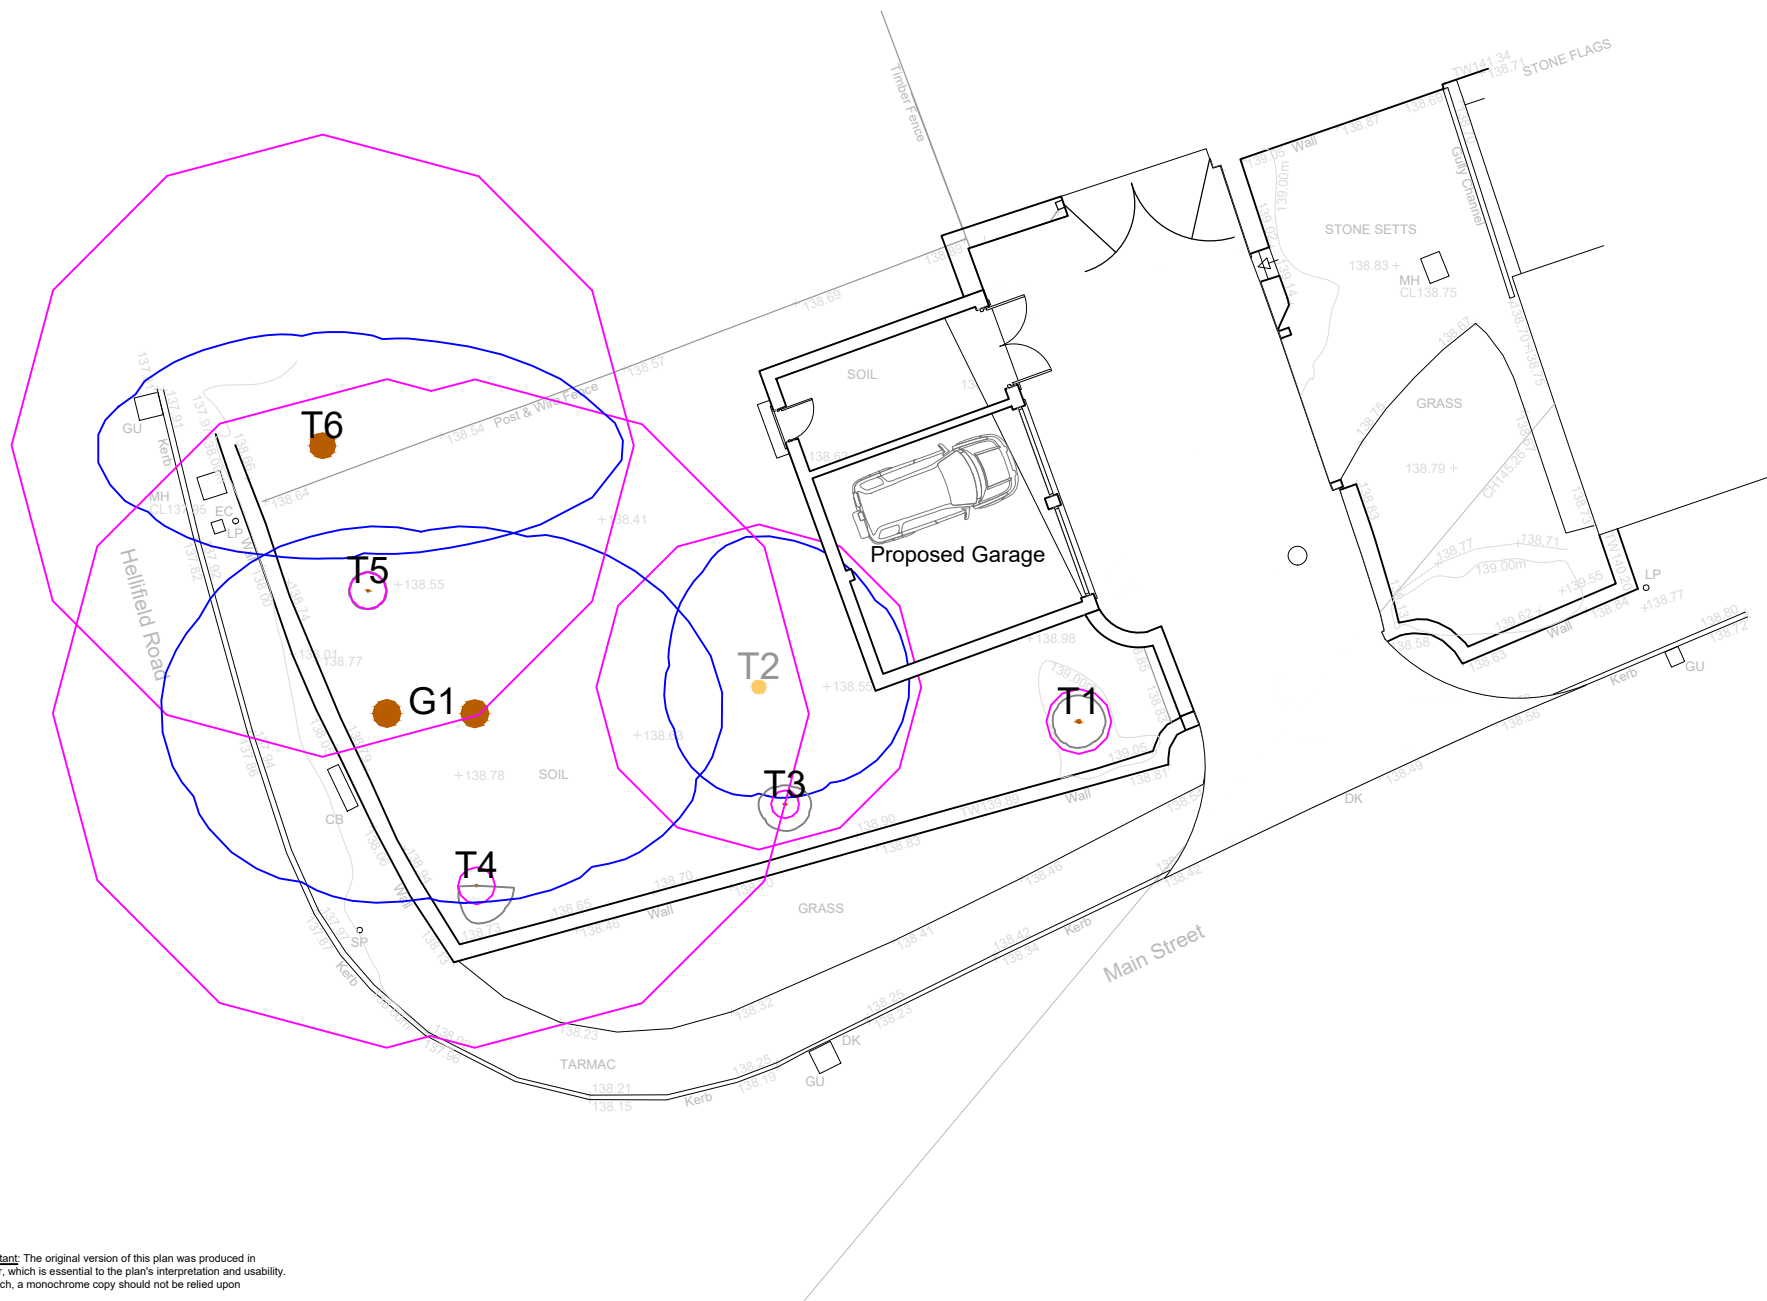
Title:
TREE IMPACT PLAN

Note 1: The locations of trees recently planted T1, T3, T4 and T5 were not included on the topographical survey plan provided, and were subsequently plotted by the arboricultural surveyor at the time of the survey using a combination of GPS siting and measurement from existing site features where possible. As such, the plotted locations of these trees cannot therefore be considered to be wholly accurate

Note 2: Trees with their numbers detailed in grey are proposed for removal in the context of the proposed development

RPAs
Area(s) of Ground Around Trees that Should be Protected Throughout Development Works with Protective Fencing to form a Construction Exclusion Zone - see Appended Temporary Protective Fencing Specification

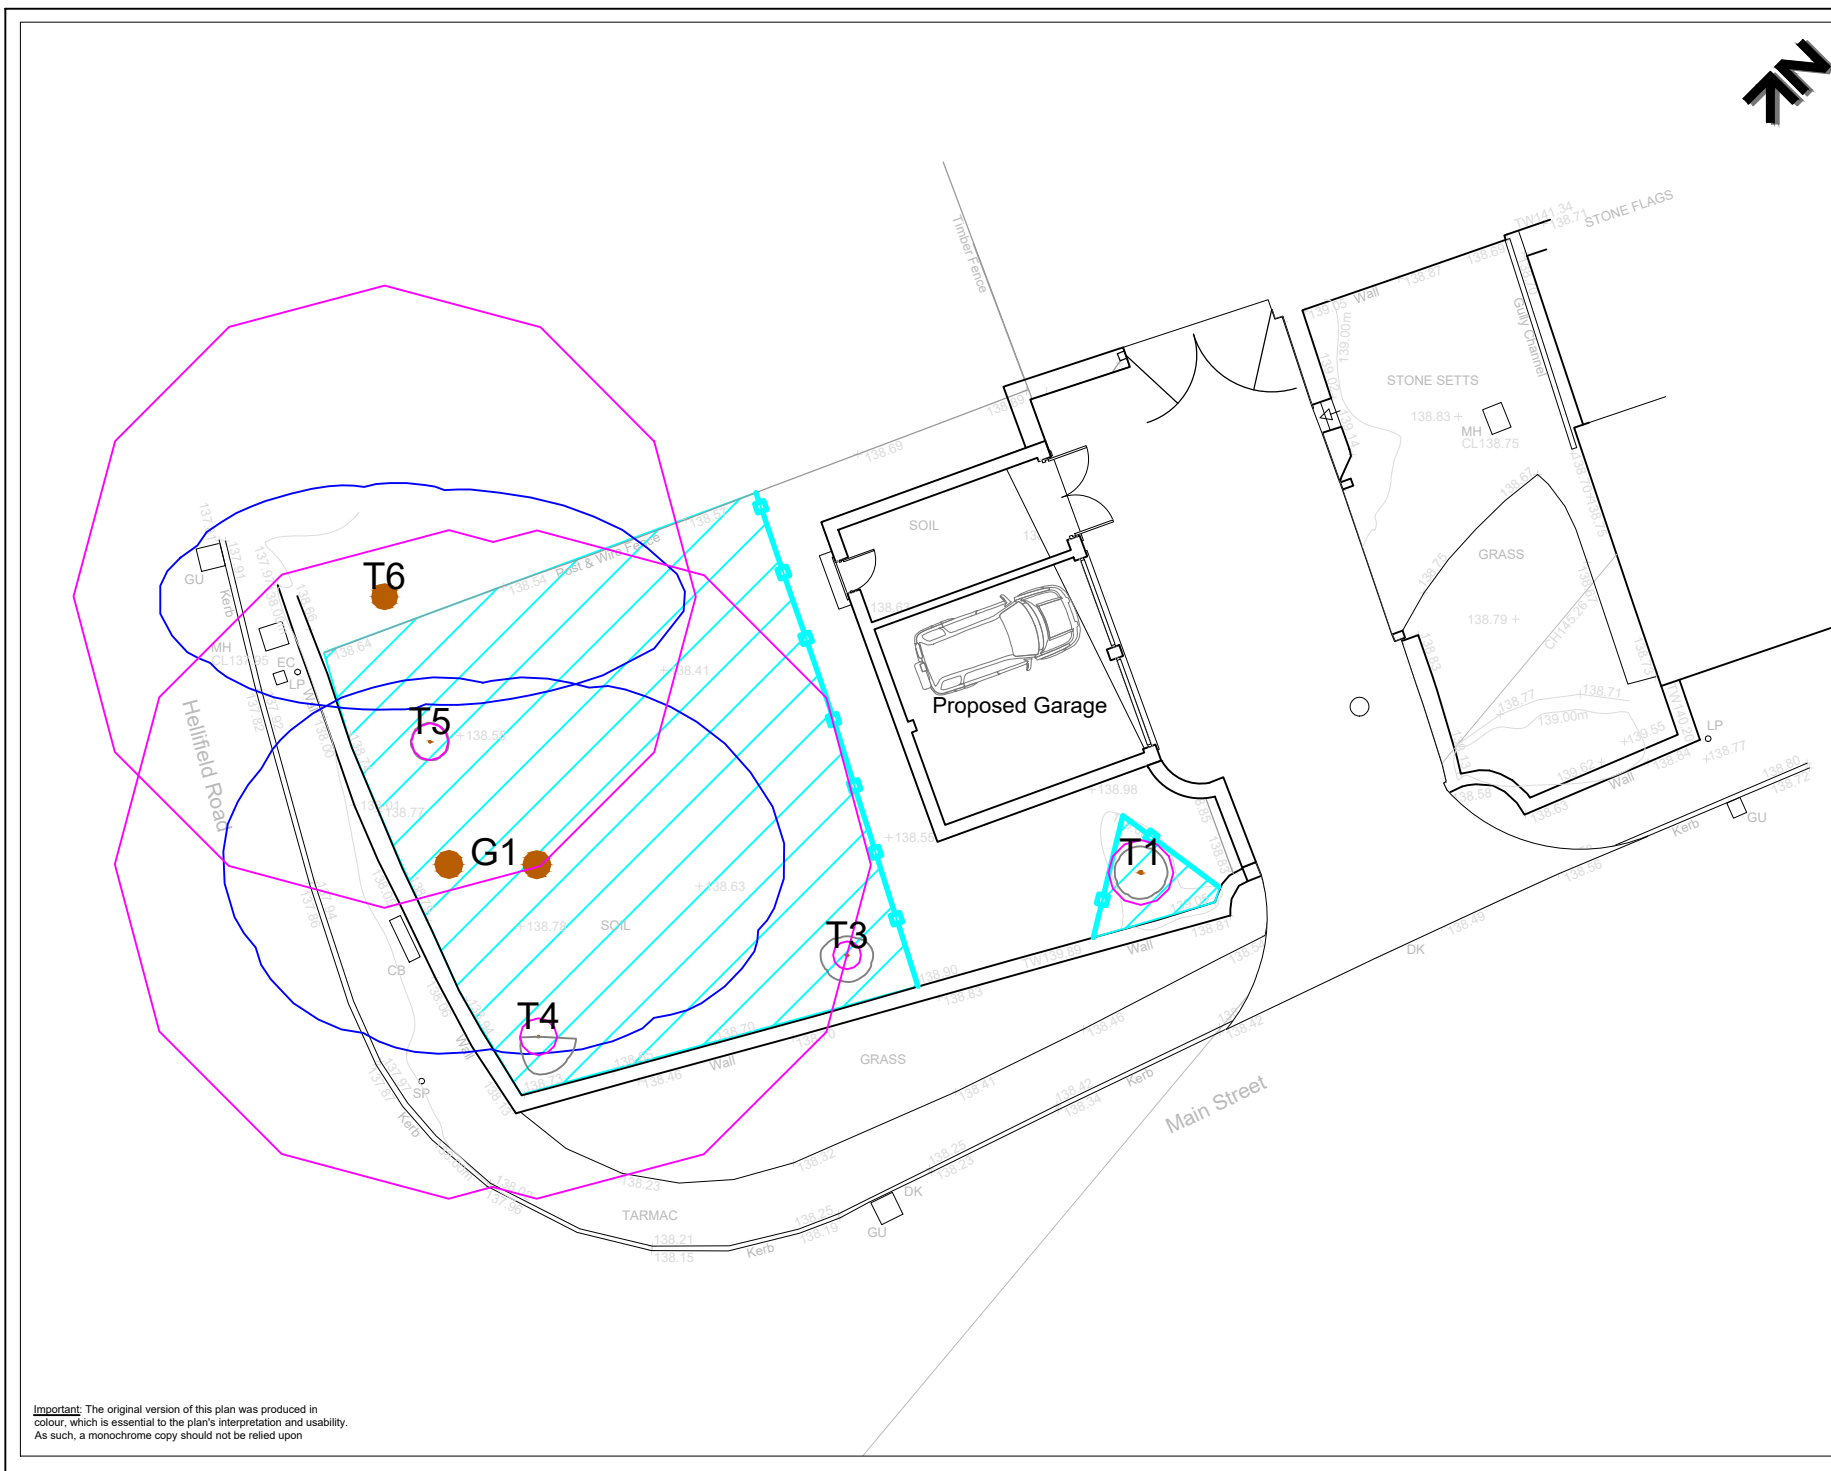
Root Protection Areas (RPAs): RPAs Area(s) of Ground Around Trees that Should be Protected Throughout Development Works with Protective Fencing to form a Construction Exclusion Zone - see Appended Temporary Protective Fencing Specification	
Tree Protection Measures: Construction Exclusion Zones (CEZs) Area(s) of Ground Around Retained Trees that are to be Enclosed with 'Type 1' Temporary Fencing Throughout Development Works. Note 1: Bold Line with Squares Represents Recommended Positioning of Fencing - see Temporary Protective Fencing Specification	
Project: THE GLEBE BARN MAIN STREET GISBURN LANCASHIRE BB7 4HR	
Agent: PWA PLANNING	
Title: TREE PROTECTION PLAN in Respect of Proposed Construction of Detached Garage	
Scale:	1:200@A4
Date:	March 2022
Drawn by:	PH
Checked by:	JL
Bowland Tree Consultancy Ltd e: info@bowlandtreeconsultancy.co.uk t: 01772 437190	
Ref: BTC2444-TPP	Rev:
