Arboricultural Constraints Appraisal

in Relation to Proposed Construction
of Detached Residential Property at

**Ashgreen House, Wiswell Lane,
Whalley, Lancashire, BB7 4AF**

Title:
TREE CONSTRAINTS PLAN
in Relation to Proposed Construction of Detached Residential Property

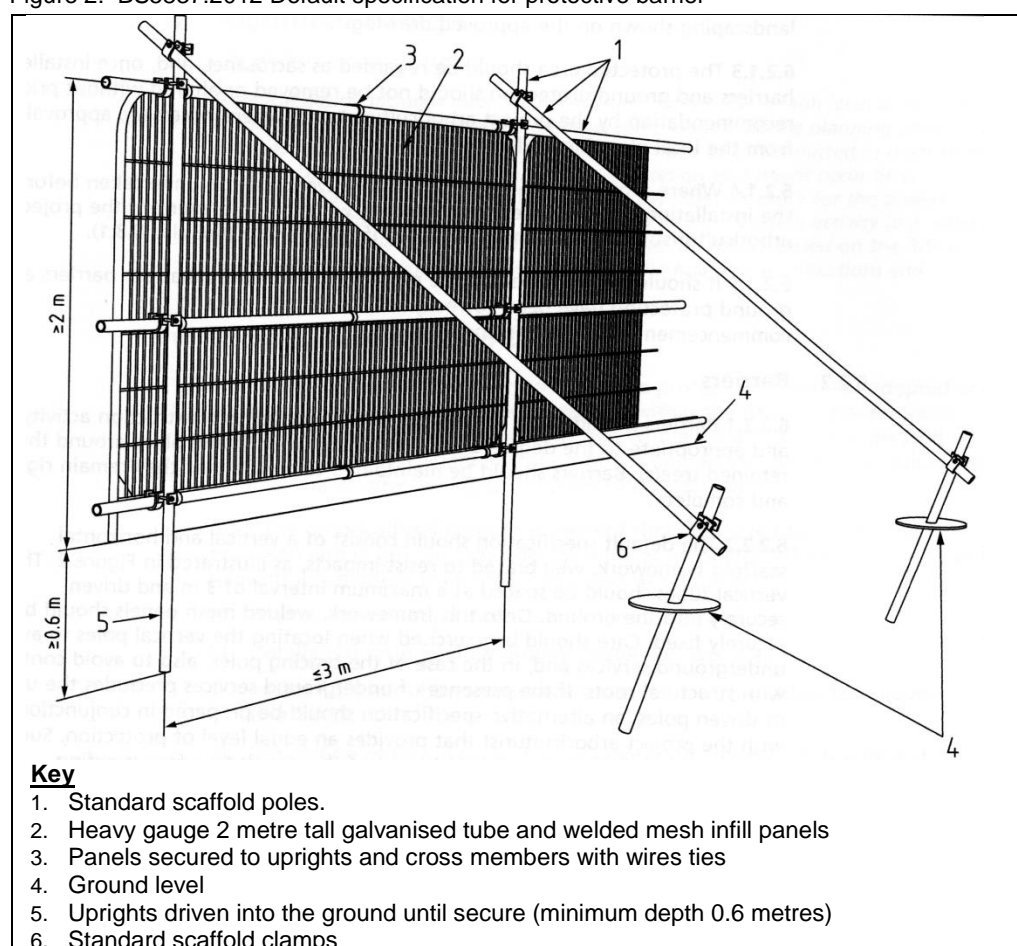
Figure 2: BS5837:2012 Default specification for protective barrier

Type 1 (i.e. 'Default') Temporary Protective Fencing Construction (see Figure 2, below)

1. Temporary protective fencing panels shall be weldmesh "Heras" panels of at least 2.0 metres in height.
2. The panels shall butt together and be securely fixed to a scaffold framework, as per points 3 to 5 of Figure 2, overleaf.

3. The scaffold framework shall comprise of upright poles of at least 3.0 metres in length driven no less than 0.6 metres into the ground at maximum 3.0 metre centres with horizontal and diagonal poles fixed to the uprights, as per points 4 to 5.

4. The two horizontal rail poles shall be attached to the uprights at heights of 0.6 and 1.8 metres with 3 no. clamps to each joint.
5. The diagonal scaffold pole struts be clamped to the top rail of the scaffold framework at a 45° angle and extend back into the CEZ and clamped to a 0.7 metre length of scaffold tube that shall be driven no less than 0.5m into the ground.

6. No fixing shall be made to any tree and all possible precautions shall be taken to prevent damage to tree roots when locating posts.
7. A 600mm x 300mm warning sign reading "TREE PROTECTION AREA KEEP OUT" (see Figure 1) shall be fixed to every 10.0 metre length of protective fencing.

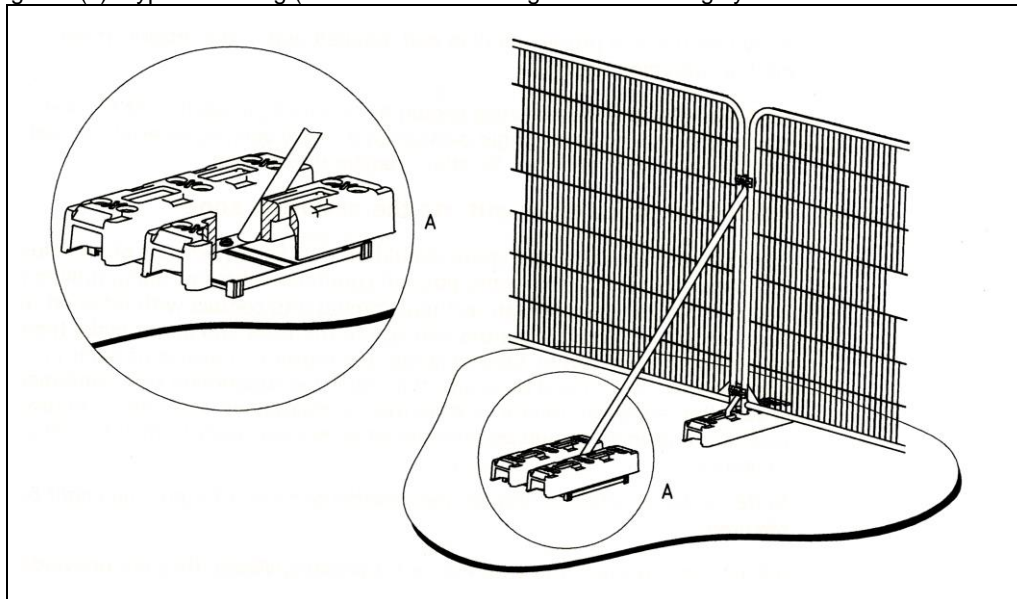
Figure 3(b): Type 3 Fencing (BS5837:2012 above-ground stabilising system with strut on block tray)

Type 3 Temporary Protective Fencing Construction (see Figure 3(b), overleaf)

1. Temporary protective fencing panels shall be weldmesh "Heras" panels of at least 2.0 metres in height.
2. The panels shall stand on rubber or concrete feet.

3. The panels shall butt together, and be joined together using a minimum of two anti-tamper couplers, installed so that they can only be removed from inside the fence.

4. The distance between the fence couplers shall be at least 1.0 metre, and shall be uniform throughout the fence.
5. The panels shall be supported on the inner side by stabiliser struts, which shall be clamped to the scaffold framework at a 45° angle and extend back into the CEZ and shall be attached to a block tray base (Figure 3b).

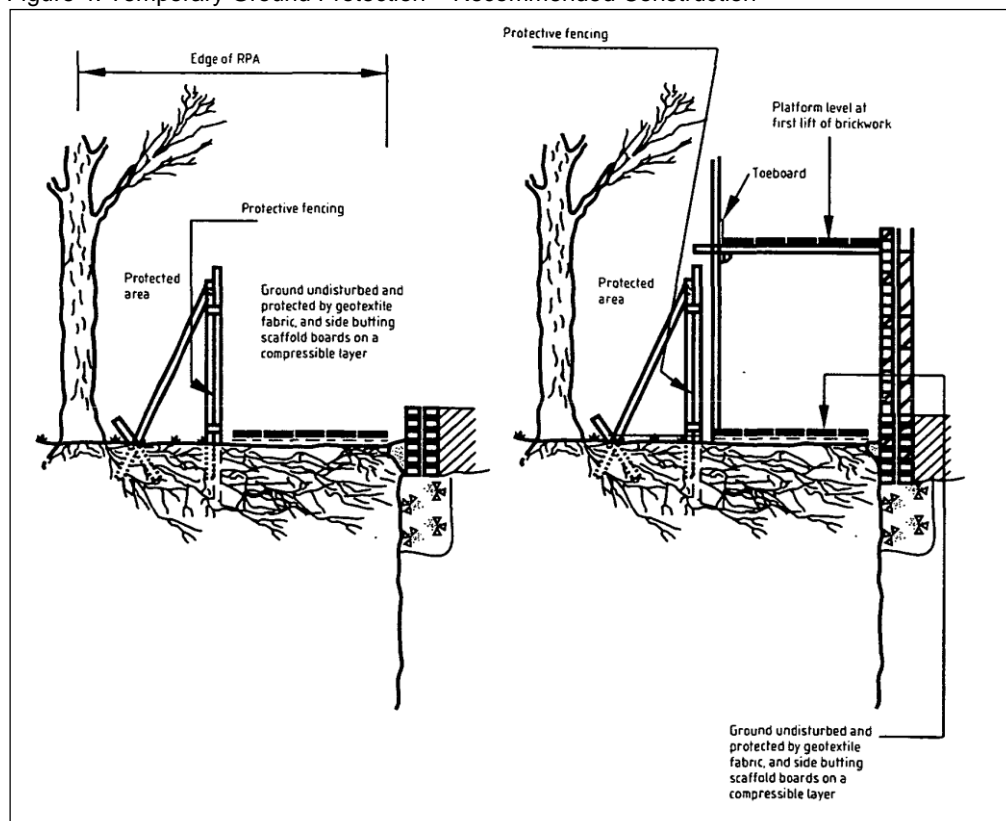
Figure 4: Temporary Ground Protection – Recommended Construction

Temporary Ground Protection

1. Any necessary Temporary Ground Protection areas shall conform to Figure 4, below, unless otherwise agreed with the LPA.
2. The Ground Protection Area shall be left undisturbed and covered by a semi-permeable geotextile membrane which shall, in turn, be covered by a compressible layer consisting of a material such as woodchip.
3. Side-butting scaffold boards shall then be fitted to cover the Ground Protection Area.
4. On completion of installation, and prior to any demolition or construction works, site preparation, excavation or delivery of plant and materials, the Consulting Arboriculturist or the LPA Tree Officer, as agreed, shall inspect the Temporary Ground Protection.
5. The Temporary Ground Protection shall remain in place until completion of the project and only removed following receipt of written permission from the LPA.
