# **Arboricultural Constraints Appraisal**

in Relation to Proposed Construction  
of a Detached Residential Property at

**1 Ribblesdale Avenue,  
Wilpshire, Lancashire,  
BB1 9LY**

**Title:**  
**TREE CONSTRAINTS PLAN**  
in Relation to Proposed Construction of a Detached Residential Property

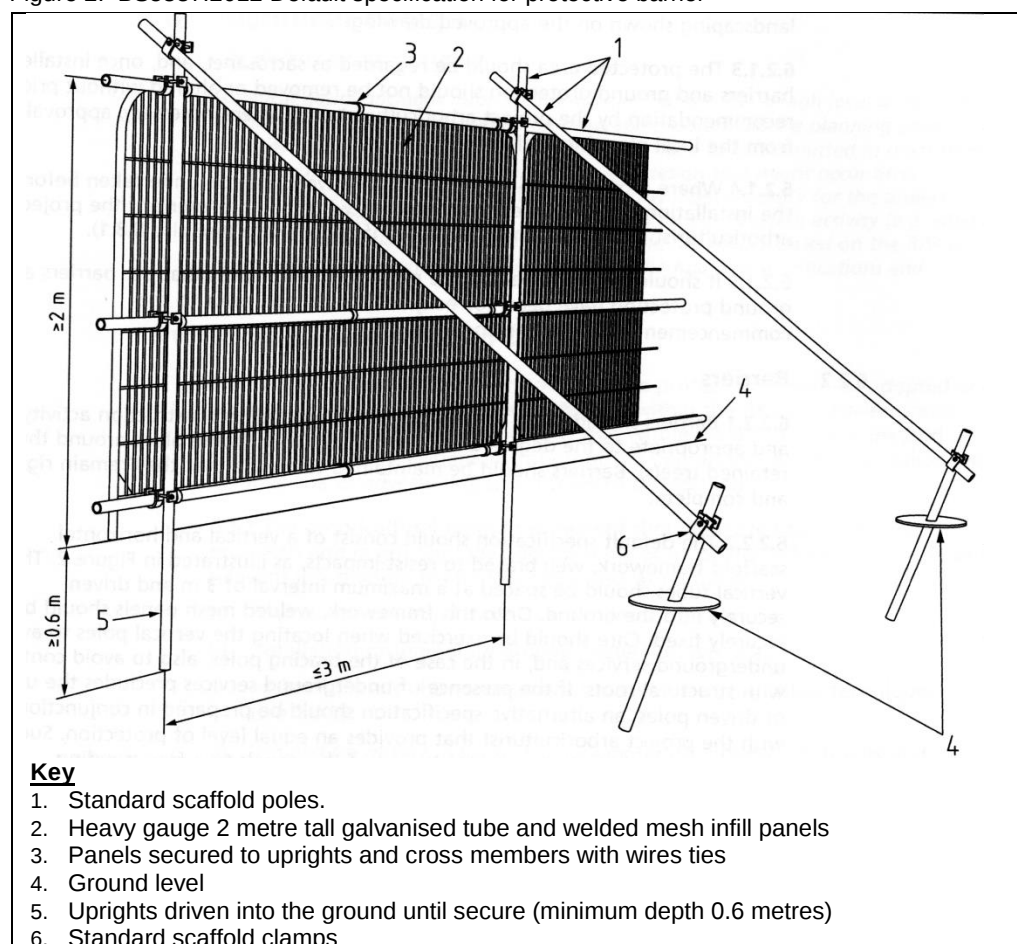
Figure 2: BS5837:2012 Default specification for protective barrier

**Type 1 (i.e. 'Default') Temporary Protective Fencing Construction** (see Figure 2, below)

1. Temporary protective fencing panels shall be weldmesh "Heras" panels of at least 2.0 metres in height.
2. The panels shall butt together and be securely fixed to a scaffold framework, as per points 3 to 5 of Figure 2, overleaf.

3. The scaffold framework shall comprise of upright poles of at least 3.0 metres in length driven no less than 0.6 metres into the ground at maximum 3.0 metre centres with horizontal and diagonal poles fixed to the uprights, as per points 4 to 5.

4. The two horizontal rail poles shall be attached to the uprights at heights of 0.6 and 1.8 metres with 3 no. clamps to each joint.
5. The diagonal scaffold pole struts be clamped to the top rail of the scaffold framework at a 45° angle and extend back into the CEZ and clamped to a 0.7 metre length of scaffold tube that shall be driven no less than 0.5m into the ground.

6. No fixing shall be made to any tree and all possible precautions shall be taken to prevent damage to tree roots when locating posts.
7. A 600mm x 300mm warning sign reading "TREE PROTECTION AREA KEEP OUT" (see Figure 1) shall be fixed to every 10.0 metre length of protective fencing.

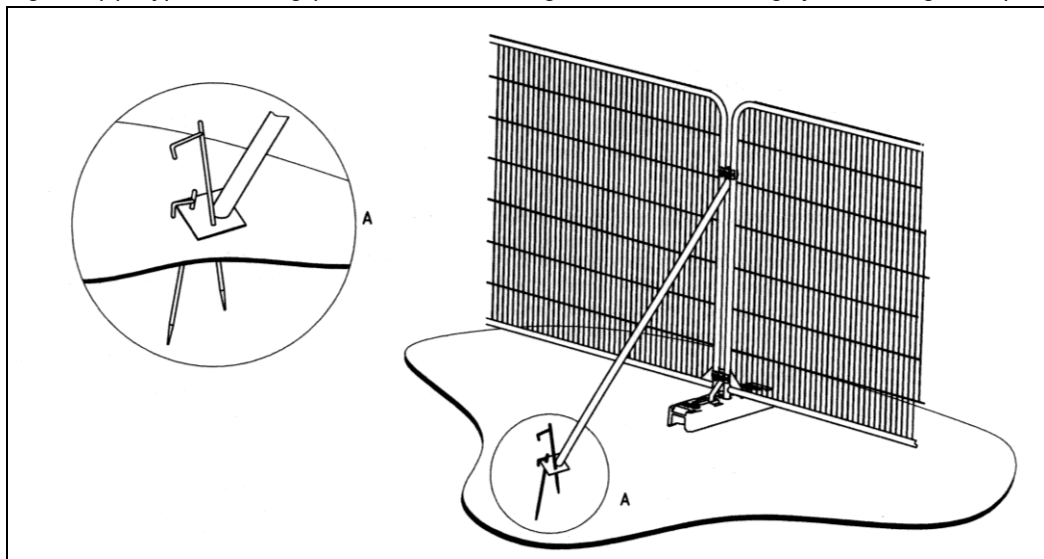
Figure 3(a): Type 2 Fencing (BS5837:2012 above-ground strut stabilising system with ground pins)

### **Type 2 Temporary Protective Fencing Construction** (see Figure 3(a), below)

1. Temporary protective fencing panels shall be weldmesh "Heras" panels of at least 2.0 metres in height.
2. The panels shall stand on rubber or concrete feet.

3. The panels shall butt together, and be joined together using a minimum of two anti-tamper couplers, installed so that they can only be removed from inside the fence.

4. The distance between the fence couplers shall be at least 1.0 metre, and shall be uniform throughout the fence.
5. The panels shall be supported on the inner side by stabiliser struts, which shall be clamped to the scaffold framework at a 45° angle and extend back into the CEZ and shall be attached to a base plate, which shall be secured to the ground with pins (Figure 3a).

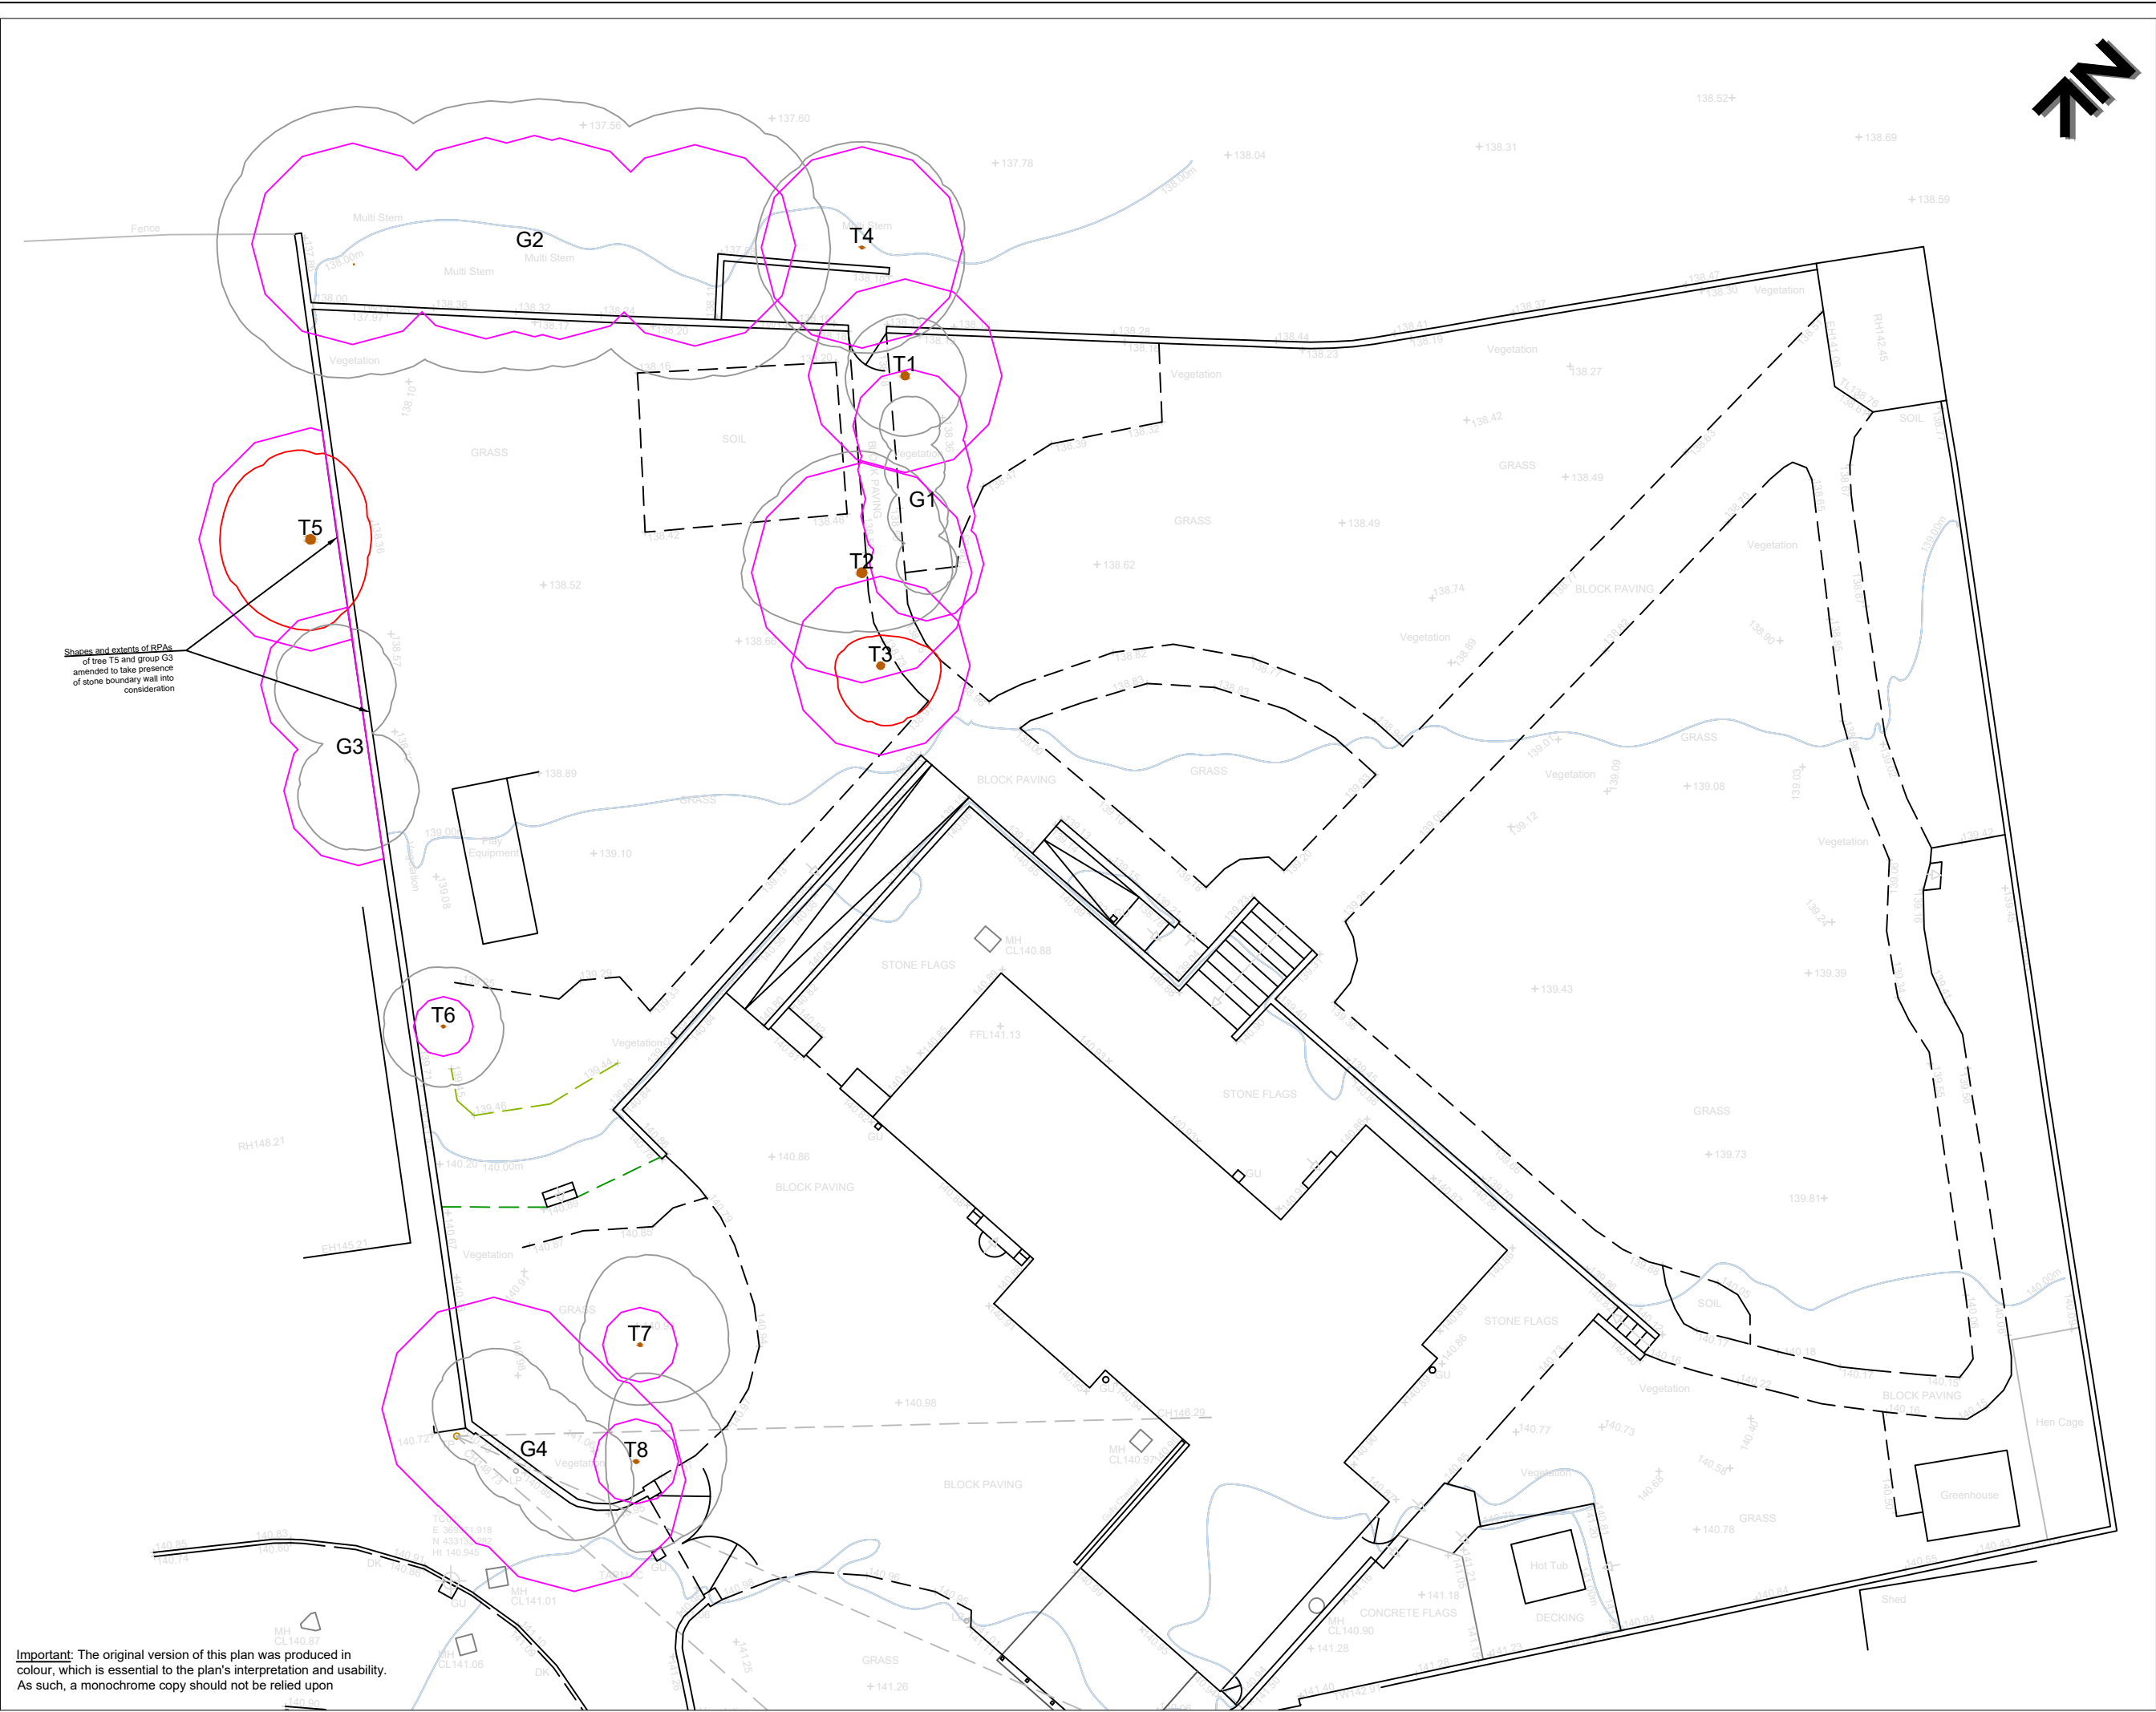
Note: The locations of trees T1, T5 and T6, and groups G1, G3 and G4 were not included on the topographical survey plan provided, and were subsequently plotted by the arboriculturist at the time of the survey using GPS and, where possible, measurement from existing site features or, where not possible, estimation. As such, the locations of these trees and the locations and extents of these groups cannot therefore be considered to be entirely accurate

RPAs  
Area(s) of Ground Around Trees that Should be Protected Throughout Development Works with Protective Fencing to form a Construction Exclusion Zone - see Temporary Protective Fencing Specification
