# HERITAGE STATEMENT

Horse Walker & Multipurpose Agricultural Building.

Land at Portfield Farm Barn, Portfield Lane, Whalley, BB7 9DP

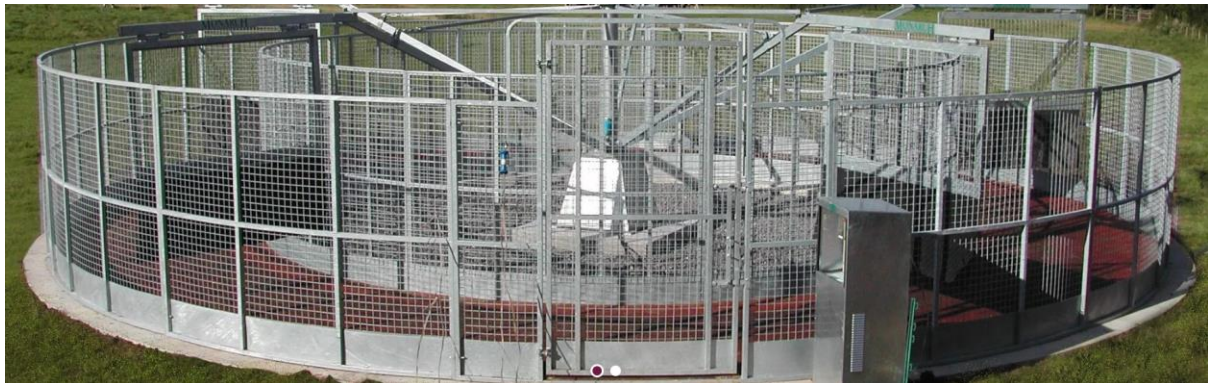
Proposed image of horse walker

Sit between the Barn and the proposed development is an existing menage that is enclosed by timber post and rail fencing. Behind this will sit the horse walker, a galvanized steel structure approximately 2m high.

The proposed design of the storage building reflects the materials used for agricultural buildings in the rural locality and the horse walker is potentially demountable can be removed in the future.
