**BAT SURVEY AT -
10 PENDLETON AVENUE
CLITHEROE**

**DATE AND TIME OF VISIT
10nd July 2023 2.30pm**

Conversion of roof space to form additional accommodation.

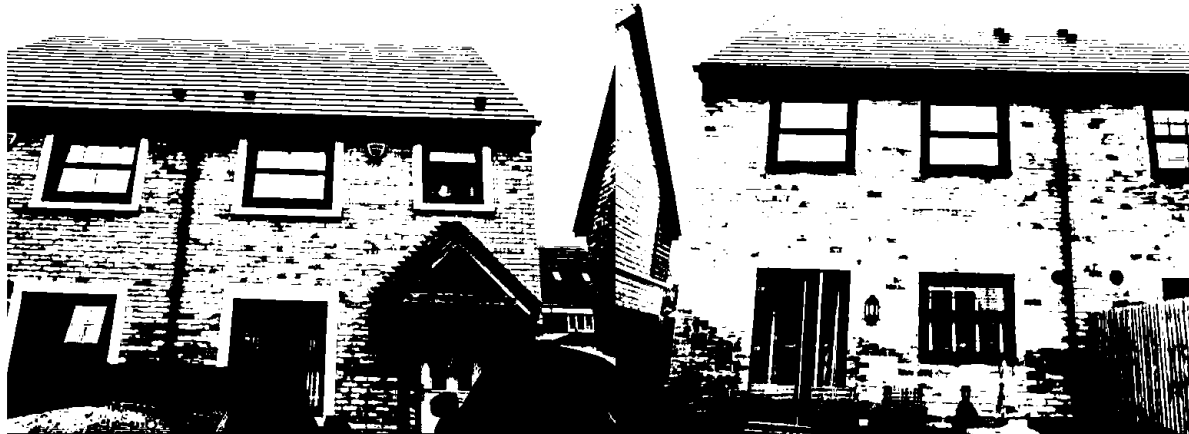
Semi detached house built in 2019.

Front elevation

Rear elevation
