### Re: Proposed development at Glebe Barn, Main Street, Gisburn BB7 4HR

We understand that the proposal is for the conversion of an existing garage into a kitchen and roof replacement to the dwelling house, and the installation of roof lights to an existing, detached garage building.

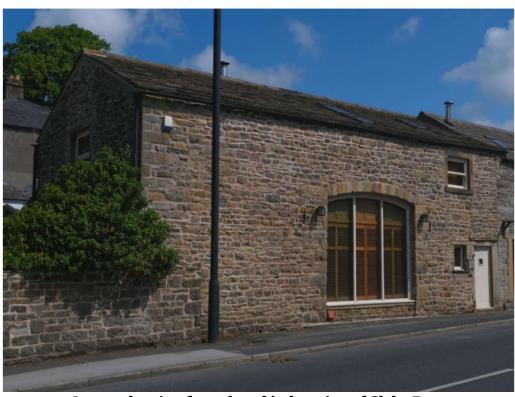
Image showing front (south) elevation of Glebe Barn

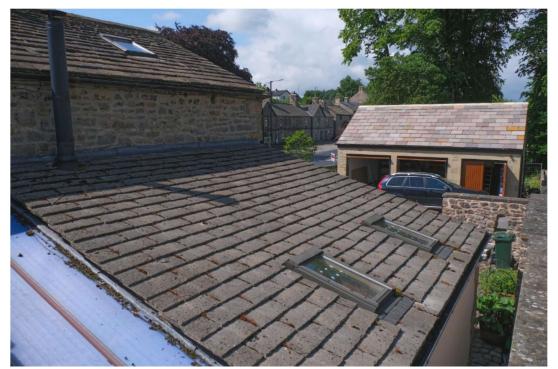
The walls of the dwelling house are constructed of stone, in good condition with no gaps. The roof of the house is covered with original stone tiles and the single garage is a mono-pitch roof with cement tiles. Velux windows are present on both the north and south pitch of the roofs. The ridge, roof edges and west gable verge are all well-sealed with no visible gaps; there are however, gaps throughout the dwelling house roof coverings, associated with the natural fit of the stone and these gaps have some potential for bats throughout the year. There are no enclosed roof spaces associated with the dwelling house and integral garage. The roof in the dwelling house is vaulted and used as living rooms and all internal ceilings are sealed and well maintained.

Image showing rear (north) elevation showing roof coverings on dwelling house, single mono-pitch garage and view of double garage in background.

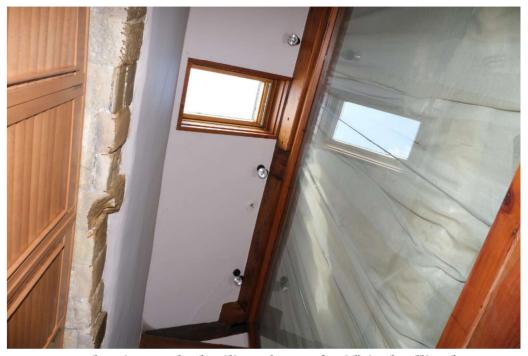
Image showing vaulted ceilings (no roof void) in dwelling house

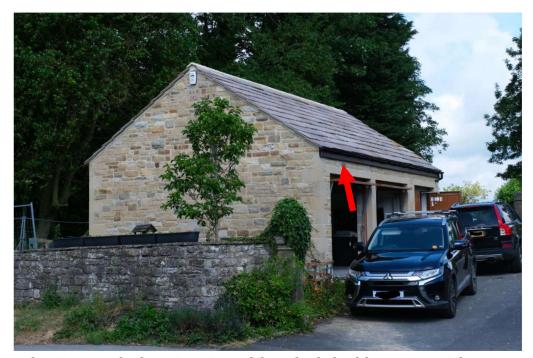
Low potential –gaps associated with the roof covering (dwelling house), fascia boards and wall tops (detached garage)

The garden areas are paved with very limited vegetation suitable for nesting birds. Small birds could utilise gaps associated with roof coverings on the dwelling house and the wall tops and fascia gaps associated with the detached garage.

Image showing south elevation view of detached, double garage with mature trees to the immediate west and north. Small gaps present (red arrow) along wall top and fascia boards on the west and east elevation

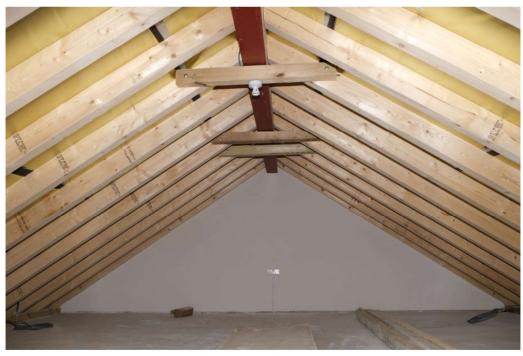
The detached double garage is a new building constructed of stone outer walls with block inner walls and steel frame supports. The roof is covered with slate and underlined with a modern roof membrane. There is a large roof void (divided in two). The roof void is boarded on the floor with rock wool insulation beneath the floor boards. There are a small number of gaps along the wall top and behind the UPVC fascia boards on the east and west elevation and these gaps have some potential for use by bats throughout the year, as well as use by small birds during the bird nesting season (February to September).

Image showing roof void with intact modern roof liner above detached double garage
