Details of window & door repair/replacement.

Windows

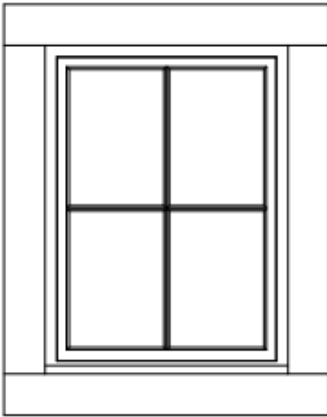
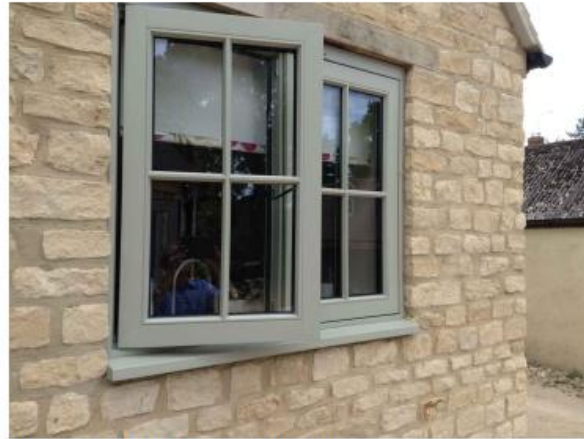
Timber Casement Window Details:

- Side opening
- Double glazing

Proposed Painted Timber Windows

Proposed Timber Casement Window Elevation

See SPA Drawing: 6521 DOC3 for full detail/cross section.

Images taken from 6521 DOC3.

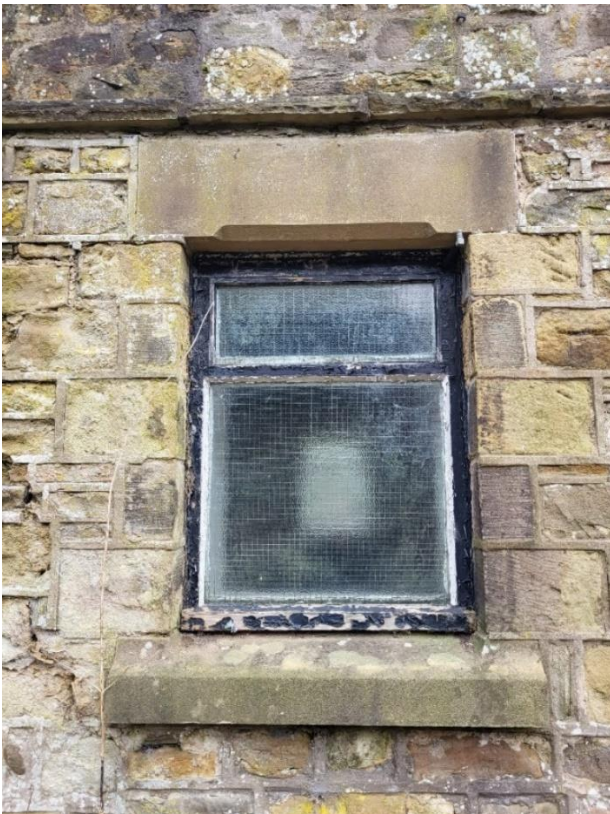
Image below of window and surround on the men's toilet block which is being removed.

Existing window below 69cmx95cm.

Stone surrounds to be reused on the new window W01 to match W14 & W15 which are on the same elevation.

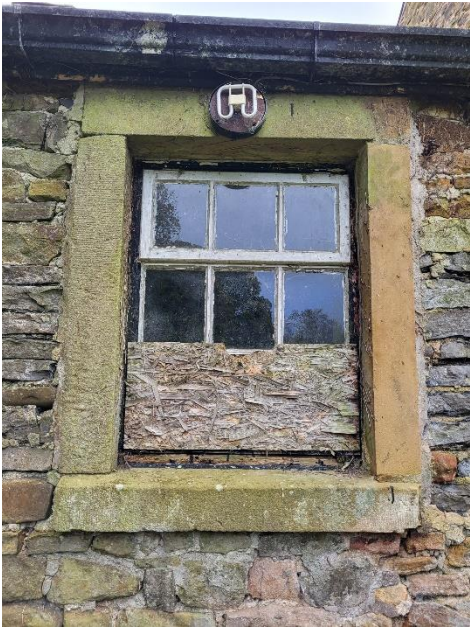
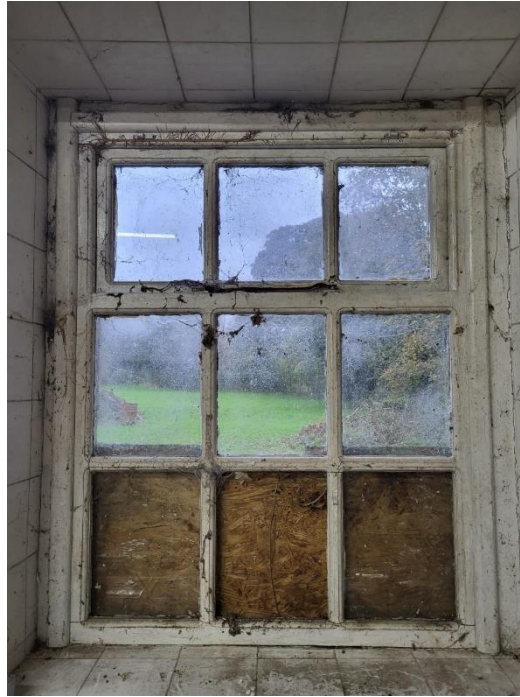
W03 – Workshop

98cmx113cm

Repair/restore.

- Replace missing glazing and handle.
- Top opening.
- Retain existing single glazing.

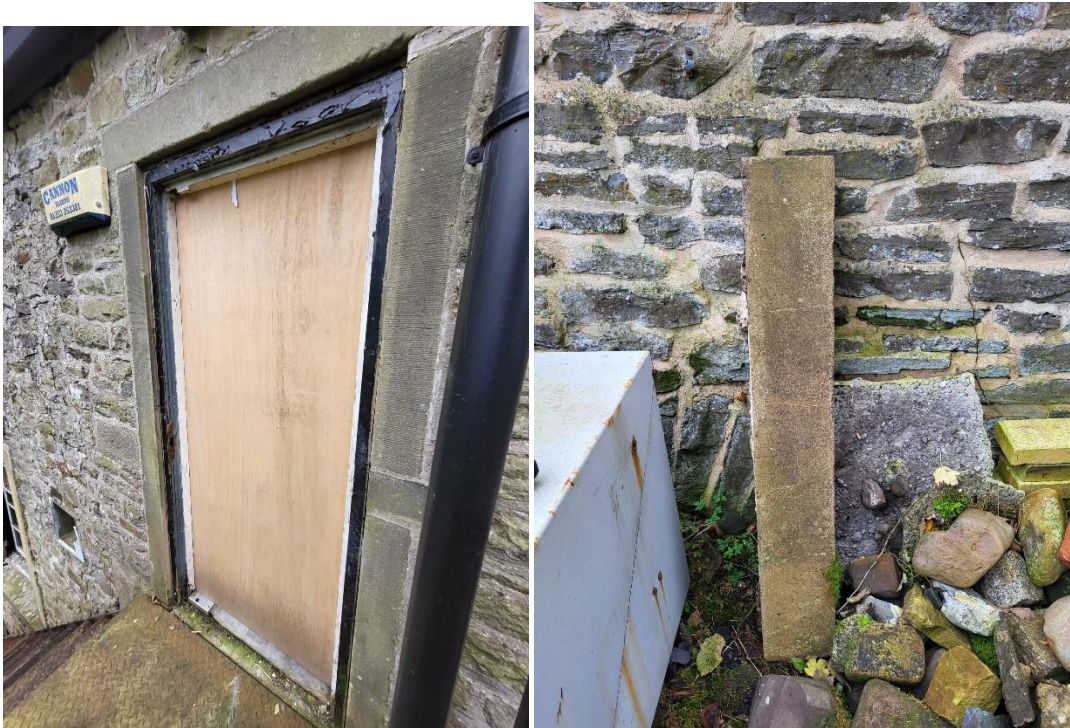
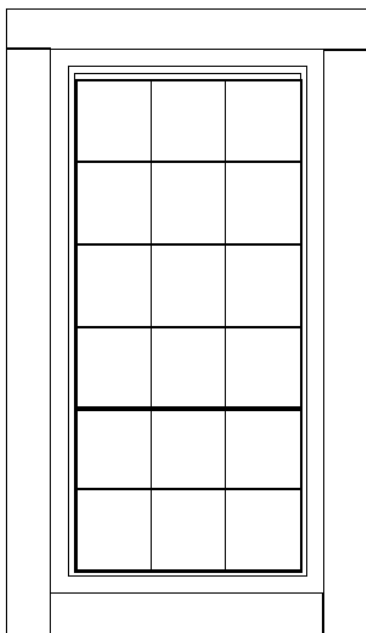
W04 - NEW – Ensuite - Long glass window to ensuite

200cmx90cm

Design

Window frame - 2000mm X 900mm

New stone surround piece needed at the bottom - Stone found on site.

Double glazing.

No opening for safety at floor level and there is another window which opens in the same room.

Design to match existing windows on the rear of the property.

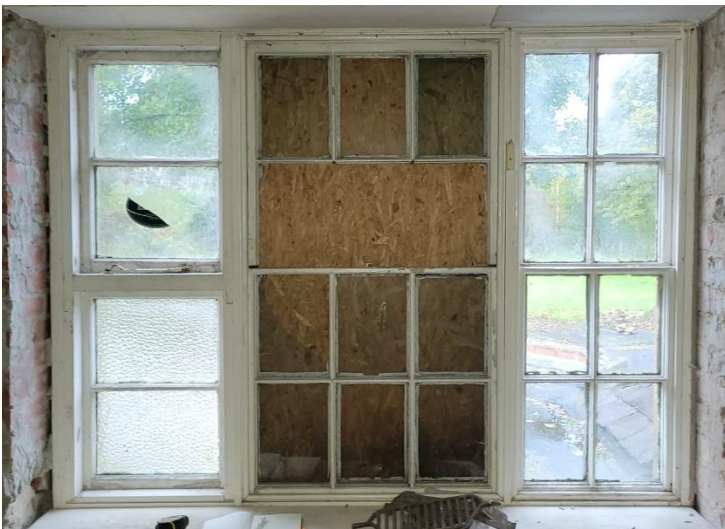
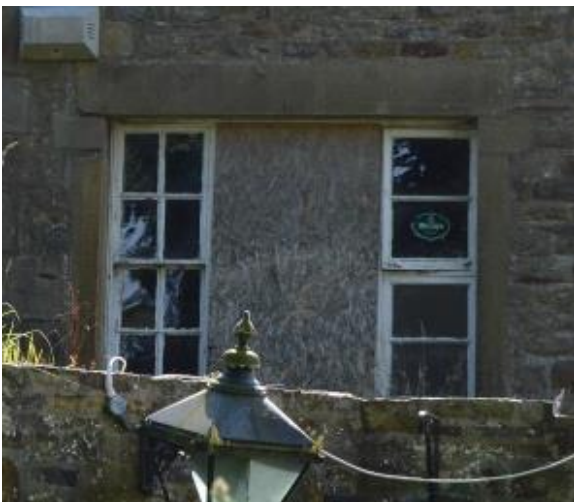
W05 Bedroom – Replace with new – Mismatched over time and broken.

196cmx143cm

Middle sash 80cmx143cm

Side sections 57x143cm

Double glazing.

Sliding sash middle panel to be replaced like for like.

Side panels to match current left-hand side (if looking from the outside)

No opening on the side panels.

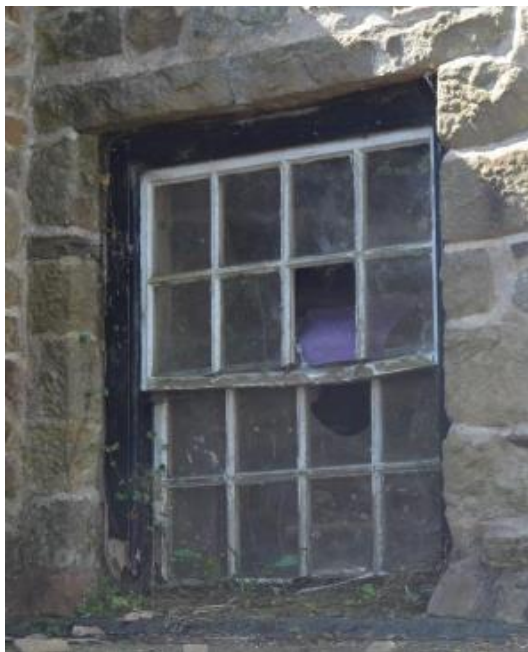
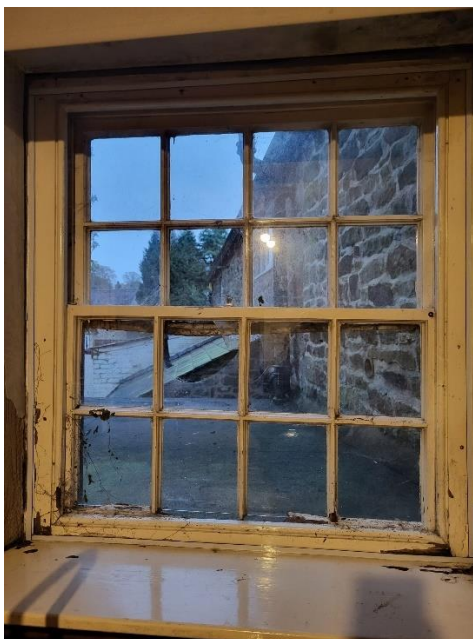
W08 – Holiday let kitchen - 110cmx105cm

Replace – Frames are rotten/not able to repair.

Replace like for like, sliding sash windows with original design.

Double glazing

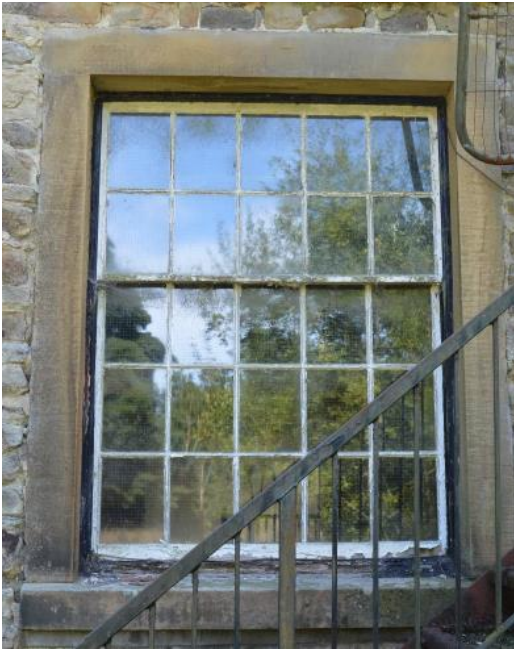
W10 - Bar

150cmx175cm

Repair/restore existing sliding sash window.

New beads, ropes, and weights.

Glazing type – remove existing commercial safety glass glazing and replace with double glazing.

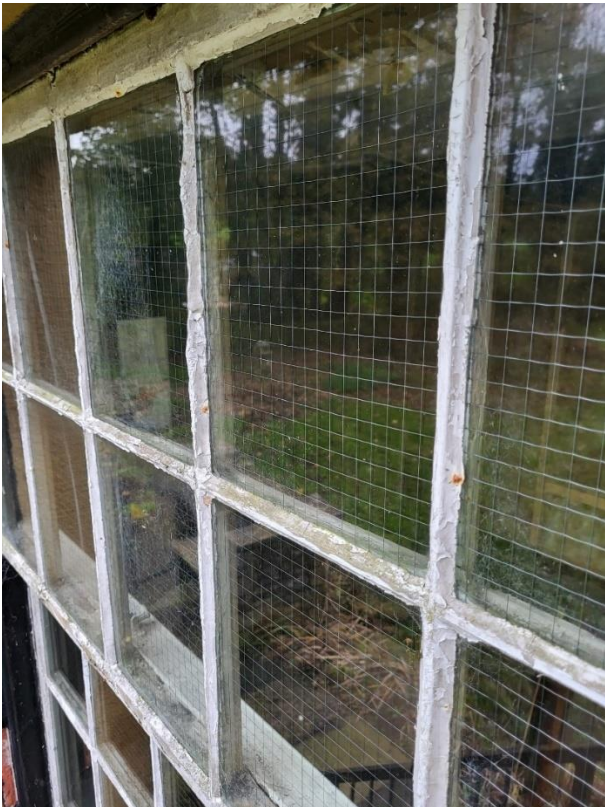
Close up of the safety glass

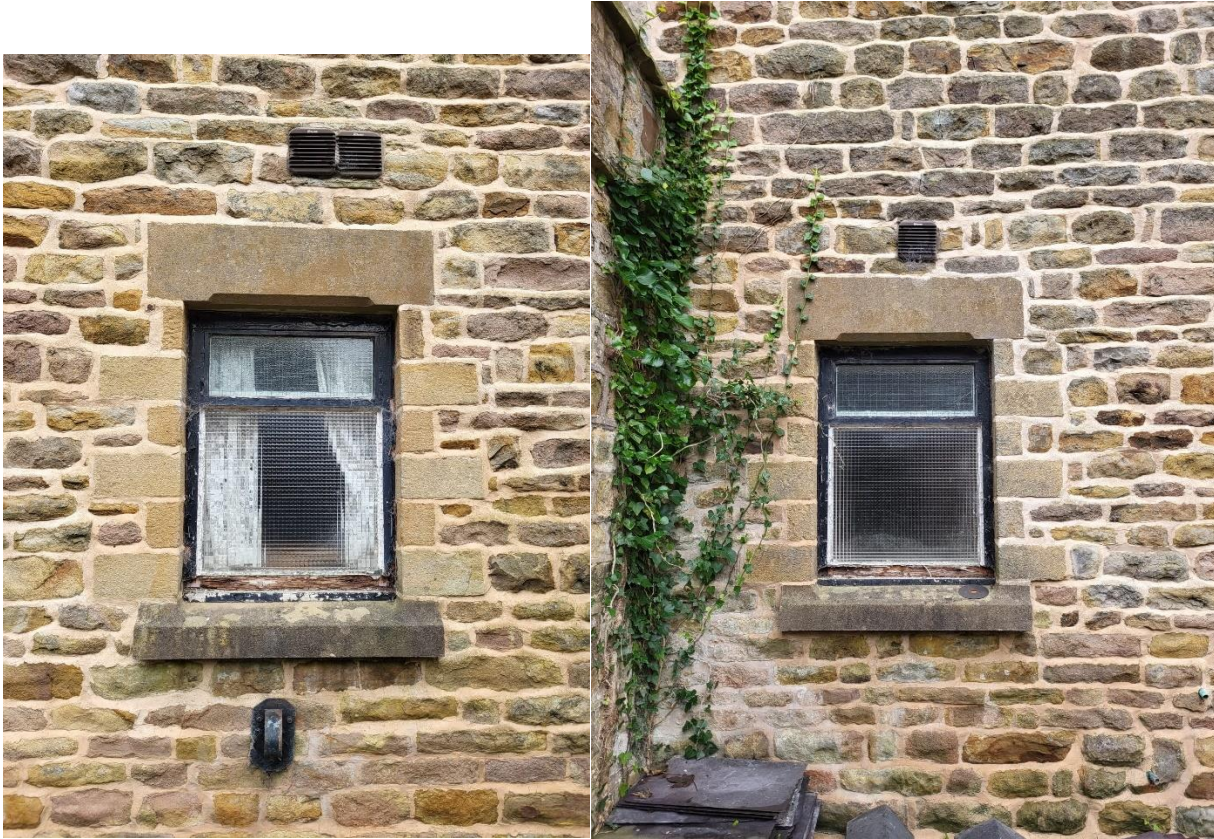
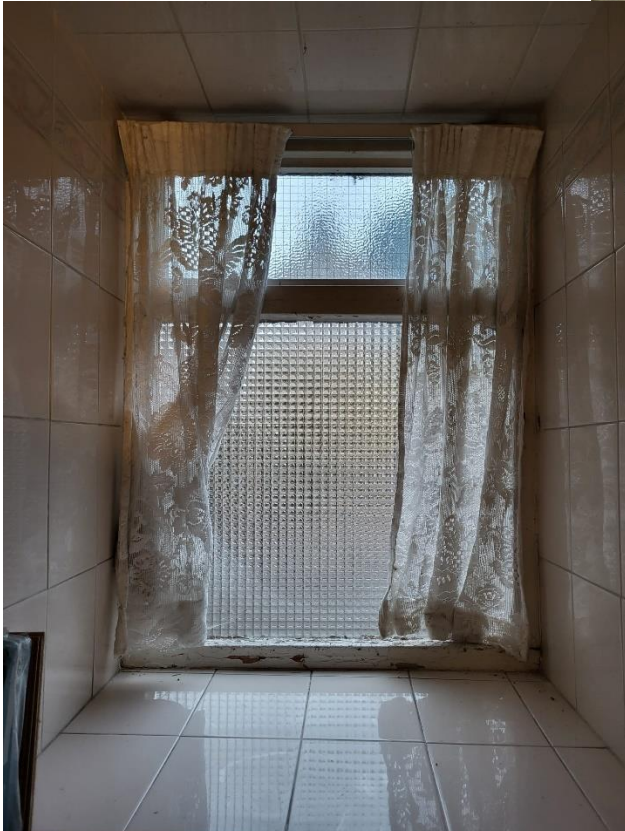
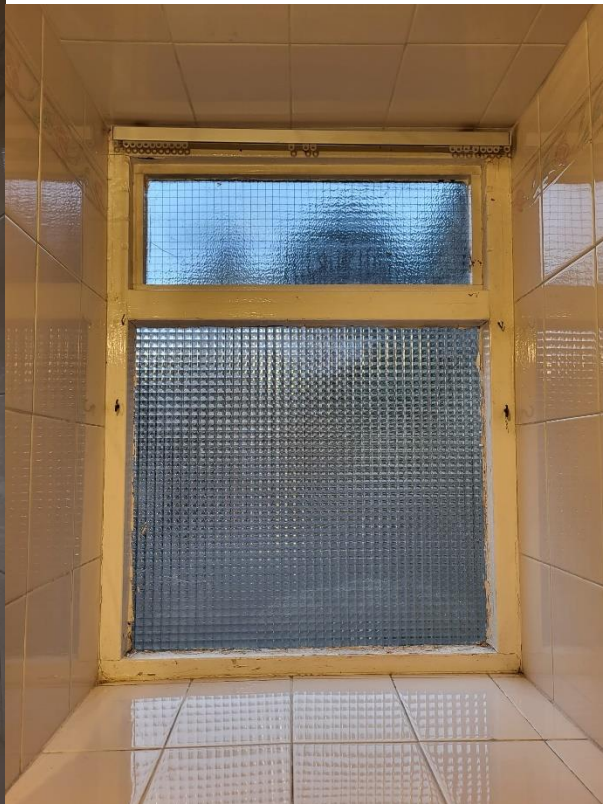
W14 & W15 – Utility Room and Shower Room

Both 87cmx66cm

Replace both windows – Rotten and they're of no historical interest.

Double glazing. Obscured glass for the shower room.

Side opening – See *SPA Drawing: 6521 DOC3*.

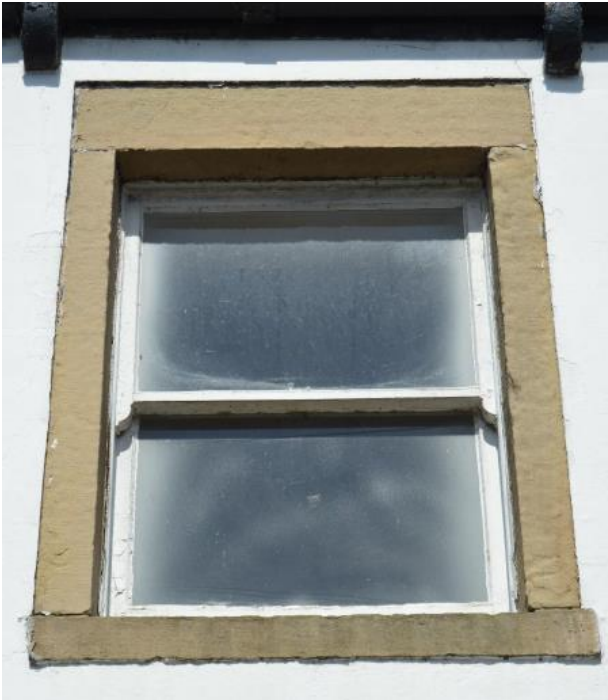
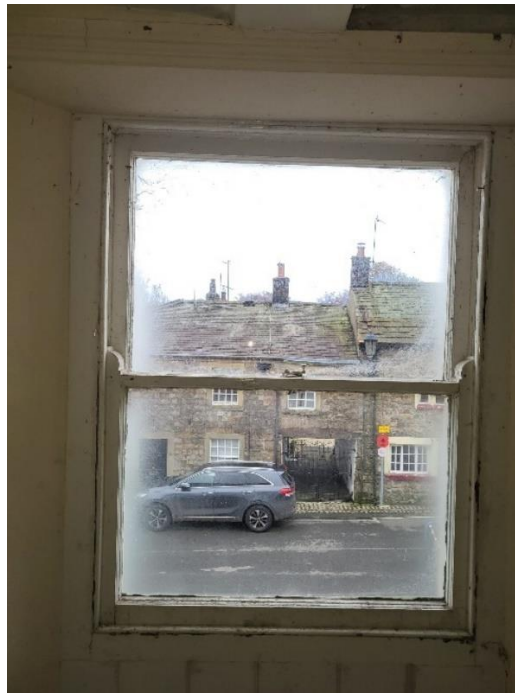
W16 – Bedroom

120cmx137cm

To be repaired and restored.

New beads, weights and ropes where needed.

Double glazing.

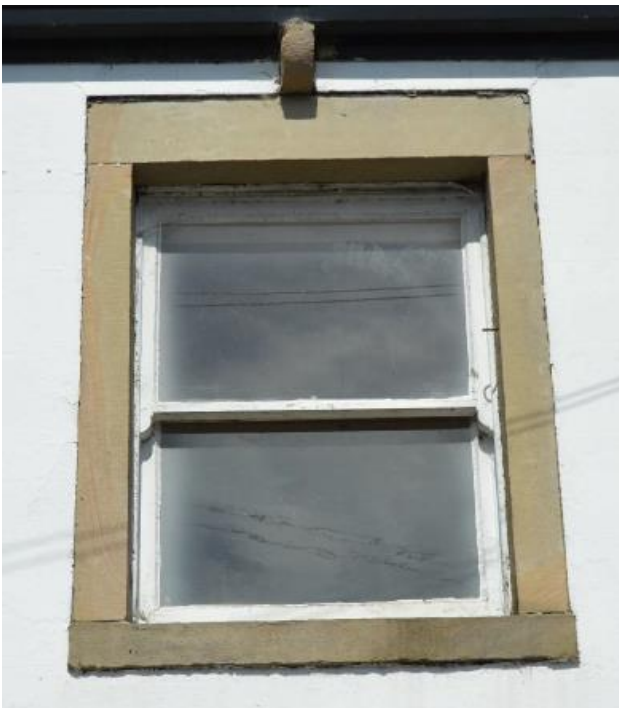
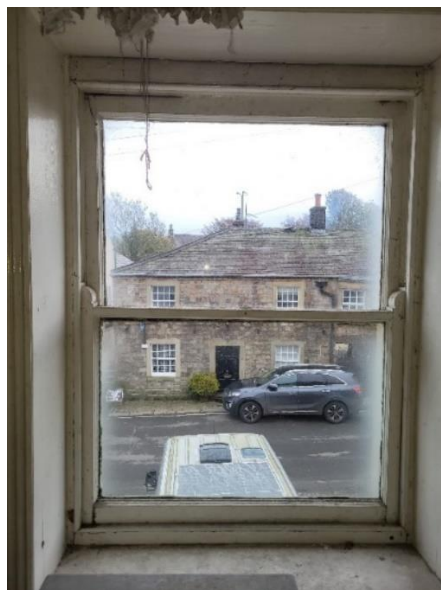
W17 – Landing

110cmx150cm

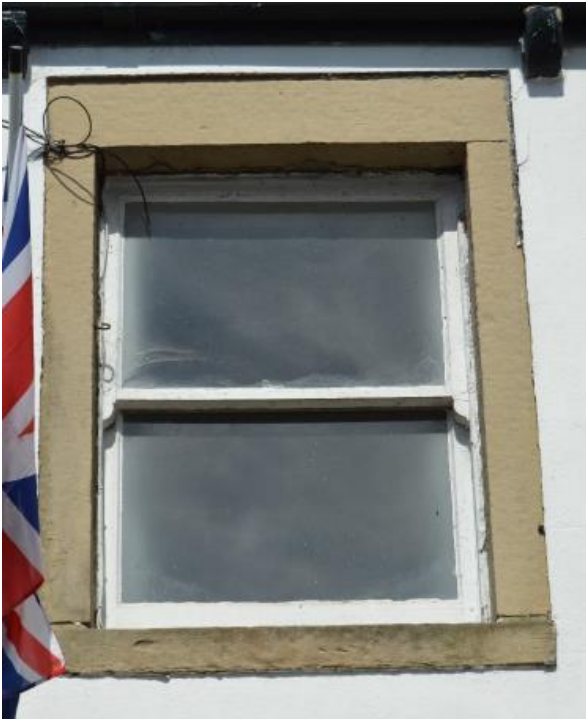
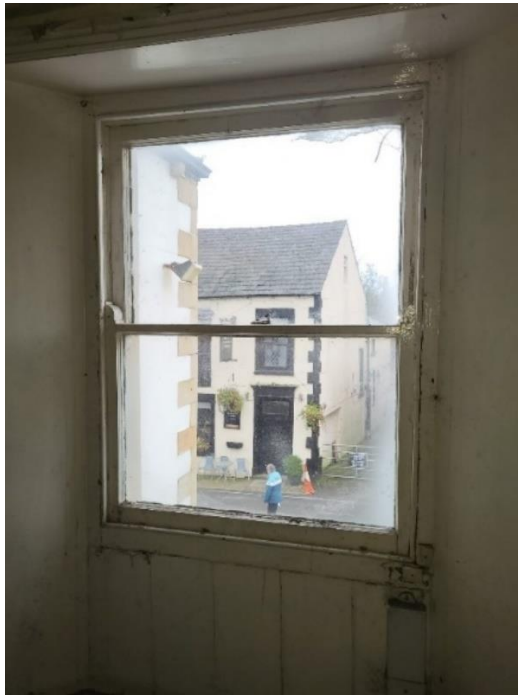
W18 – Bedroom

115cmx143cm

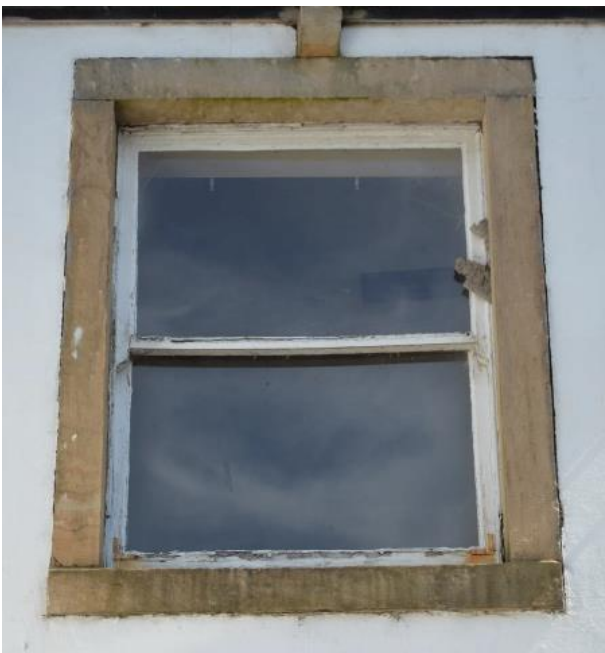
W19 – Holiday let main bedroom

180cmx147cm

Replace - Frames are rotten, broken and not repairable.

Replace like for like, sliding sash window.

Double glazing.

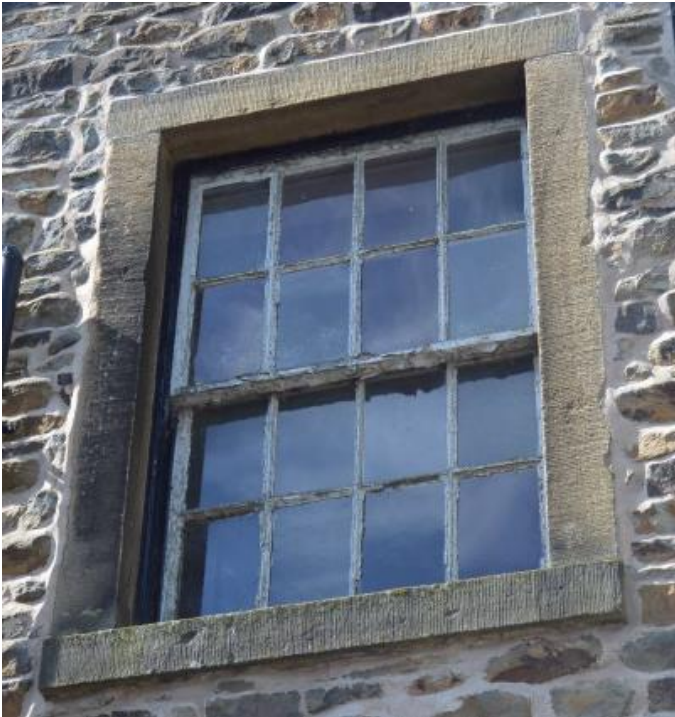
W20 – Holiday let small bedroom.

115cmx161cm

Repair/restore.

Glazing – retain existing single glazing.

New weights/ropes.

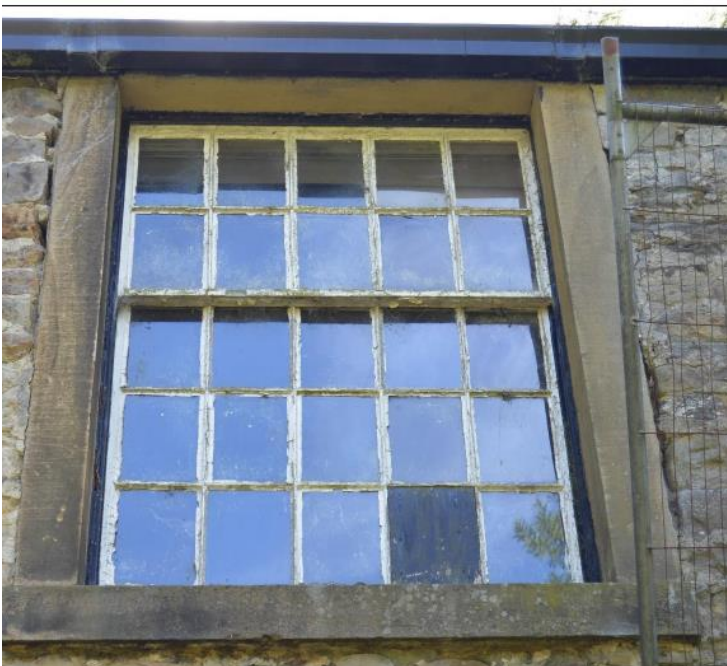
W21 – Master Bedroom

150cmx195cm

Repair and restore.

Replace missing glass.

Glazing – retain existing single glazing.

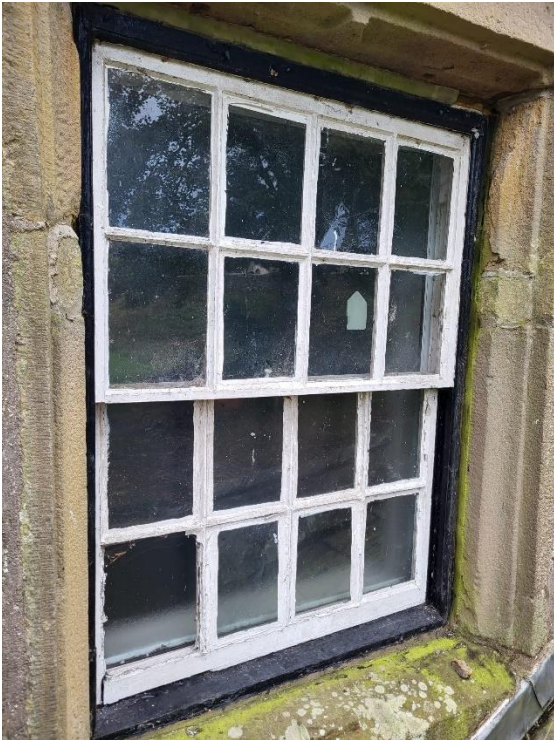
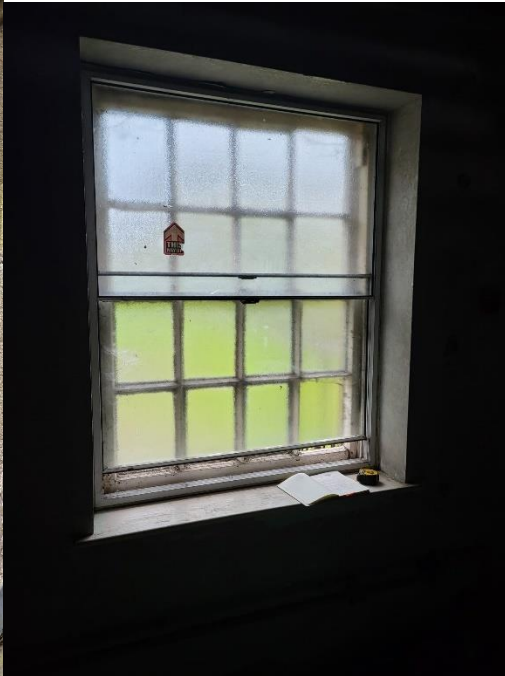
W22 – Ensuite

115cmx142cm

Replace window– Rotten and broken frame.

Sliding sash window, replicate original design.

Double glazing.

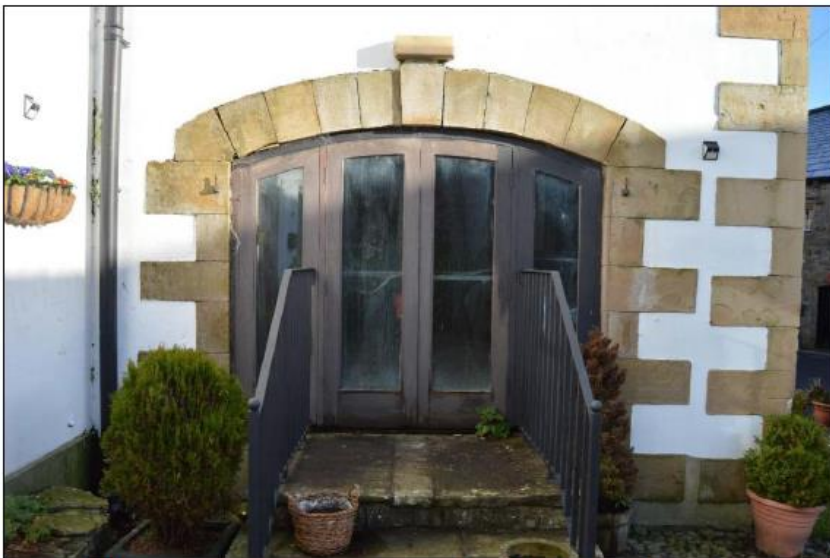
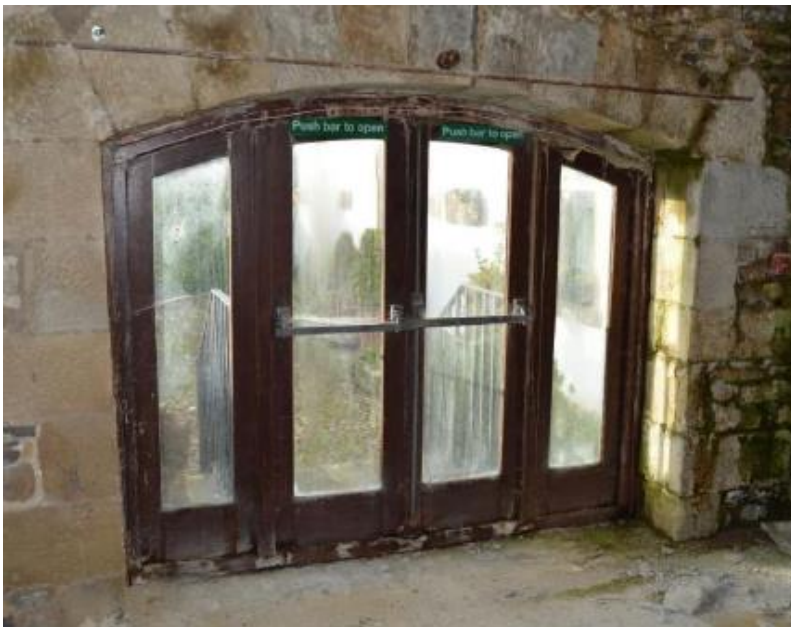
D03 - 250mc wide x 200cm tall at the widest/tallest points

Replace the existing double glazing which has failed/blown.

Repair rotten areas like for like.

Doors to be painted white externally.

Remove the fire escape mechanism and replace with handle and lock below to allow access from the outside into the holiday let.

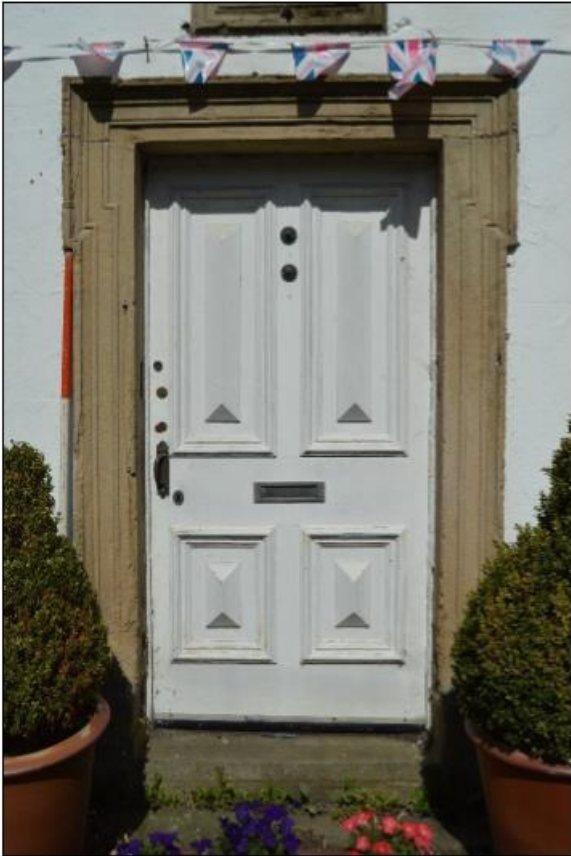
D04

No changes.

Refresh white paint.
