Notes.		
notes.		
Project. KEEPERS COTTAGE PROPOSED BOUTIQUE HOTEL		
Client. FORTIS HOSPITALITY SOLUTIONS (GLOBAL) LTD		
Drawing title: DEMOLITIONS (AS CARRIED OUT)		
Status.		
Scale: 1:100 AT A1		
Drawn by:	Checked:	PH
Date: 19 MARCH 2024		
Project no. PHA/750	Fig. no. 100/2	Rev.

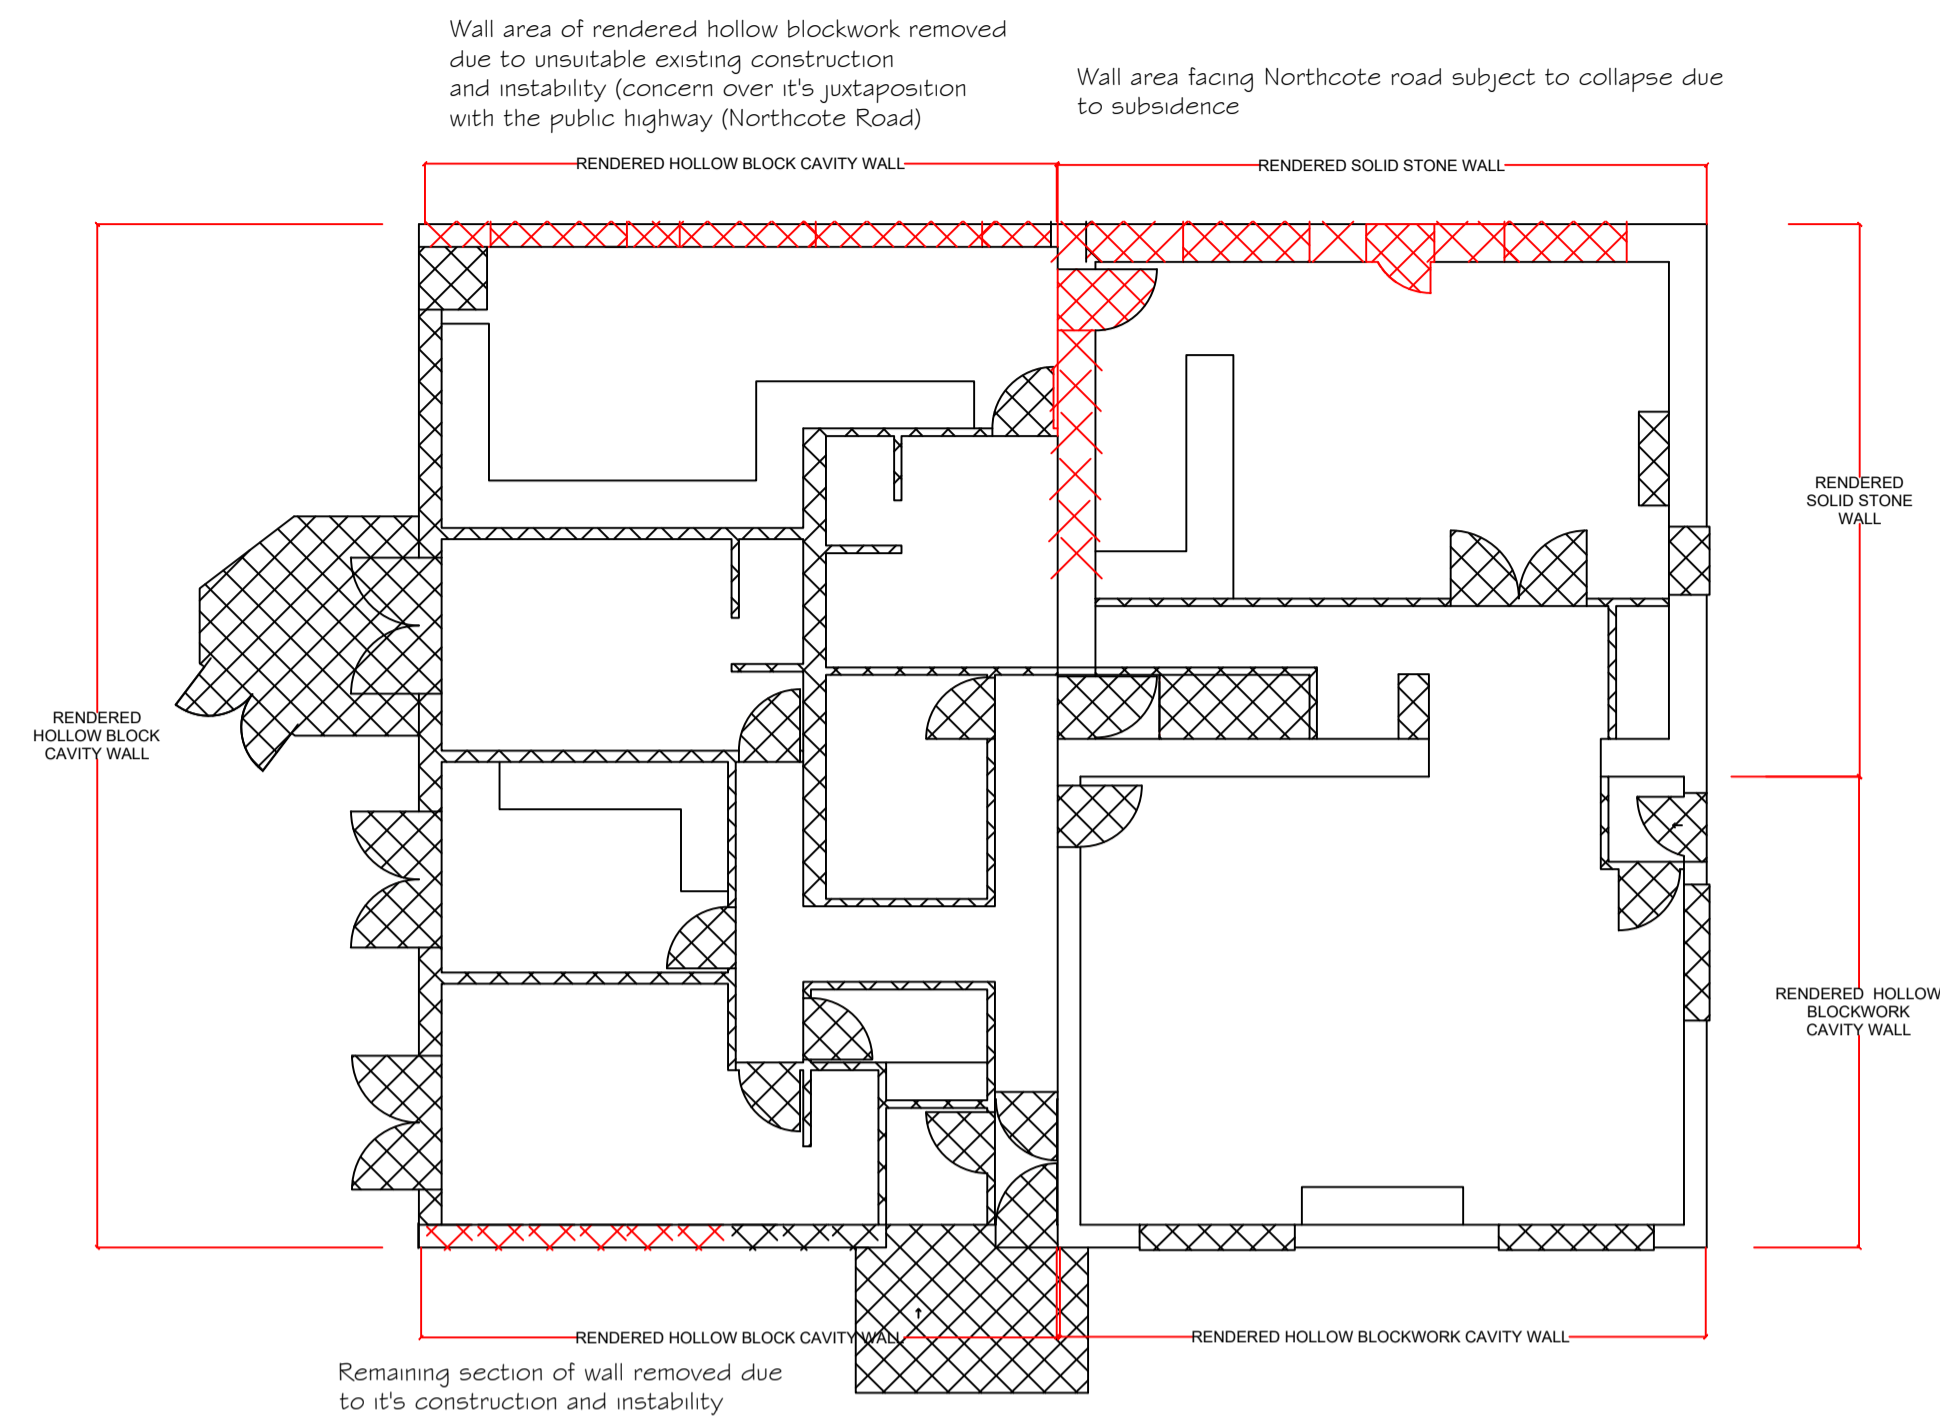
GROUND FLOOR DEMOLITIONS

The demolitions as approved are demonstrated by the white cross hatching on the plans which are as the approved plans A1.7 & A1.8. The red cross hatching shows the extent of the collapse and demolitions carried out. The shaded areas on the elevations show the extent of the demolitions (including openings to be altered/infilled etc) to the external walls as carried out including the areas as approved. Internal walls and floors are also stripped away as approved including the complete removal of the entire roof structure to facilitate the re-development works. Refer to the supplementary sheet (AG.7) which shows the existing and proposed (as approved) elevations and the extent of the redevelopment by virtue of the pink shaded areas to all four facades. Refer to the supporting statements which provides further information.

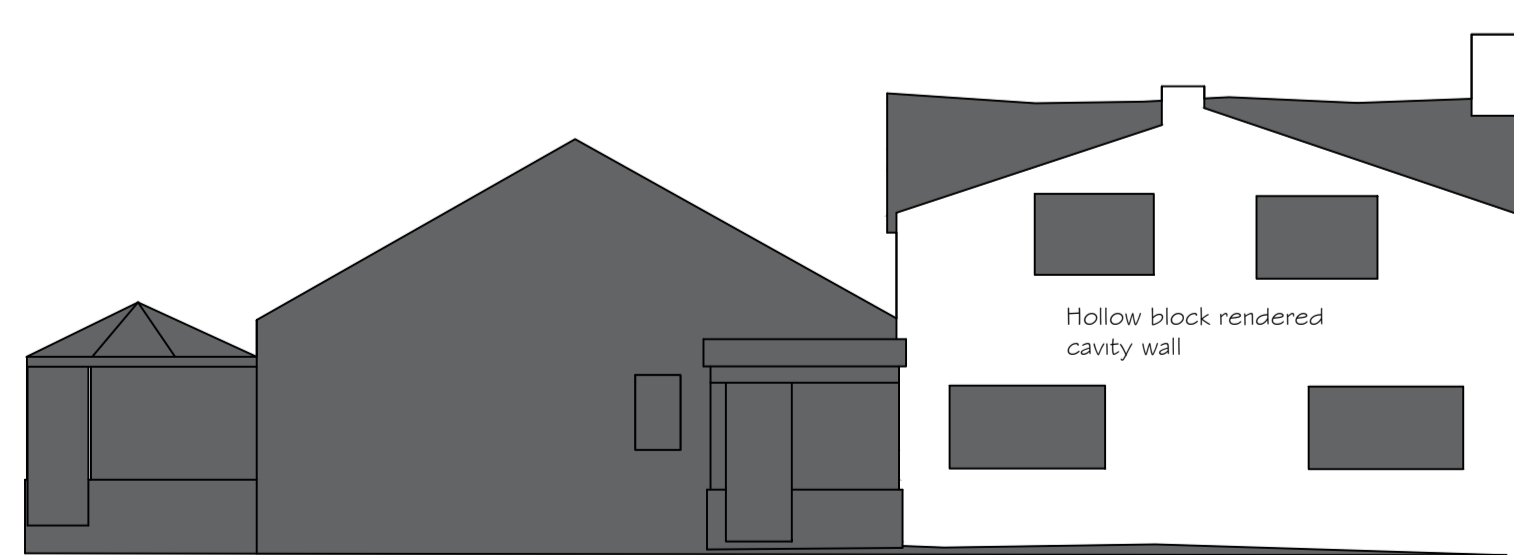
SOUTH EAST ELEVATION AS DEMOLISHED (and future demolitions)
