Project:
KEEPERS COTTAGE
PROPOSED BOUTIQUE HOTEL

Drawing title:
DEMOLITIONS (AS CARRIED OUT)

Project no. PHA/750
Dwg no. 100/2
Rev. A

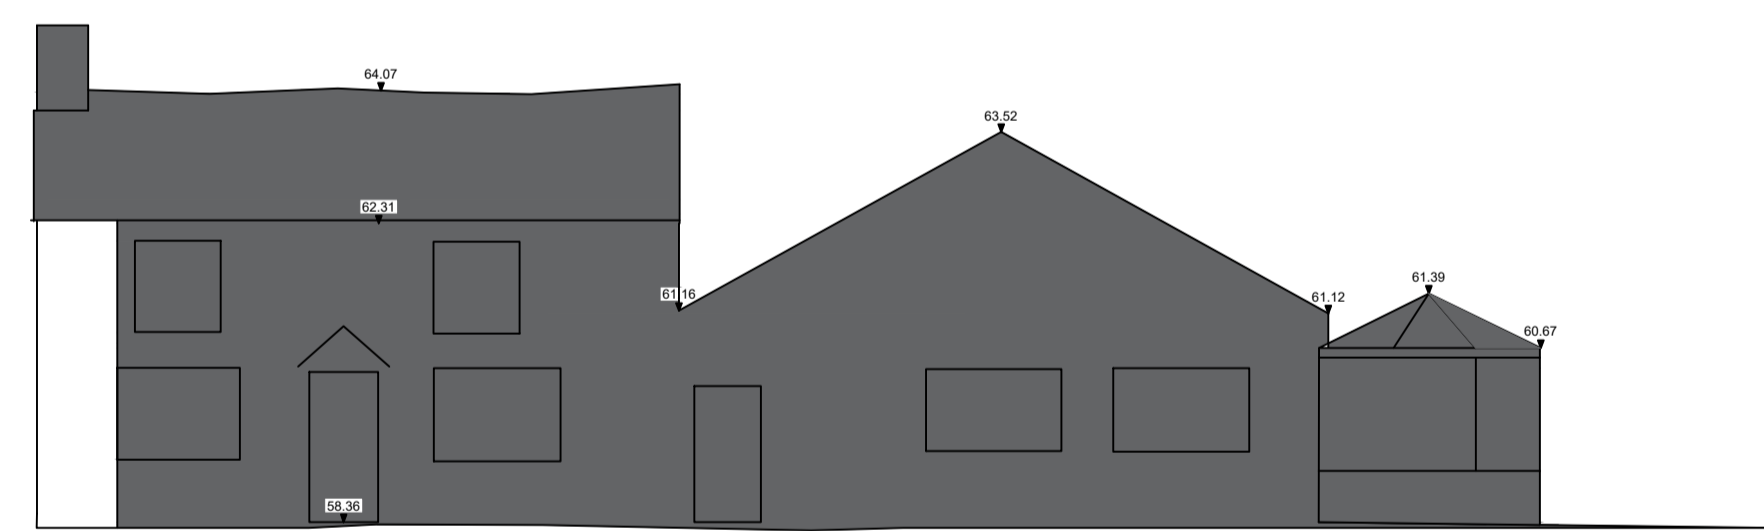
SOUTH WEST ELEVATION AS COLLAPSED/DEMOLISHED

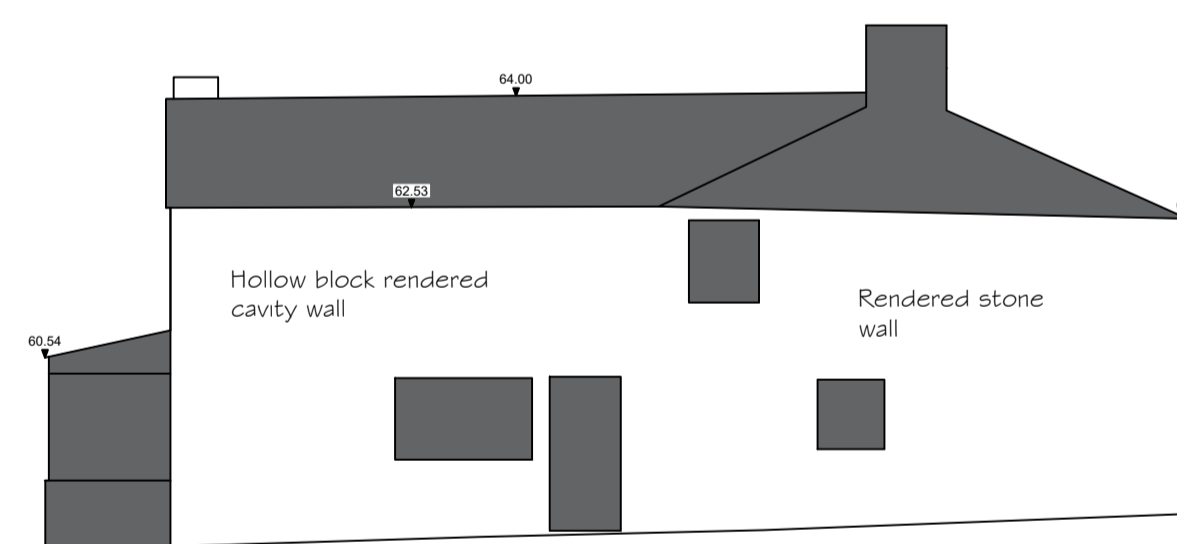
NORTH WEST ELEVATION (future demolitions)

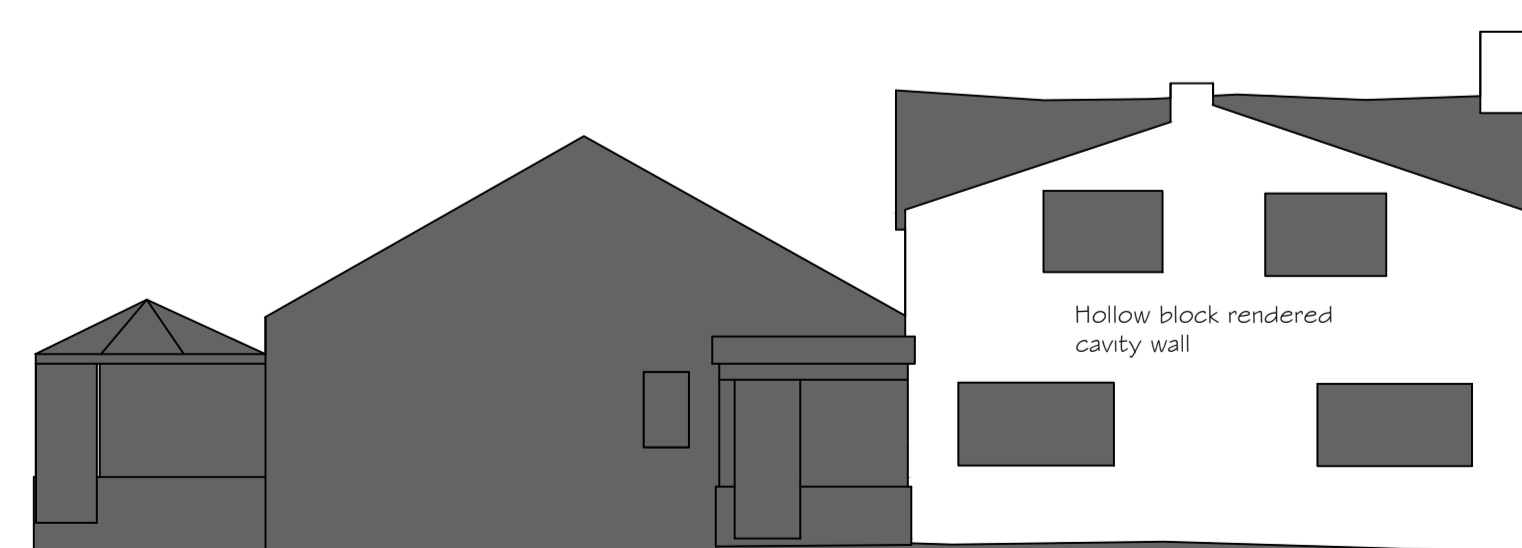
NORTH EAST ELEVATION AS DEMOLISHED (and future demolitions)

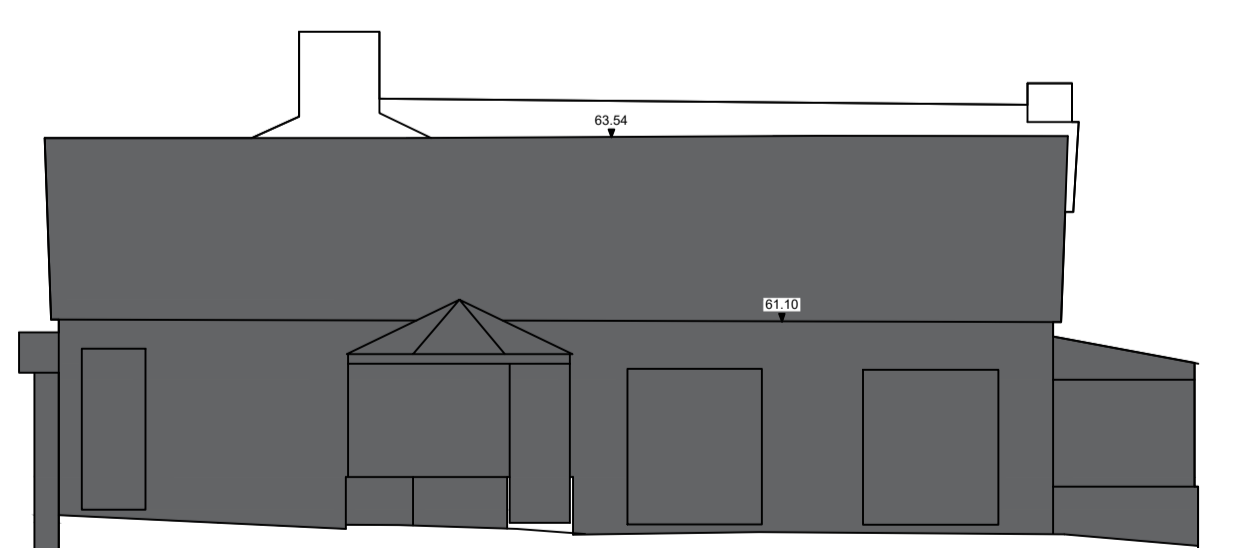
SOUTH EAST ELEVATION AS DEMOLISHED
