THE ARCHAEOLOGY CO.

Barn at 5 Talbot Street, Chipping
Heritage Statement

September 2024

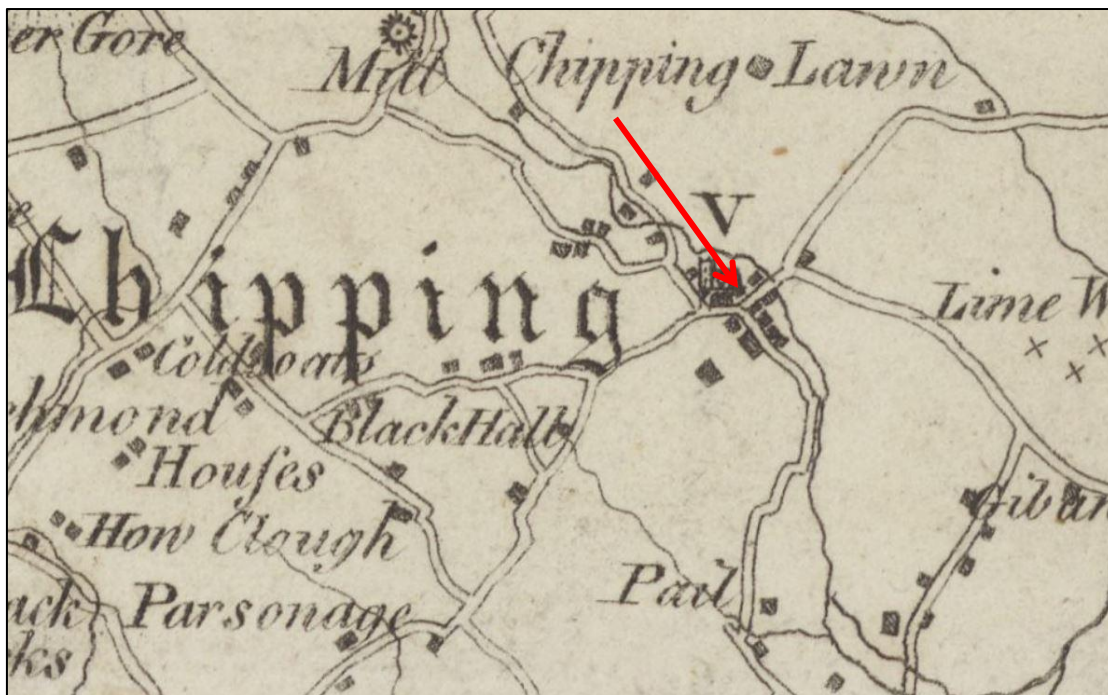
Figure 2: 1786 Yates Map of Lancashire showing Chipping

- 4.3 Among the trades recorded in the parish registers of the 17th century are those of gold-beater, glover, hat-maker and linen-weaver (Farrer & Brownbill 1911). Chipping is shown on Yates map of Lancashire from 1786. The church is shown, somewhat dominating the image. It is however unclear if the Talbot Arms or the subject barn are shown on this map. The Talbot Hotel is thought to date from 1779 (HE 1967), and the barn to be of a similar date, associated with it. By the time of Hennet and Bingley's map of 1828 a building is shown as present on the site. The Talbot Inn was noted in a trade directory of 1825, with William Sawyer as the landlord. The tithe map and schedule from 1840, show that the Talbot Inn was occupied by James Lund, but was owned by Joseph, William & Richard Robinson. The inn was recorded as "public house, brew house and garden", while the barn and adjacent plot (568) were referred to as "stable, stable-yard & cart house" (Haigh 2011). The 1841 census does not name the property, but does record James Lund as an Innkeeper in Chipping, living alongside his wife Ellen and their 10 year old daughter Mary.

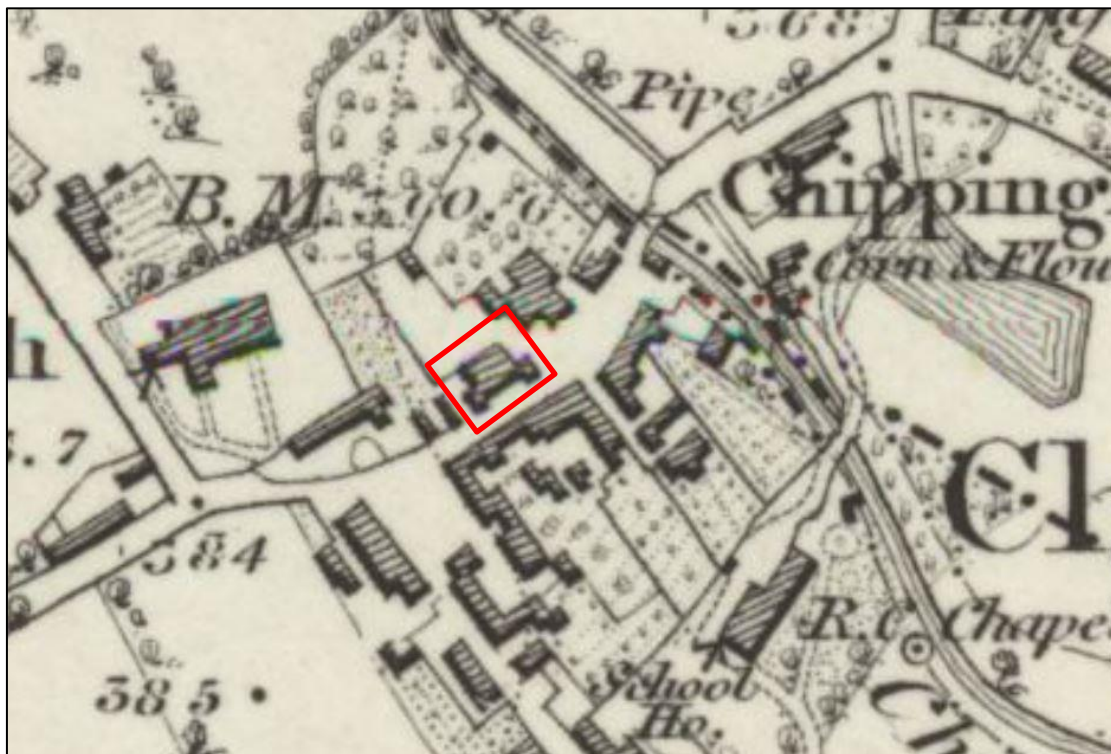
Figure 4: 1847 OS 6" map Lancashire Sheet XLVI.9

- 4.4 The Talbot Inn was used for the auction of property and inquests during this time, with newspaper reports mentioning the Inn (Preston Chronicle 05/10/1839; Preston Chronicle 12/03/1842; Blackburn Standard 31/10/1849). The barn is shown more clearly on the first edition OS map of 1847, where a rectangular structure is shown to the north side of Talbot Street, with small projecting extensions to the east and west southern corners.

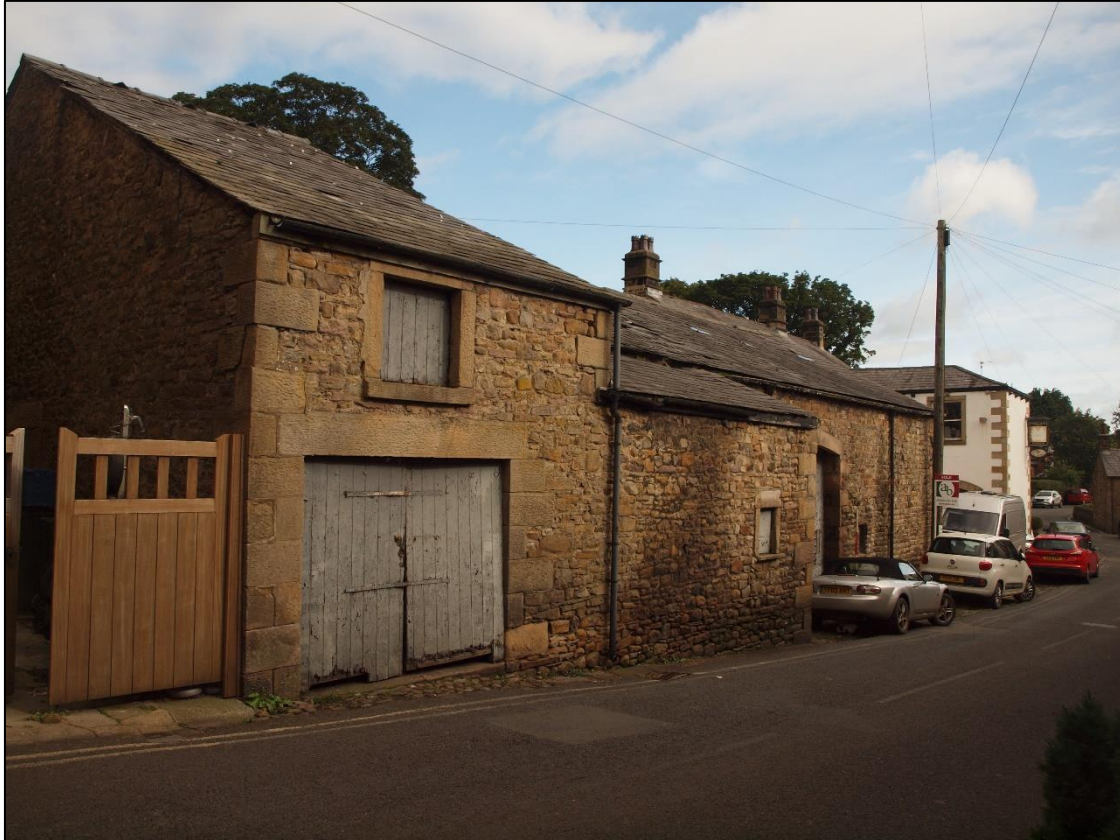
Plate 2: General shot of barn From Talbot Street showing cart door to have cill raised

- 7.4 The cills to the doors are proposed to be raised by one stone course, in order to prevent water ingress. This will also have a minor negative impact to the architectural significance of the barn, although will allow for better preservation of the building as a whole. It will have no impact to the conservation area

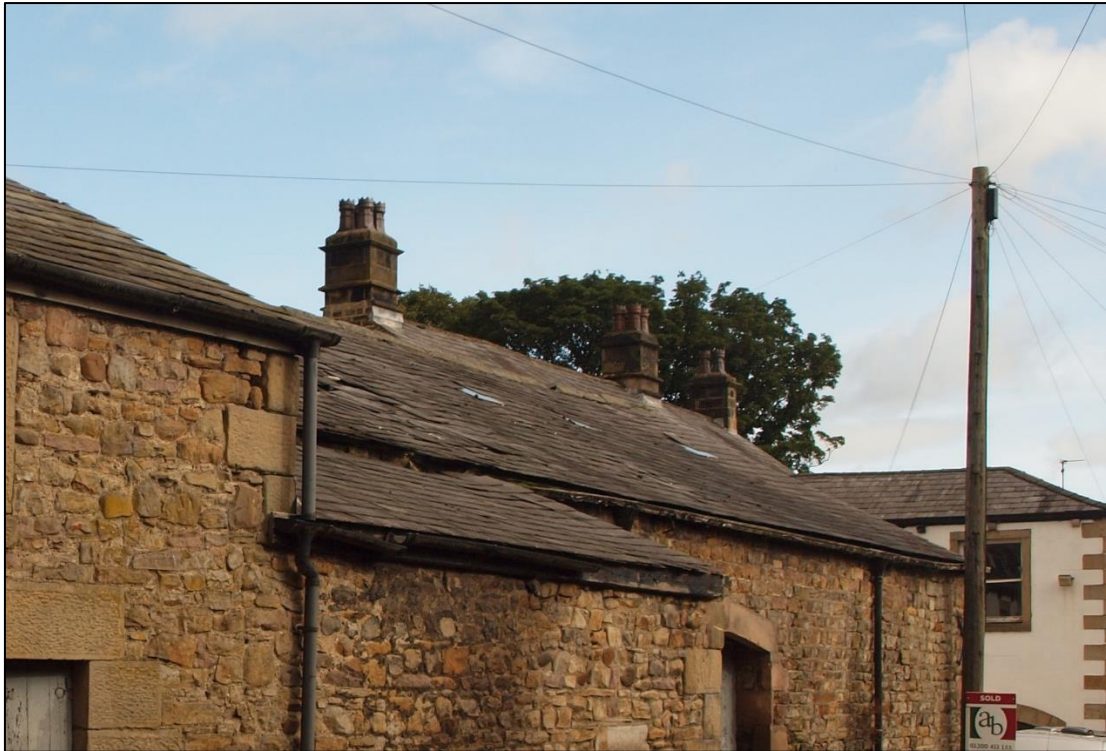
Plate 3: Detail of roof showing skylights and ridge

- 7.2 The existing roof had some vents along the ridge, instead of more modern methods of having the vents in the mortar joints. Ridge tiles which match the existing raised look will be placed at 2m intervals. This will have no impact on the heritage significance of the building or the conservation area.

- 7.7 The three skylights to the road side elevation are to be replaced with modern skylights, much as have been agreed for the neighbouring Talbot Inn. This will have no impact on the heritage significance of the building or the conservation area.

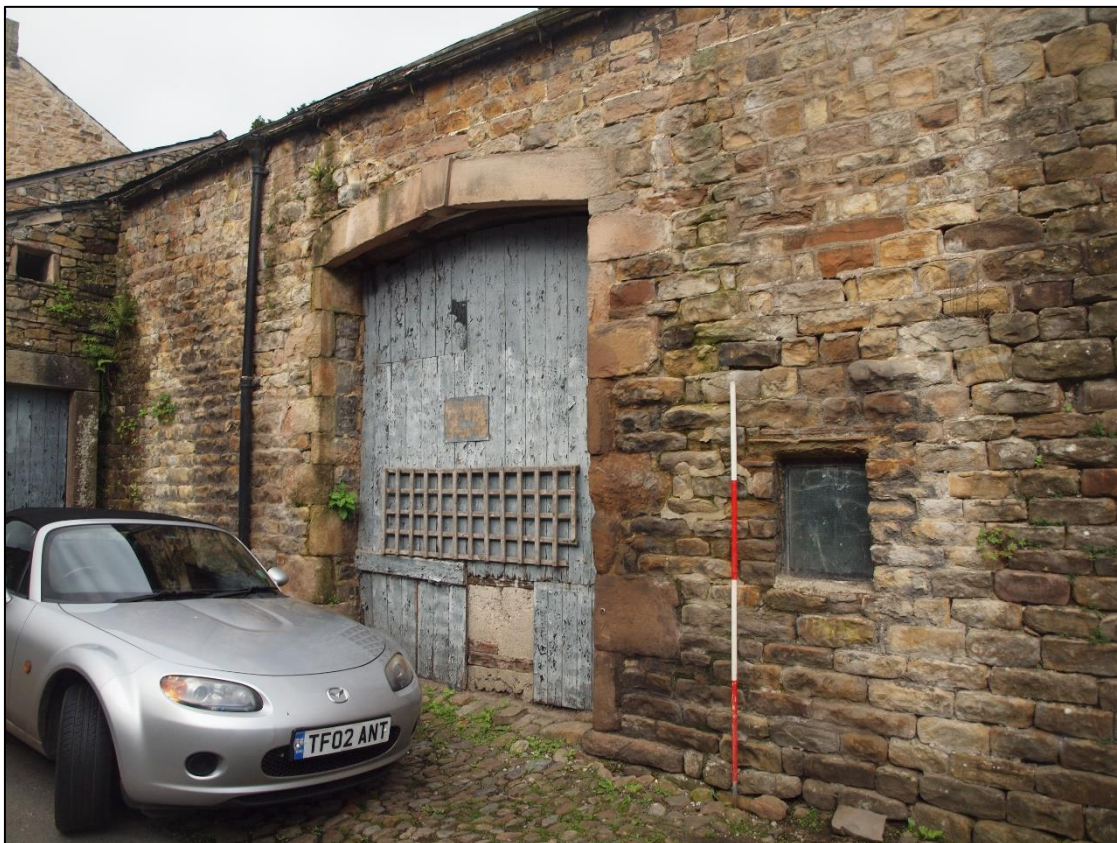
Plate 4: Barn door to have cill raised

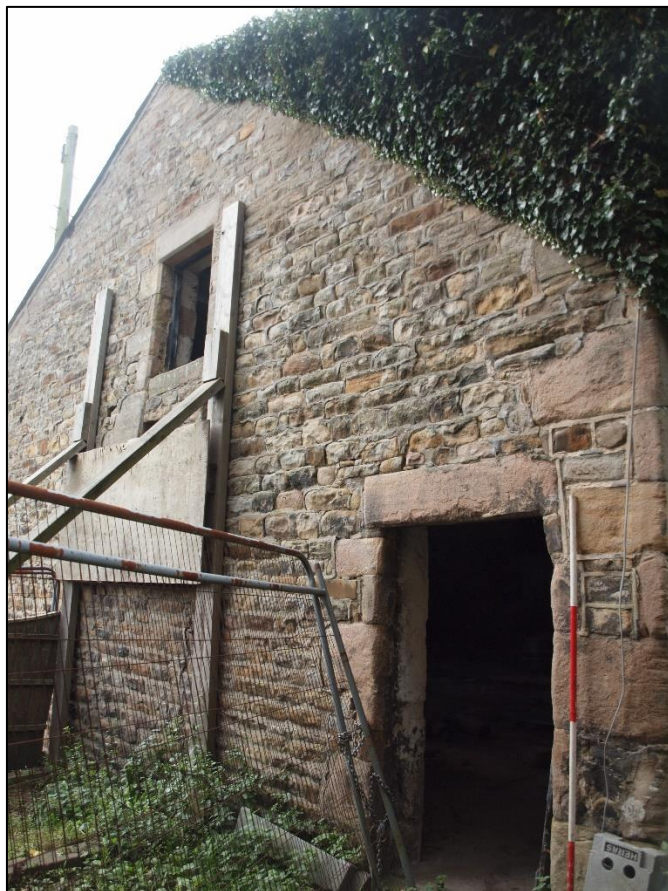
Plate 6: East gable showing doorway to have cill raised

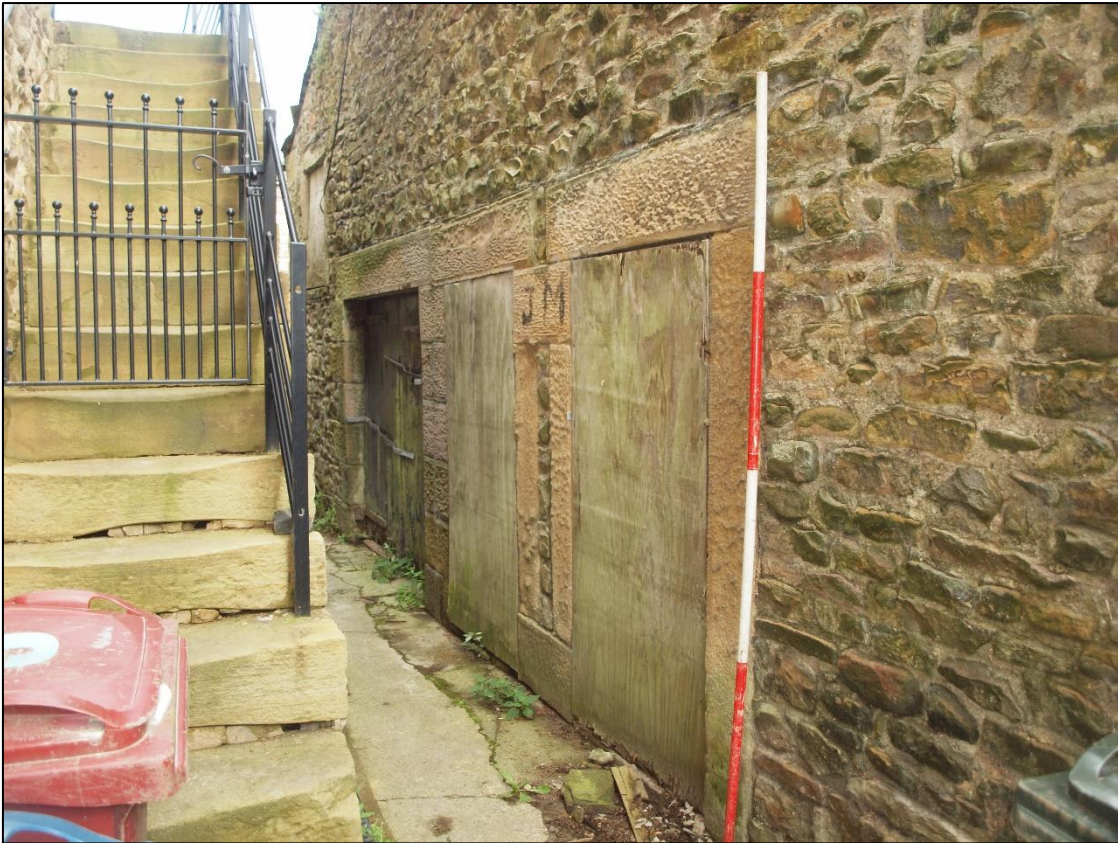
Plate 7: West gable showing doorways with cills to be raised

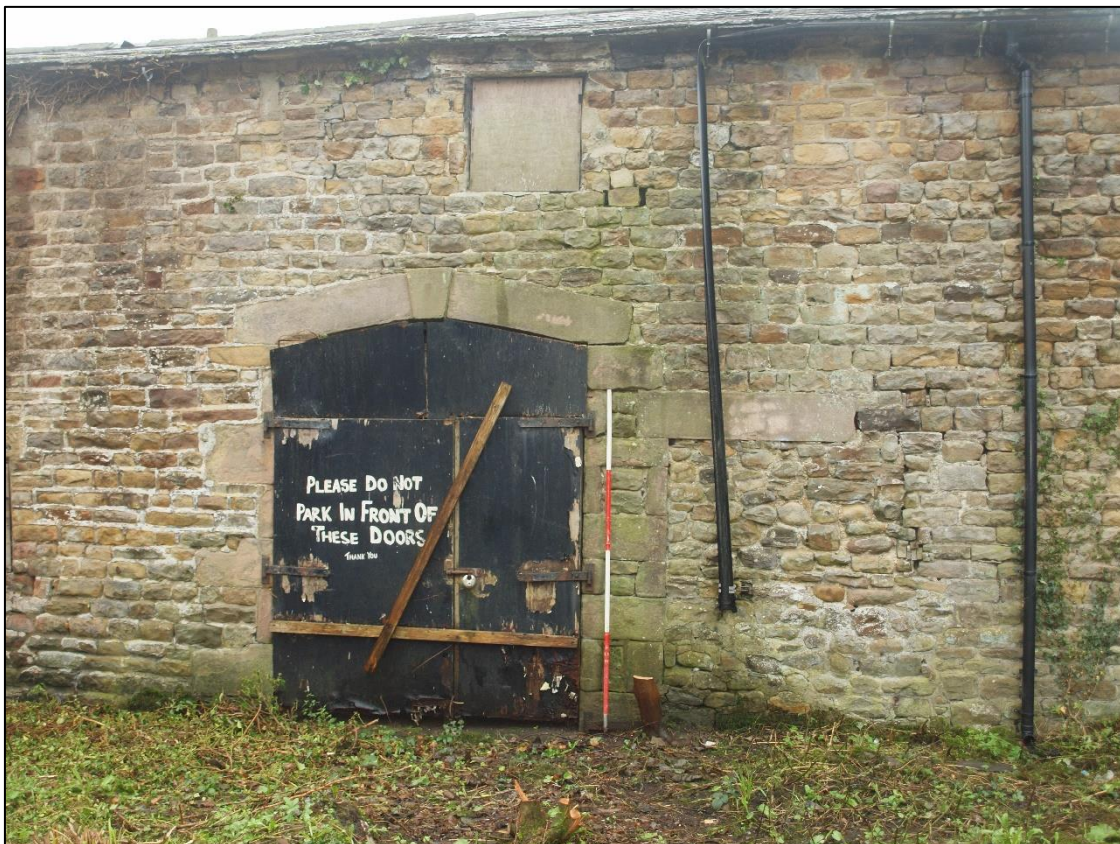
Plate 10: Barn door with cill to be raised

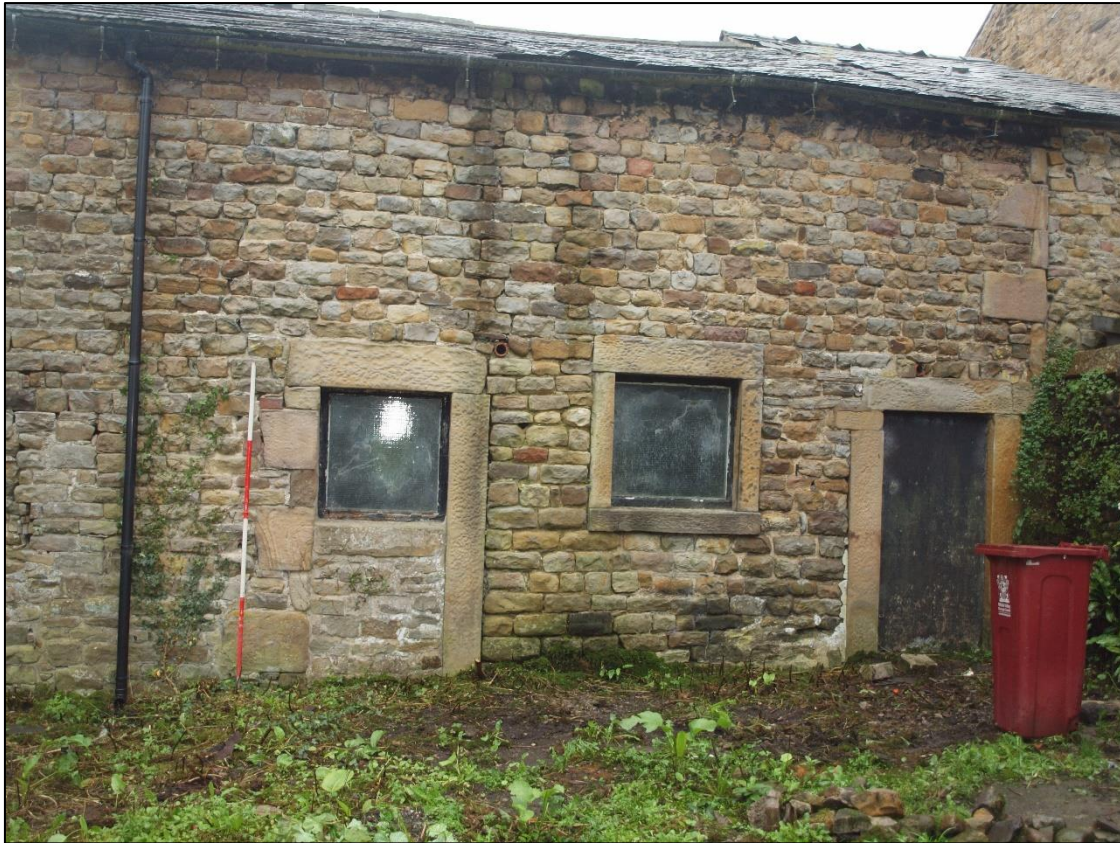
Plate 11: Doorways with cills and lintels to be raised and location of inserted first floor windows

- 7.5 Door lintels are proposed to be raised to the north (garden side) elevation. This has a minor negative impact to the architectural significance of the barn, although will have no impact to the conservation area, and will not being visible to the general public.

- 7.6 A proposed first floor window to the north (garden side) elevation is to raised and widened in order to allow it to be an escape window. This has a minor negative
