ARBORICULTURAL IMPLICATIONS ASSESSMENT

PROPOSED DEVELOPMENT

WRITTEN STONE FARM
LONGRIDGE

Author: C. Salisbury
Date: 18 December 2024
Ref: TRE/WSFL/Rev E

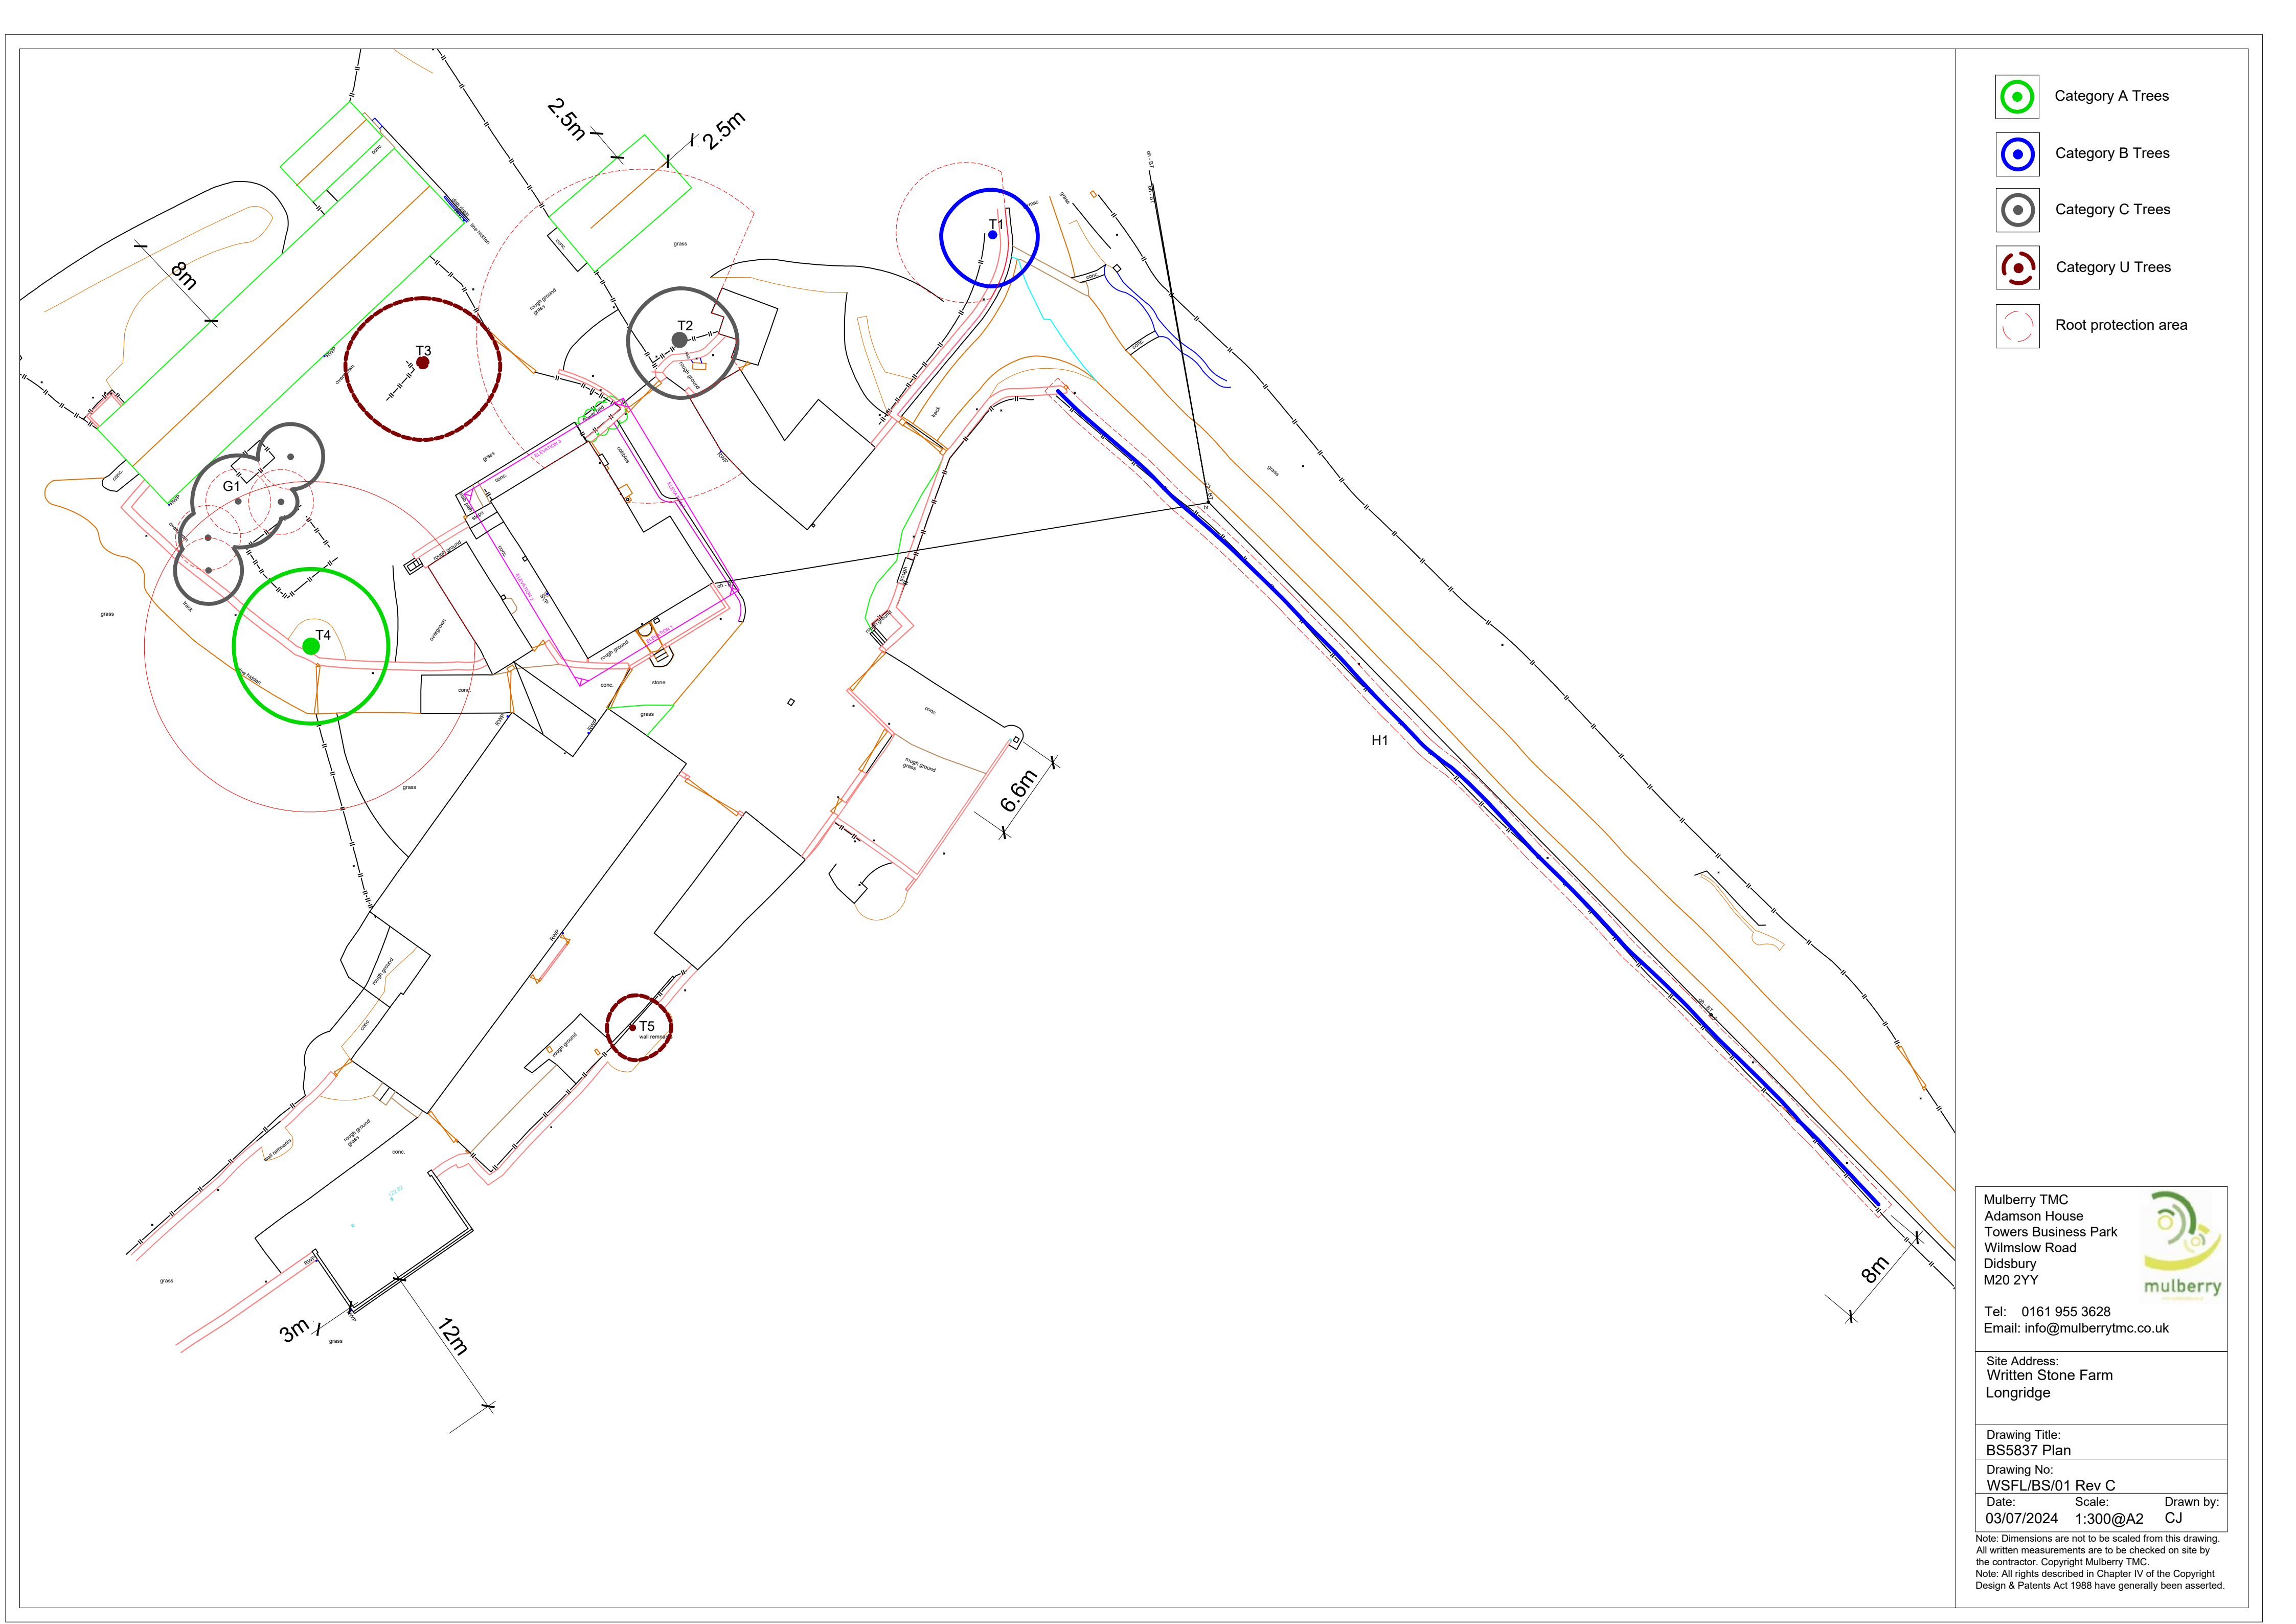
- 3.1 Due to the proposed development and its associated infrastructure there are a number of locations where the proposals are in close proximity to the trees surveyed. The Site Layout Plan within appendix three identifies the trees in relation to the proposed development.
- 3.2 In order to fully assess the impact of the proposals an Impact Table has been created detailing each tree, which shows the proximity of the associated works to the tree.
- 3.3 This can then be assessed in accordance with BS 5837:2012 to determine whether the development will have a detrimental impact on the health of each tree. Once this has been determined remedial measures can be detailed to reduce the impact the proposals will have on the treescape.

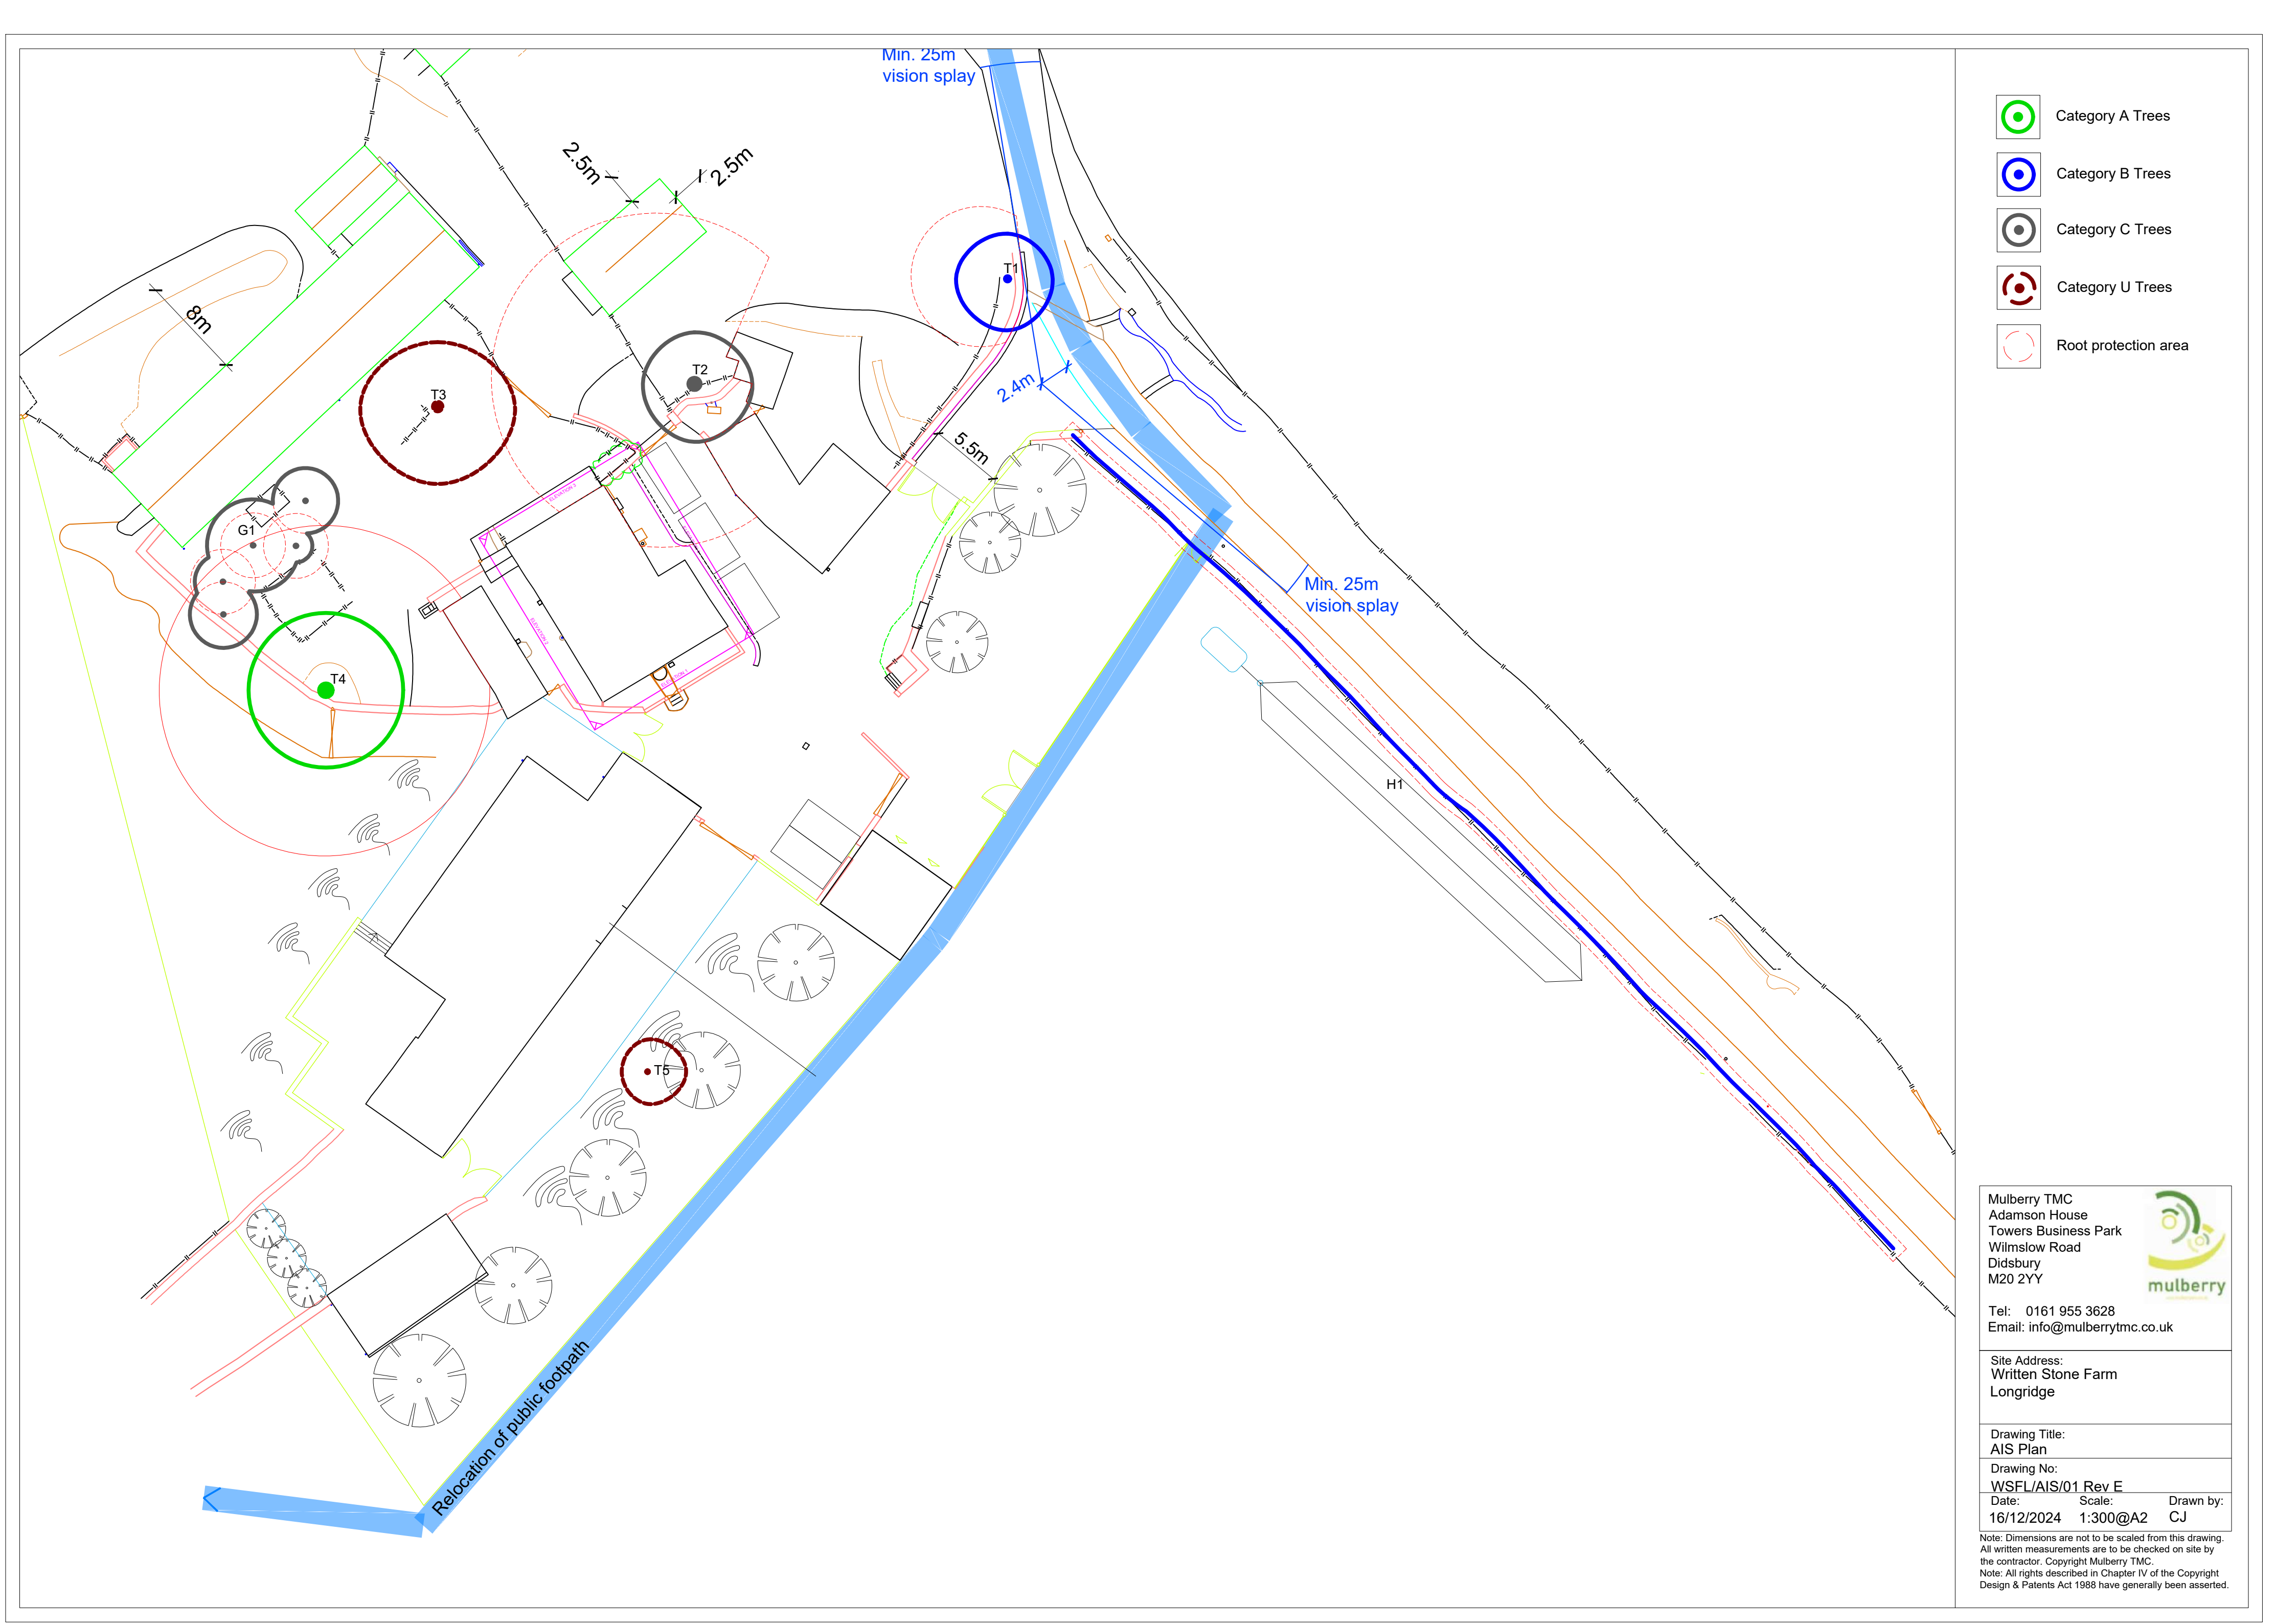
Drawing Title:
AIS Plan

Root protection area

Tree No.	Root Protection Area identified in Table 2 of BS 5837:2012	Distance to Proposed Hard Standing (m)	Distance to Proposed Development (m)	Can the Tree/s be Successfully Retained
T1	76m ²	N/A	N/A	Yes
T2	408m ²	N/A	N/A	Yes
T3	Not Assessed as the Tree Requires Removal Due to its Condition			
T4	508m ²	N/A	N/A	Yes
T5	Not Assessed as the Tree Requires Removal Due to its Condition			
G1	20m ²	N/A	N/A	Yes
H1	2m ²	1.00	33.20	Yes except for a small section for the public footpath redirection
