# **Arboricultural Impact Assessment**

in Relation to Proposed  
Construction of Building Extension at

**Cunliffe House,  
Longsight Road, Langho,  
Lancashire, BB6 8AD**

**ARBORICULTURAL IMPACT ASSESSMENT  
CUNLIFFE HOUSE, LONGSIGHT ROAD, LANGHO**

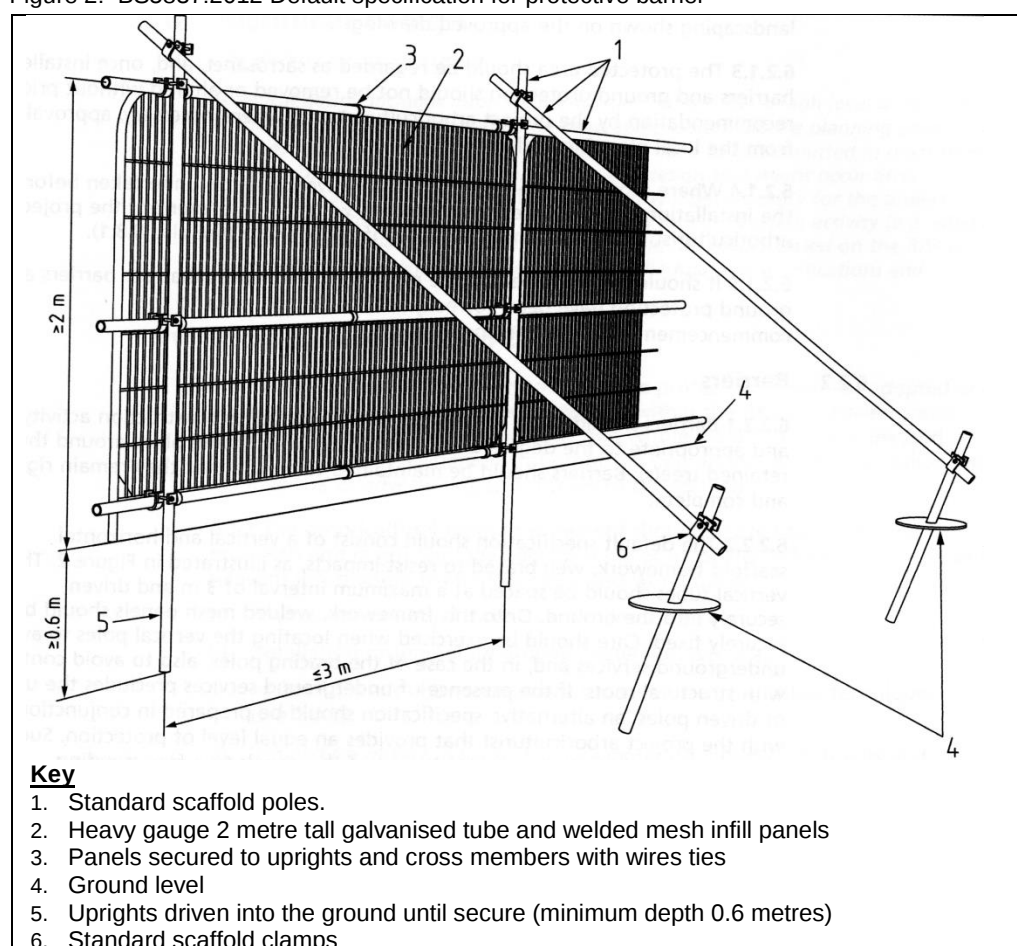
Figure 2: BS5837:2012 Default specification for protective barrier

**Type 1 (i.e. 'Default') Temporary Protective Fencing Construction** (see Figure 2, below)

1. Temporary protective fencing panels shall be weldmesh "Heras" panels of at least 2.0 metres in height.
2. The panels shall butt together and be securely fixed to a scaffold framework, as per points 3 to 5 of Figure 2, overleaf.

3. The scaffold framework shall comprise of upright poles of at least 3.0 metres in length driven no less than 0.6 metres into the ground at maximum 3.0 metre centres with horizontal and diagonal poles fixed to the uprights, as per points 4 to 5.

4. The two horizontal rail poles shall be attached to the uprights at heights of 0.6 and 1.8 metres with 3 no. clamps to each joint.
5. The diagonal scaffold pole struts be clamped to the top rail of the scaffold framework at a 45° angle and extend back into the CEZ and clamped to a 0.7 metre length of scaffold tube that shall be driven no less than 0.5m into the ground.

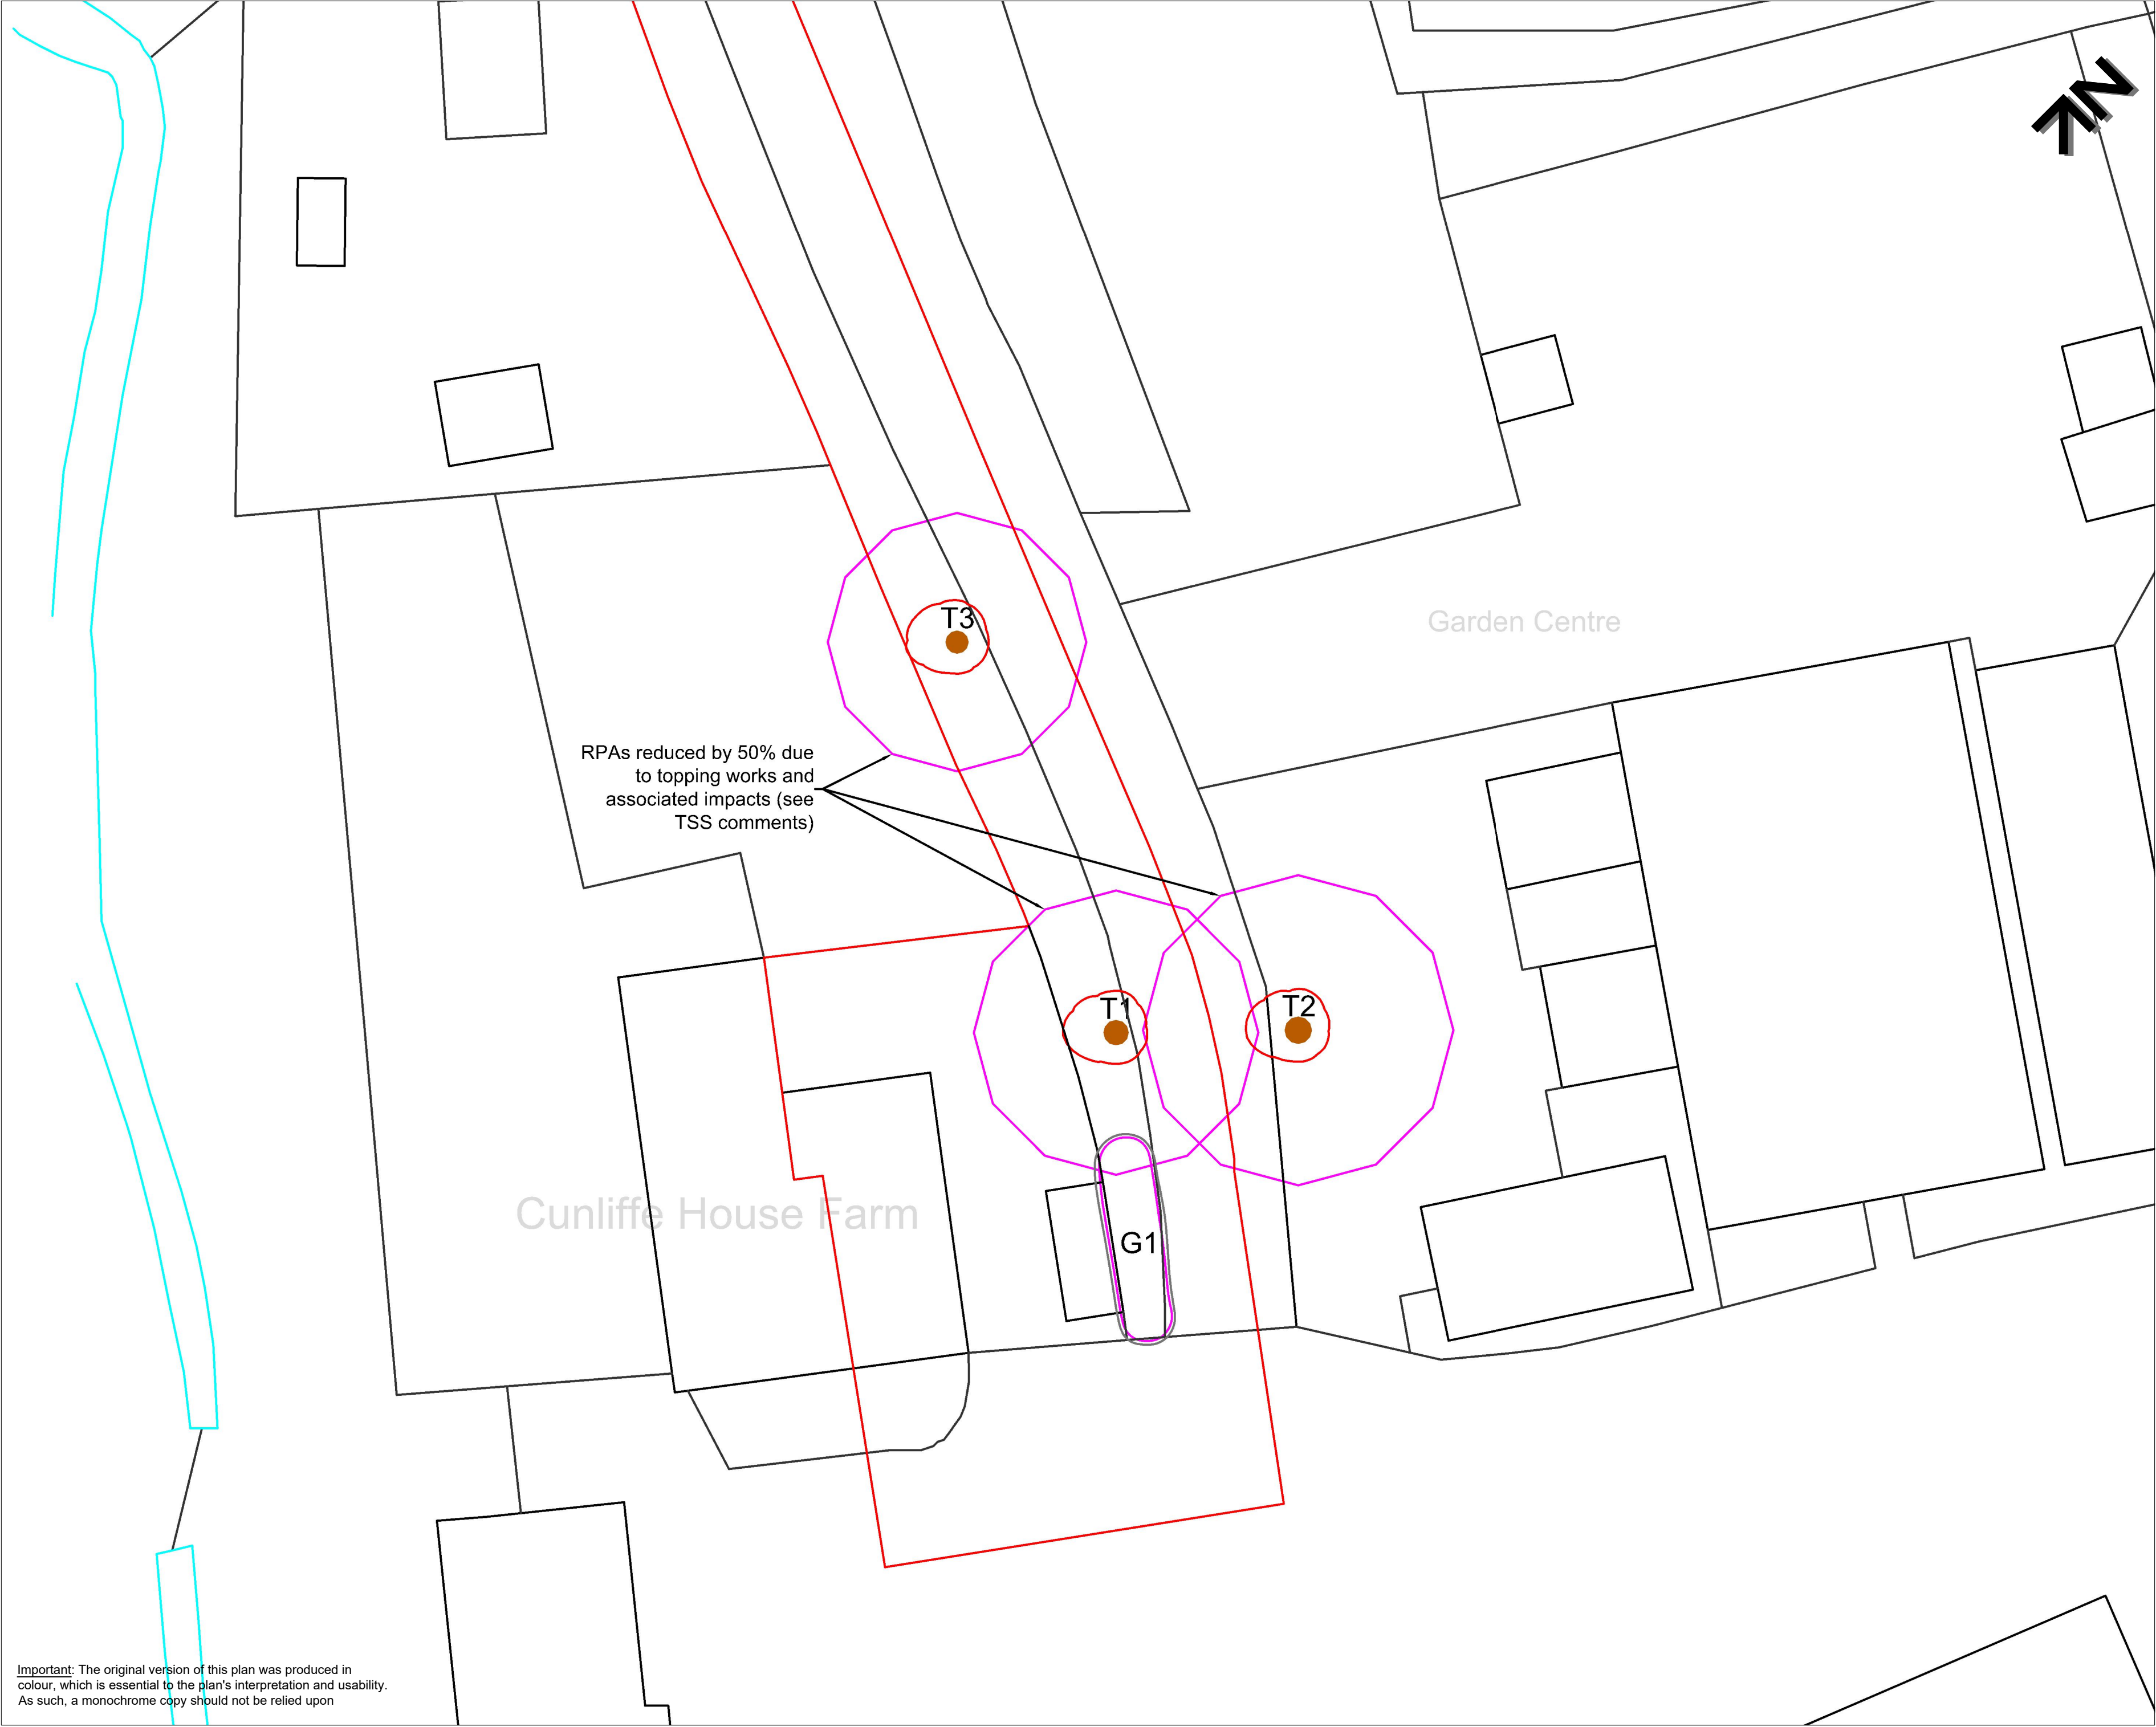
**Title:**  
**TREE CONSTRAINTS PLAN**  
in Relation to Proposed Construction of Extension

Note: The stem locations of all the surveyed trees and the locations and extents of the groups were not included on the Ordnance Survey base plan provided, and were subsequently plotted by the arboriculturist at the time of the survey using GPS and, where possible, measurement from existing site features or, where not possible, estimation. As such, the locations of the trees, and the locations and extents of the groups cannot therefore be considered to be entirely accurate

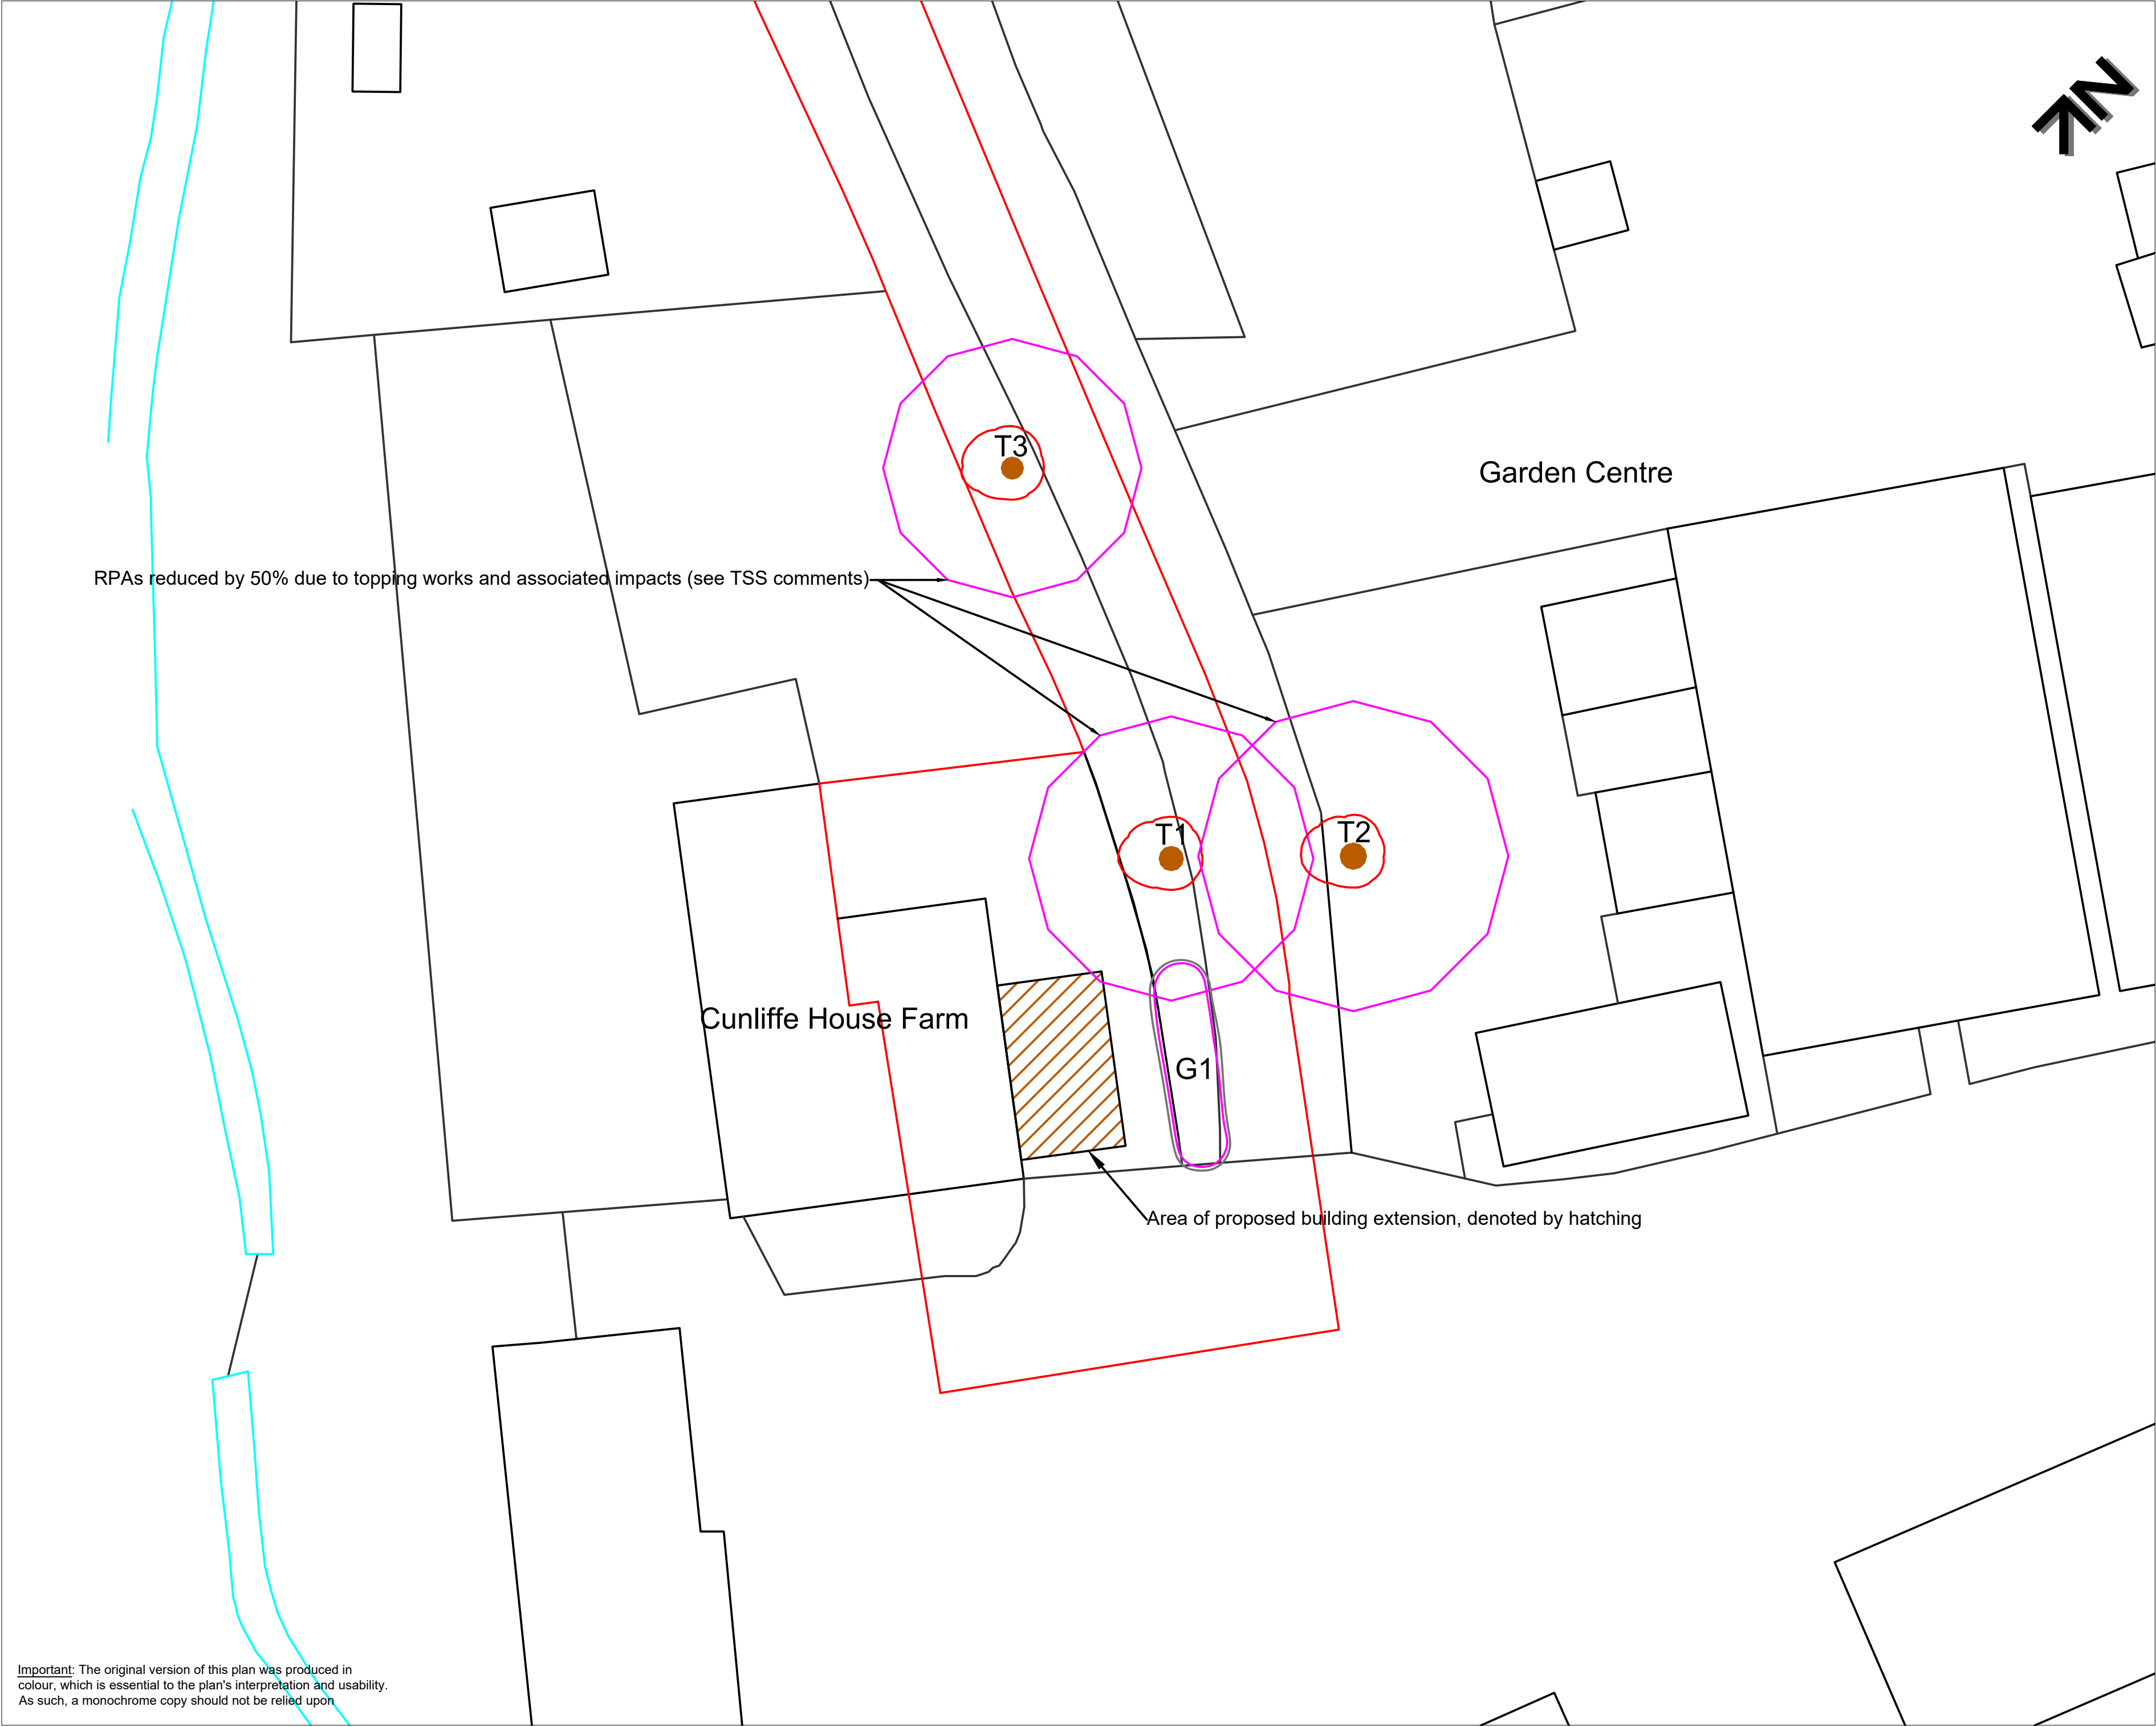
**Title:**  
**TREE IMPACT PLAN**  
in Relation to Proposed Construction of Building Extension

Note: The stem locations of all the surveyed trees and the locations and extents of the group were not included on the Ordnance Survey base plan provided, and were subsequently plotted by the arboriculturist at the time of the survey using GPS and, where possible, measurement from existing site features or, where not possible, estimation. As such, the locations of the trees, and the locations and extents of the groups cannot therefore be considered to be entirely accurate
