Arboricultural Impact Assessment

in Relation to Proposed Demolition of Existing Property and
Garage, and Construction of Two-storey Residential Property at

**Woodfield, Ribchester Road,
Dinckley, Lancashire, BB6 8AL**

Project No.: BTC2890

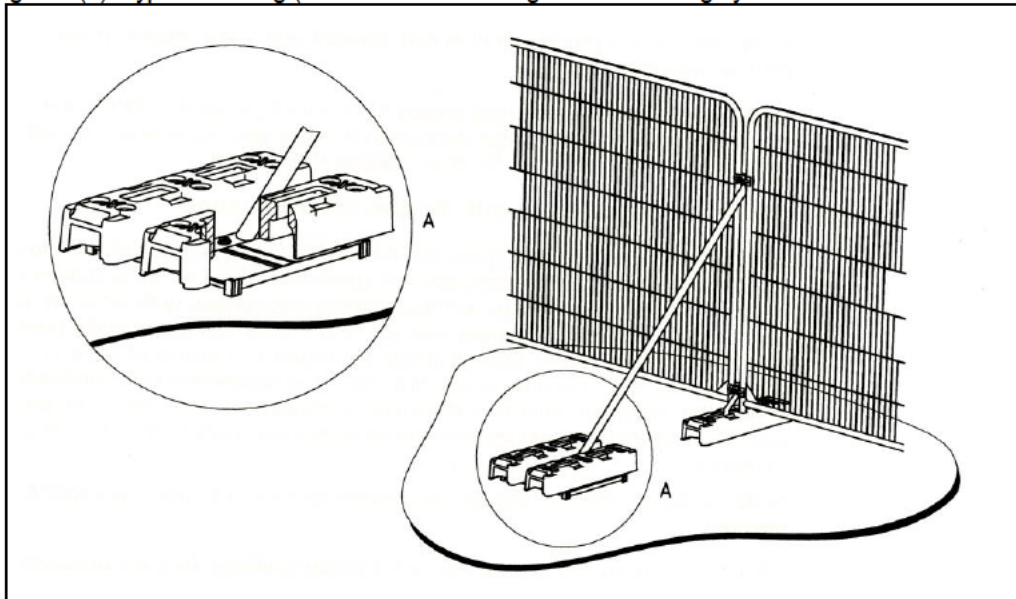
Figure 3(b): Type 3 Fencing (BS5837:2012 above-ground stabilising system with strut on block tray)

Type 3 Temporary Protective Fencing Construction (see Figure 3(b), overleaf)

1. Temporary protective fencing panels shall be weldmesh "Heras" panels of at least 2.0 metres in height.
2. The panels shall stand on rubber or concrete feet.

3. The panels shall butt together, and be joined together using a minimum of two anti-tamper couplers, installed so that they can only be removed from inside the fence.

4. The distance between the fence couplers shall be at least 1.0 metre, and shall be uniform throughout the fence.
5. The panels shall be supported on the inner side by stabiliser struts, which shall be clamped to the scaffold framework at a 45° angle and extend back into the CEZ and shall be attached to a block tray base (Figure 3b).
