# Salesbury View, Wilpshire, Blackburn, BB1 9PL

Arboricultural Impact Assessment  
Persimmon Homes (Lancashire) Ltd

**P.2258.25**  
August 2025

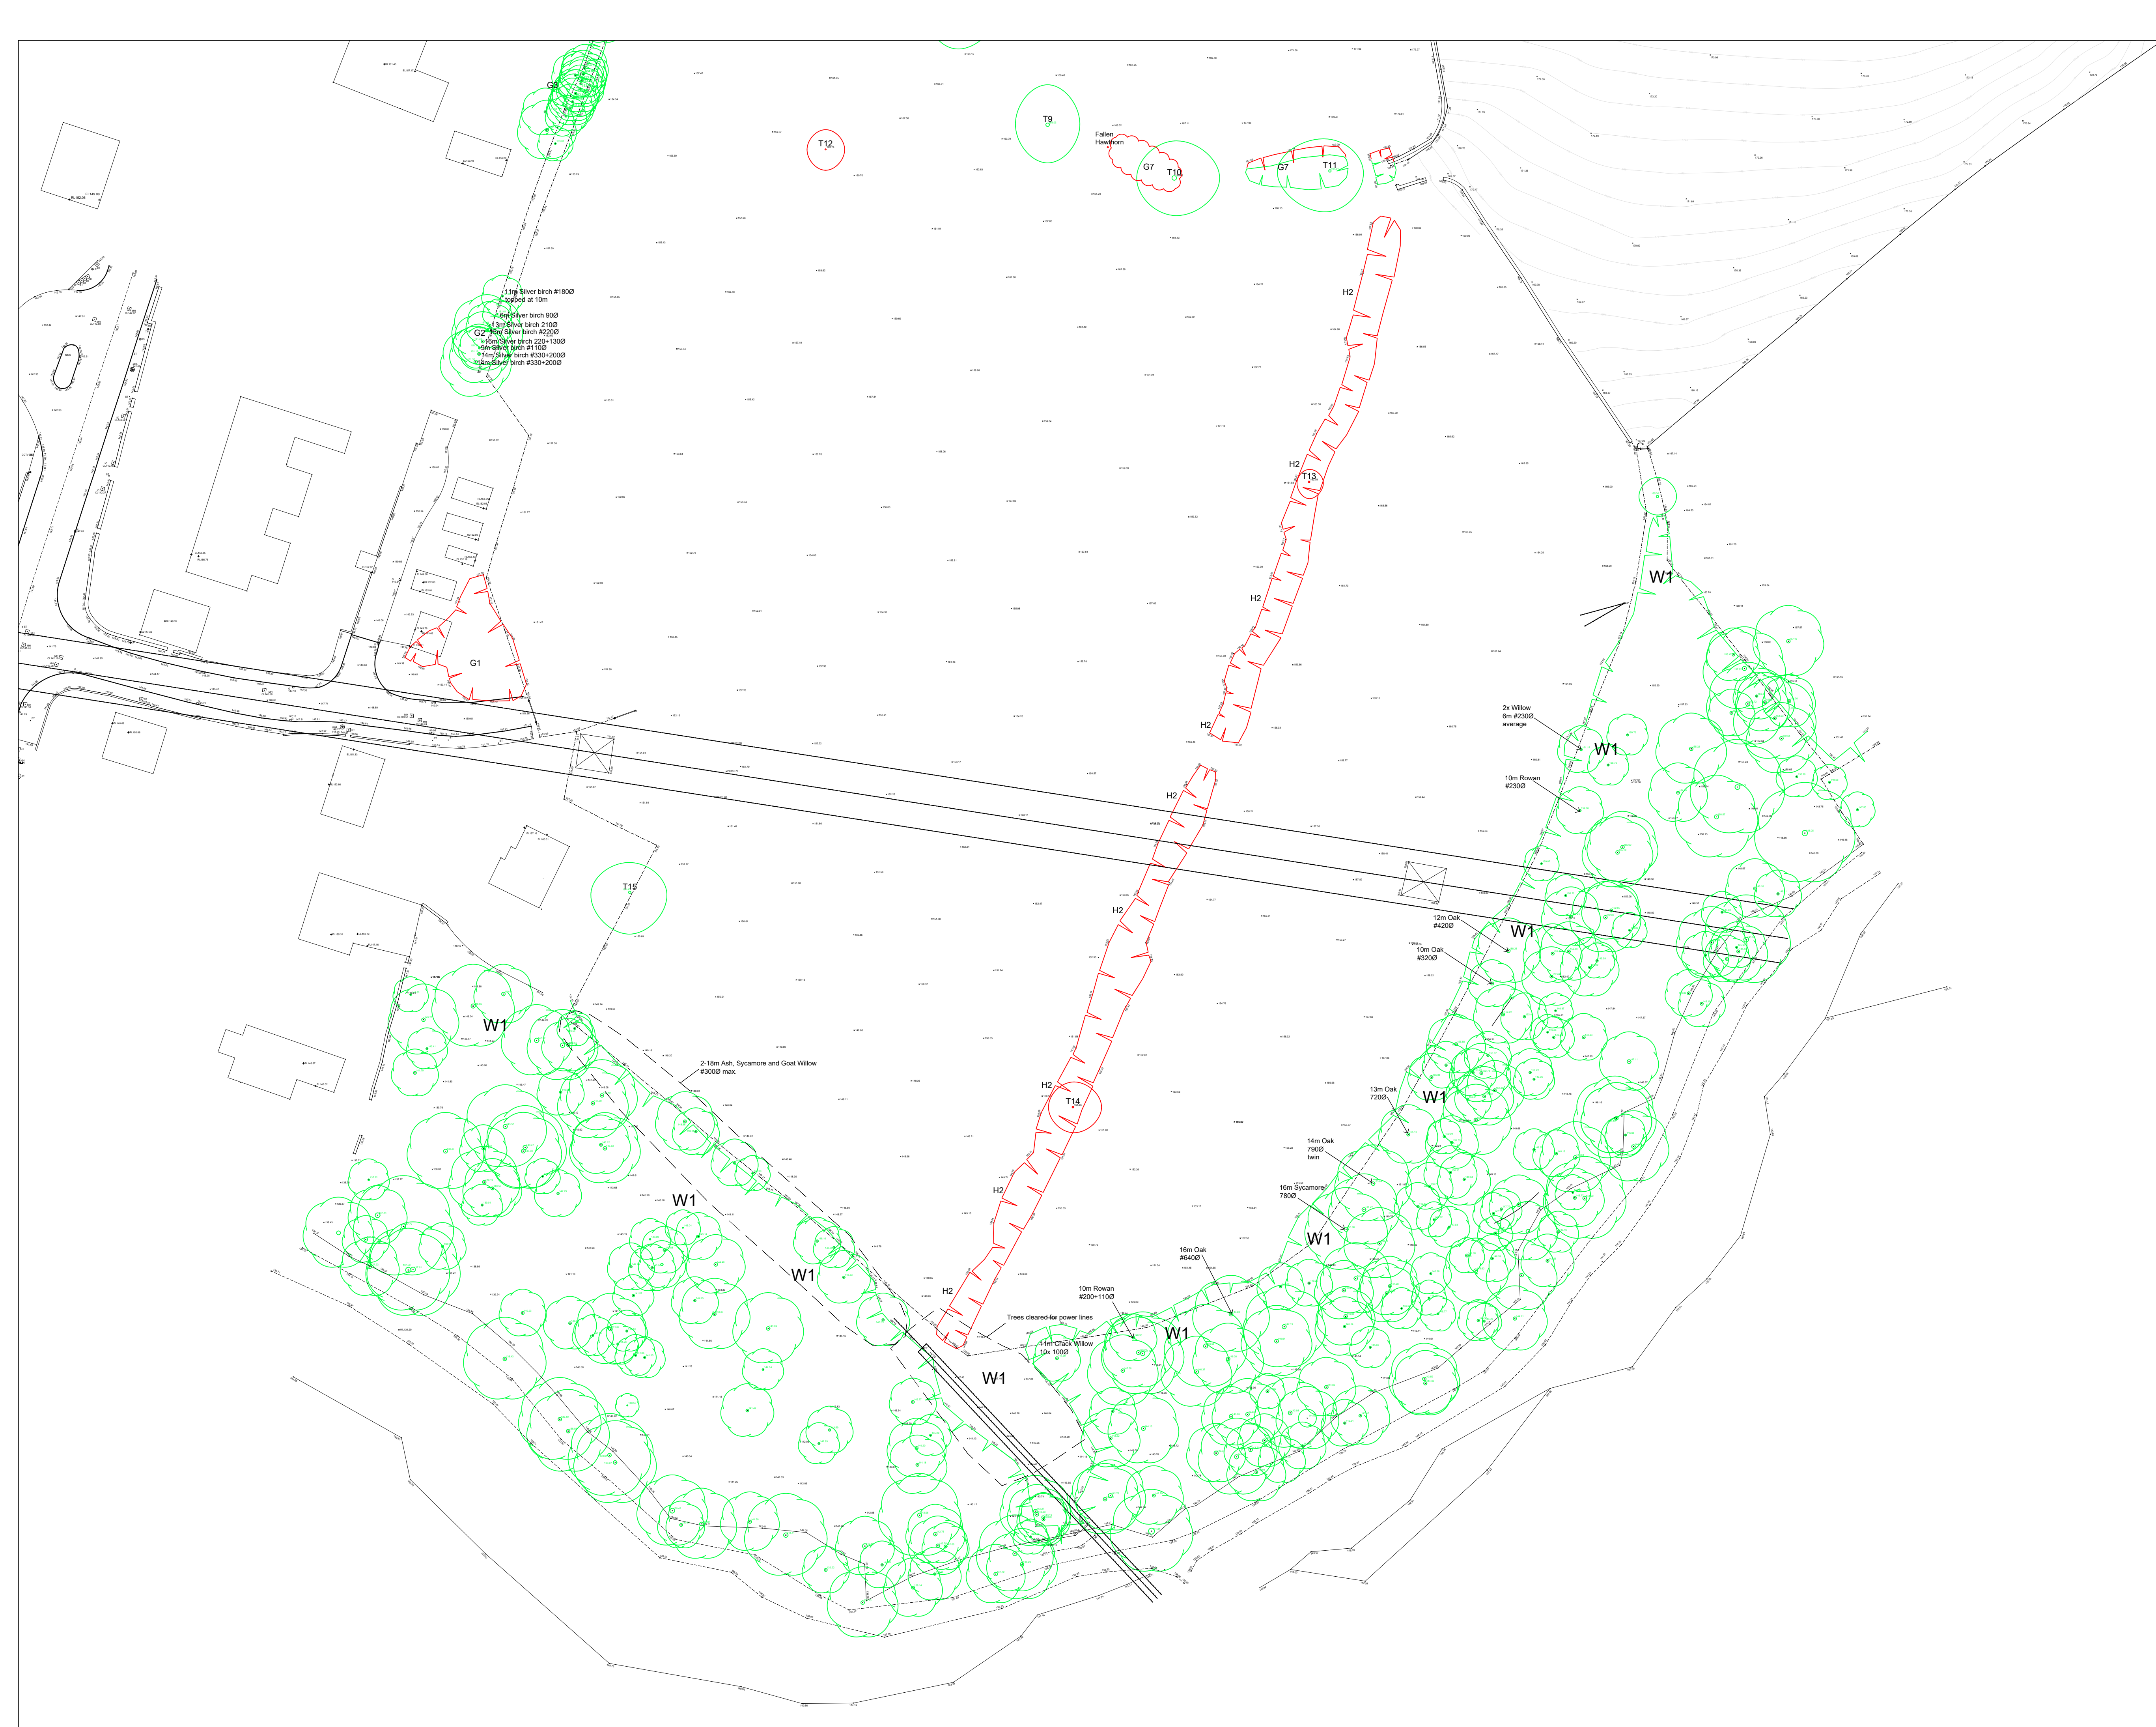
| DATE:<br>07/06/2025 | CHKD BY:<br>AC | P.2258.25.T01 | B |

**Existing Tree Cover:** 15 individual, seven groups of trees, two hedges and one woodland were recorded during our survey, the details of which can be found within Appendix 1 to this report and cross-referenced with drawing P.2258.25.T01B *Tree Survey*.

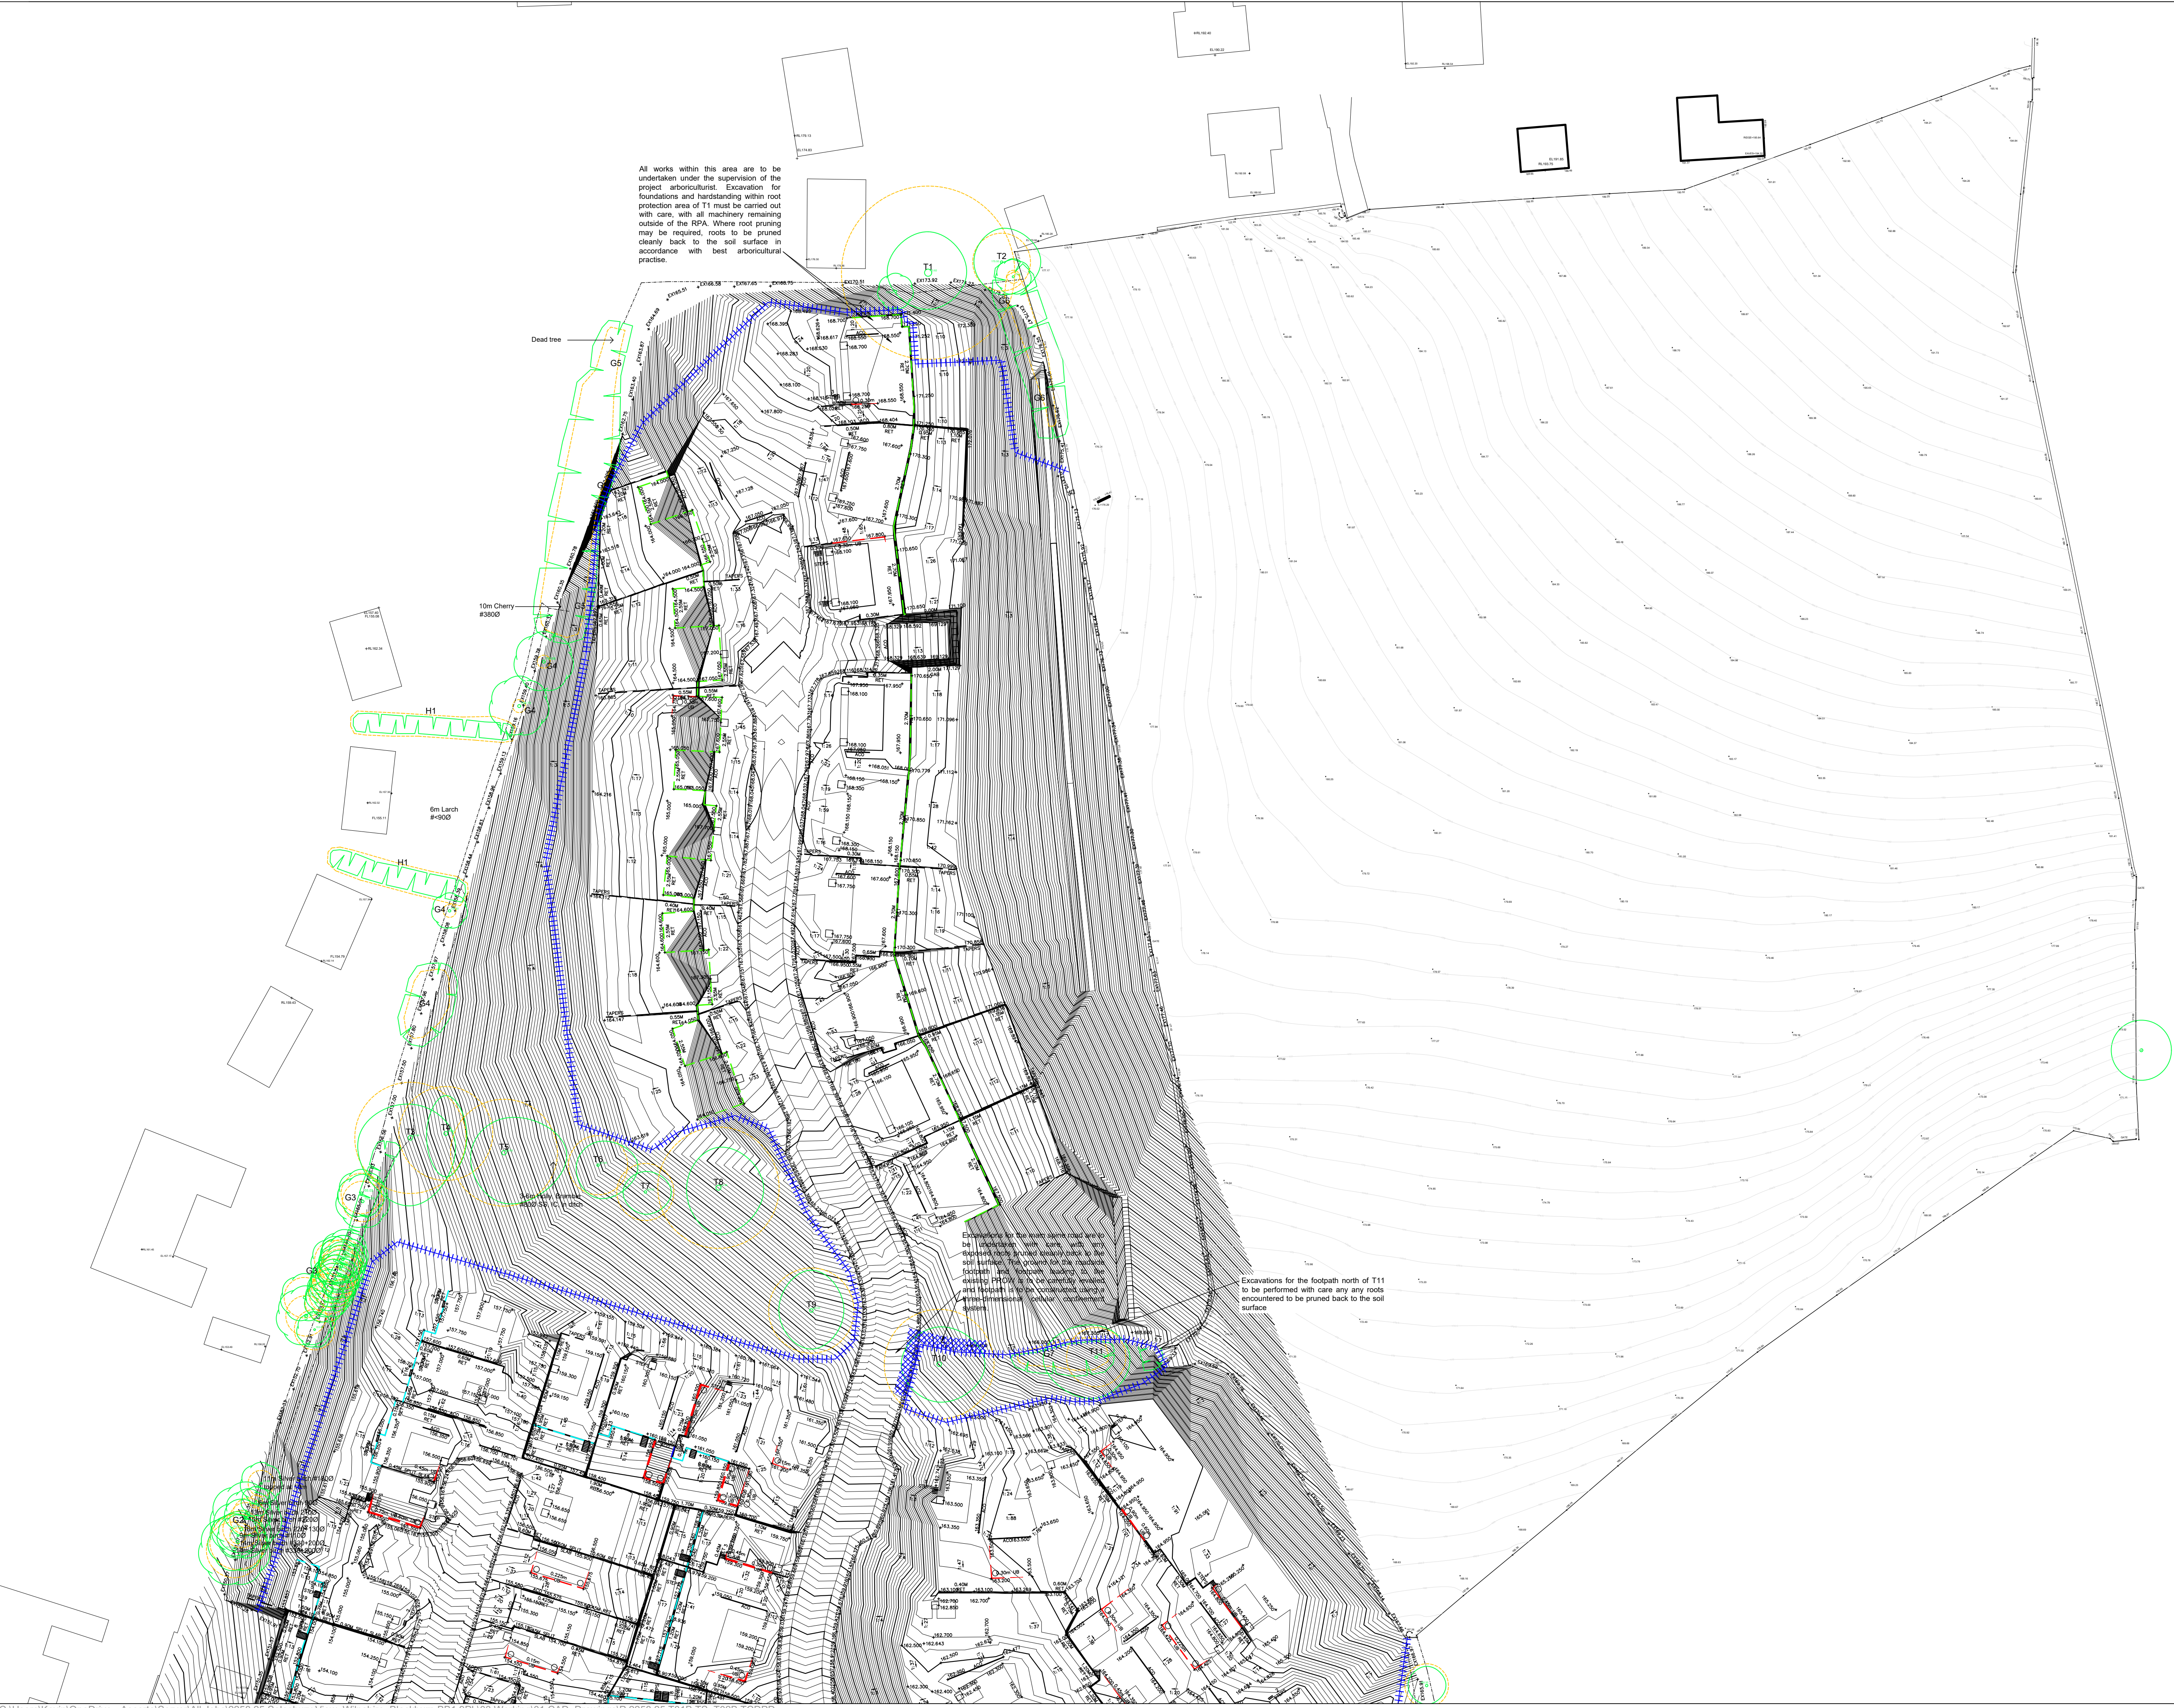
DRAWING TITLE:  
Tree Constraints & Draft Protection Drawing  
(sheet 1 of 2)  
SCALE:  
1:500 @A1  
DATE:  
07/06/2025  
DRAWN BY:  
CP  
CHKD BY:  
AC  
DRAWING No:  
P.2258.25.T02  
REV:  
B

Based on the proposed layout and those trees proposed for retention, the drawings attached to this report show our preliminary recommendations for the physical protection of retained trees throughout the construction phase. The plans indicate the location of protective barriers, as well as the specification for construction of the protective fencing in accordance with Figures 2 and 3 of the Standard. These barriers will form construction exclusion zones around the retained trees.

Extent of Root Protection Area for retained trees in accordance with BS5837: 2012 *Trees in relation to design, demolition and construction - Recommendations*

| Issue | Affecting | Mitigation / Compensation / Special Procedures |
|---|---|---|
| Indirect physical impact on retained trees | T1, T10, G7, T11 & W1 | Tree protection fencing should be erected to an agreed specification in advance of the commencement of the development. Key areas where works are proposed within or immediately adjacent to root protection areas of retained trees should be subject to an Arboricultural Method Statement, agreed in advance as a condition of planning consent. |

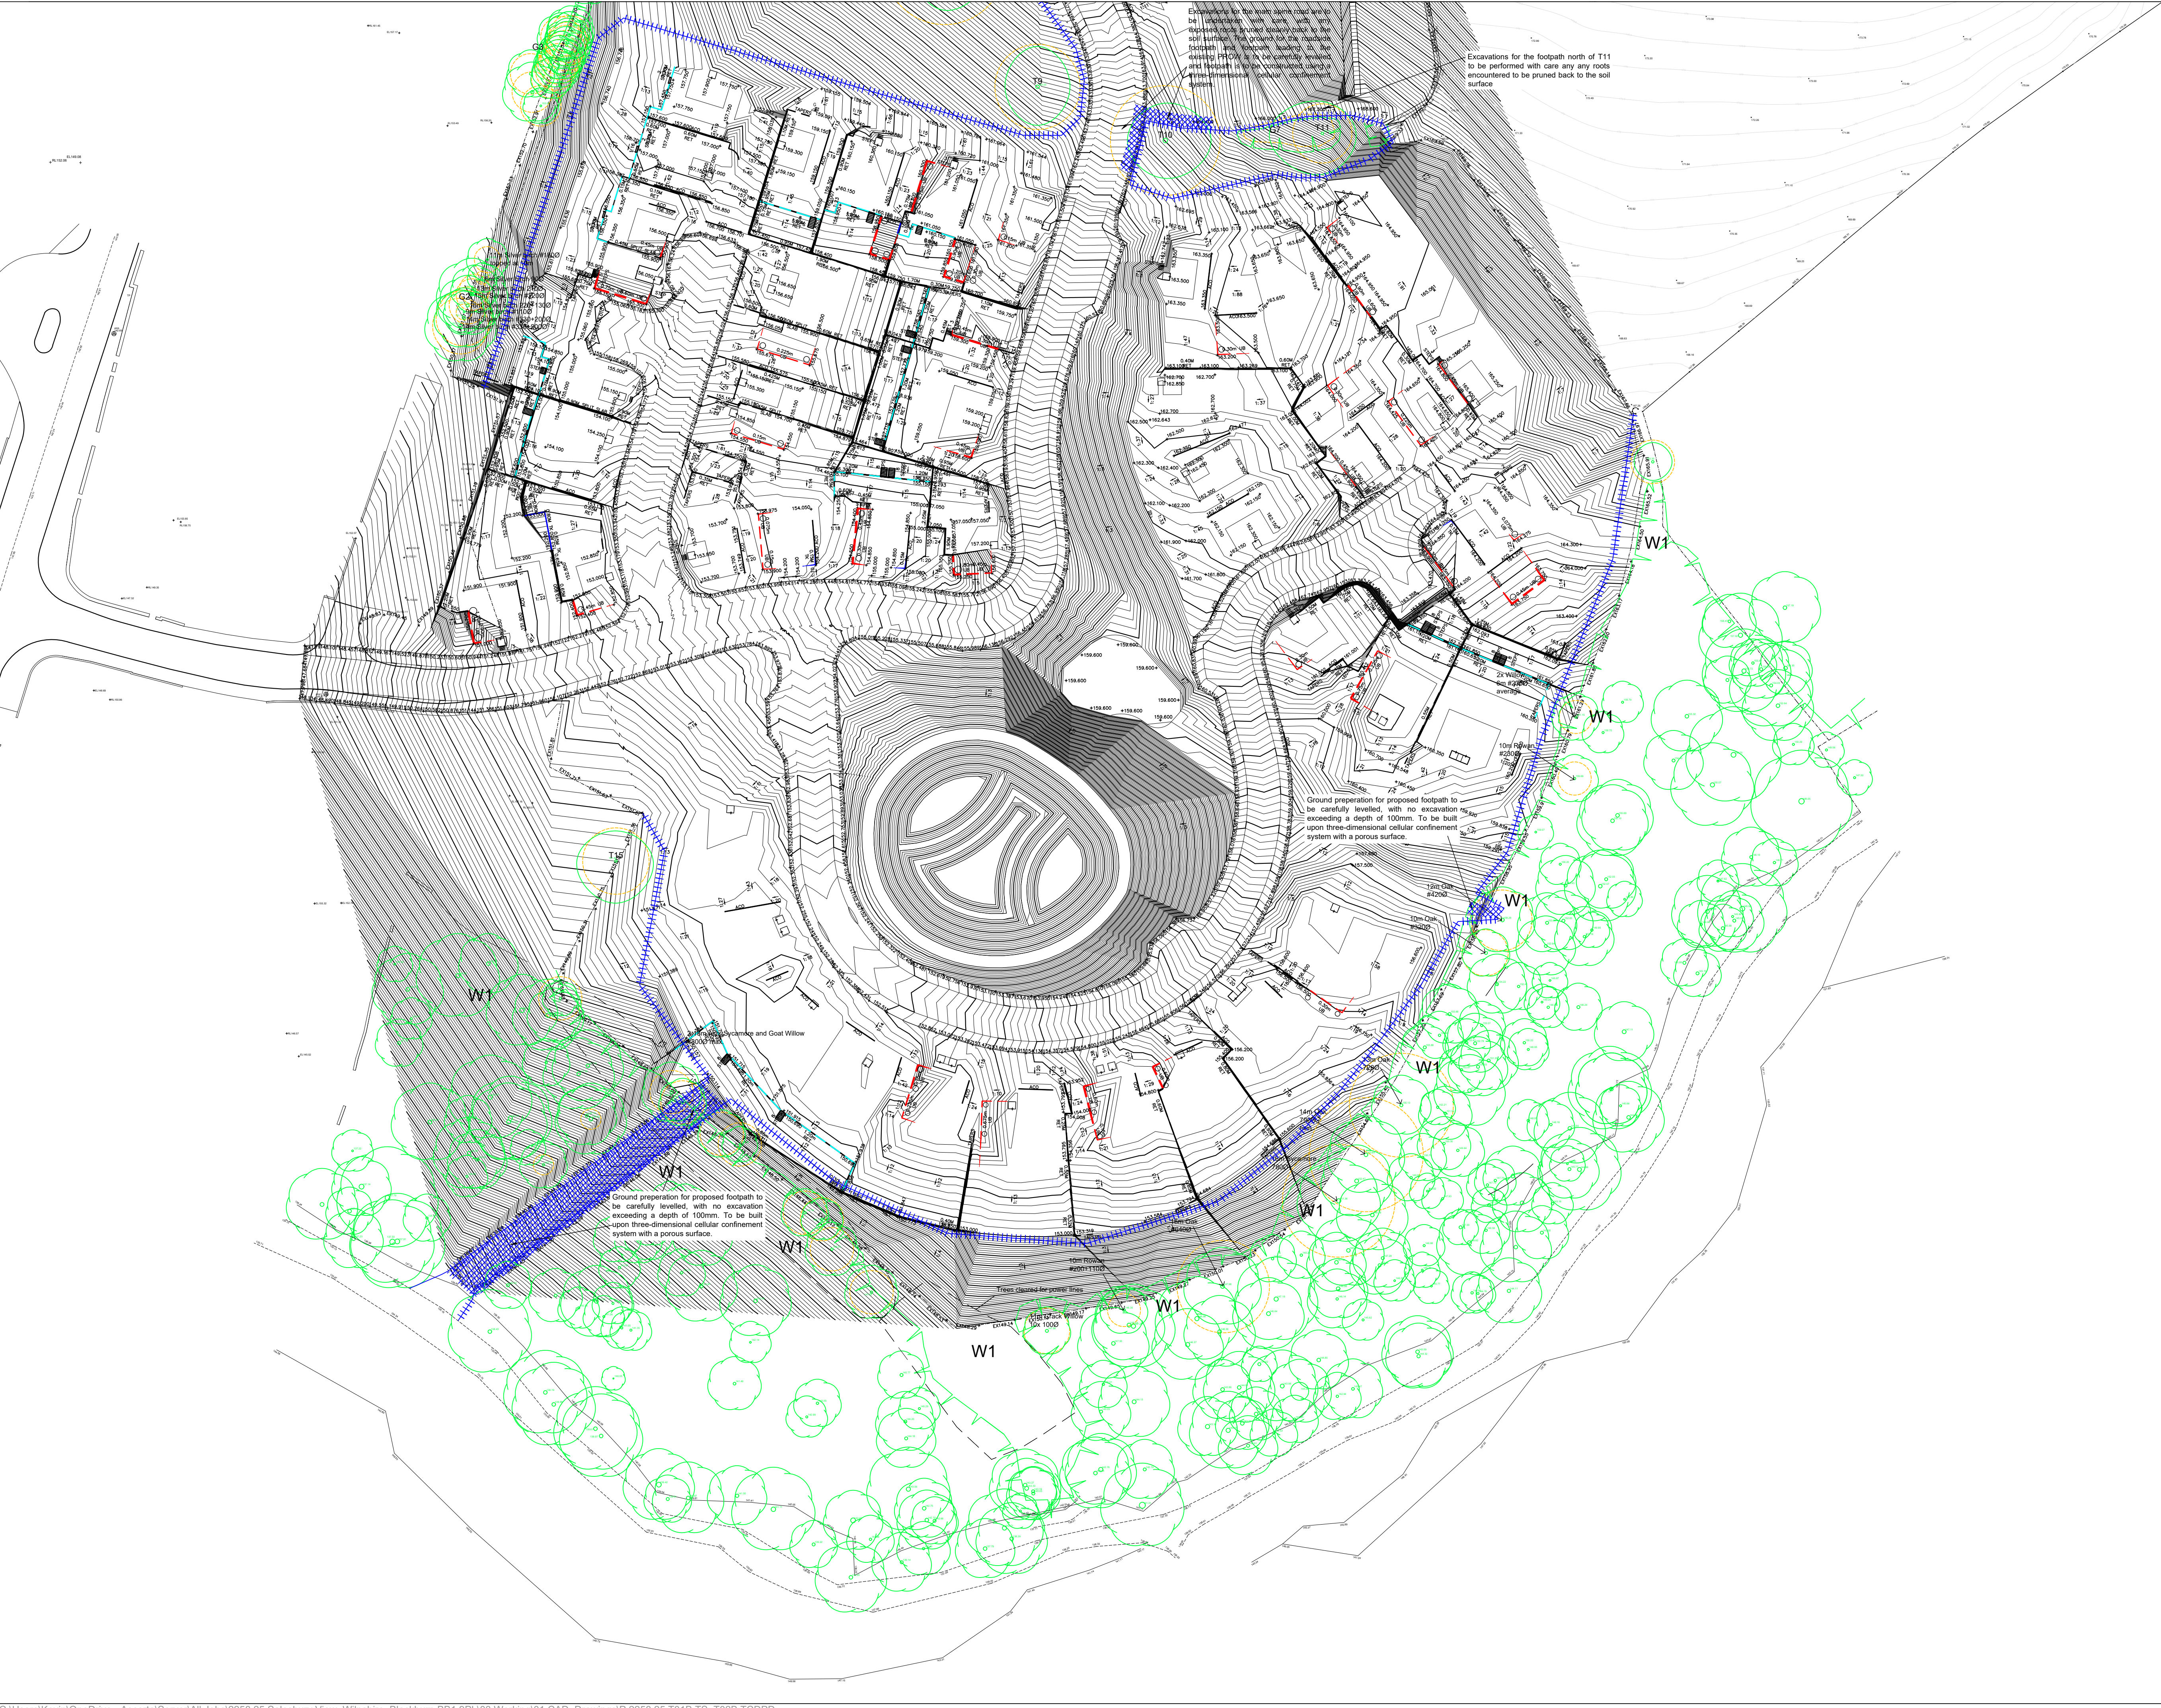
Extent of Root Protection Area for retained trees in accordance with BS5837: 2012 *Trees in relation to design, demolition and construction - Recommendations*
