# Arboricultural Impact Assessment

in Relation to Proposed Extension at

**Wiswell Eaves Barn, Pendleton Road,  
Wiswell, Lancashire, BB7 9BZ**

February 2026

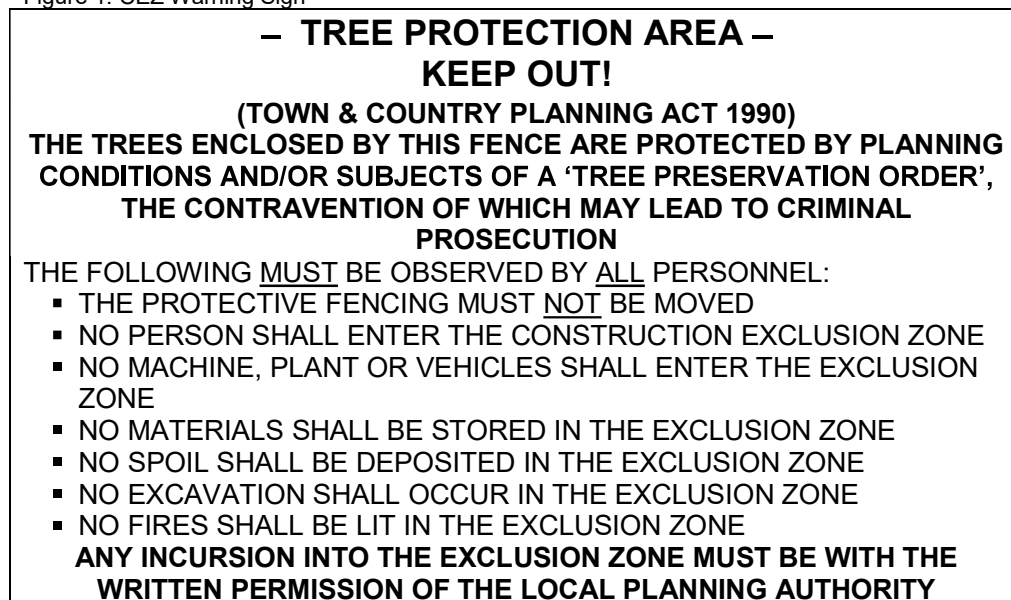
Figure 1: CEZ Warning Sign

8. be affixed with a 600mm x 300mm warning sign reading "TREE PROTECTION AREA KEEP OUT" (see Figure 1, below), at every 10.0 metre length of protective fencing.

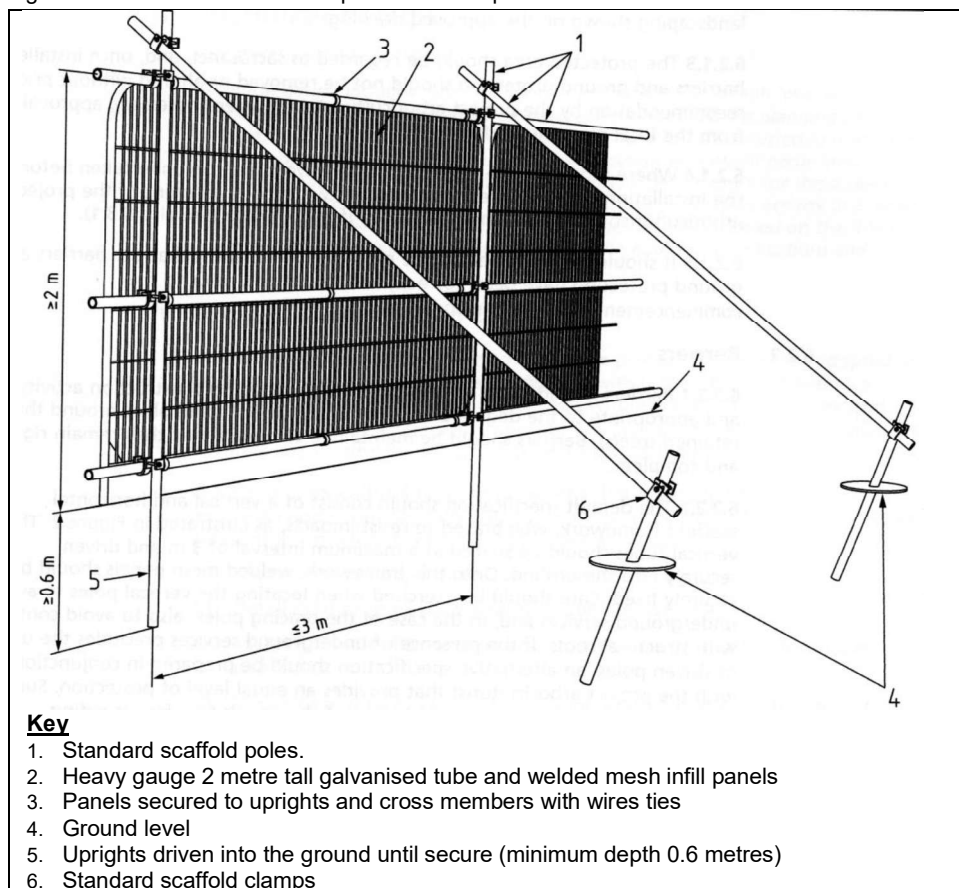
Figure 2: BS5837:2012 Default specification for protective barrier

**Type 1 (i.e. 'Default') Temporary Protective Fencing Construction** (see Figure 2, below)

1. Temporary protective fencing panels shall be weldmesh "Heras" panels of at least 2.0 metres in height.
2. The panels shall butt together and be securely fixed to a scaffold framework, as per points 3 to 5 of Figure 2, overleaf.

3. The scaffold framework shall comprise of upright poles of at least 3.0 metres in length driven no less than 0.6 metres into the ground at maximum 3.0 metre centres with horizontal and diagonal poles fixed to the uprights, as per points 4 to 5.

4. The two horizontal rail poles shall be attached to the uprights at heights of 0.6 and 1.8 metres with 3 no. clamps to each joint.
5. The diagonal scaffold pole struts be clamped to the top rail of the scaffold framework at a 45° angle and extend back into the CEZ and clamped to a 0.7 metre length of scaffold tube that shall be driven no less than 0.5m into the ground.

6. No fixing shall be made to any tree and all possible precautions shall be taken to prevent damage to tree roots when locating posts.
7. A 600mm x 300mm warning sign reading "TREE PROTECTION AREA KEEP OUT" (see Figure 1) shall be fixed to every 10.0 metre length of protective fencing.

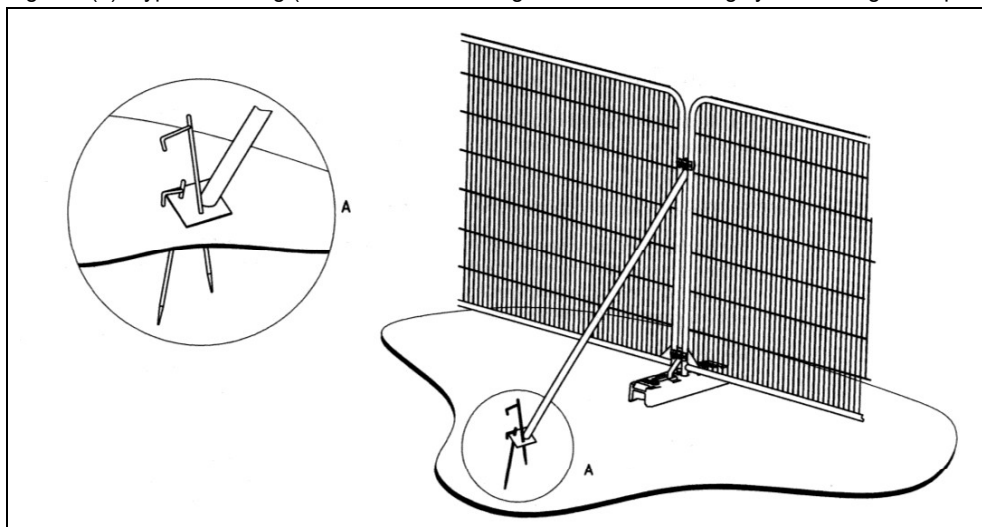
Figure 3(a): Type 2 Fencing (BS5837:2012 above-ground strut stabilising system with ground pins)

### **Type 2 Temporary Protective Fencing Construction** (see Figure 3(a), below)

1. Temporary protective fencing panels shall be weldmesh "Heras" panels of at least 2.0 metres in height.
2. The panels shall stand on rubber or concrete feet.

3. The panels shall butt together, and be joined together using a minimum of two anti-tamper couplers, installed so that they can only be removed from inside the fence.

4. The distance between the fence couplers shall be at least 1.0 metre, and shall be uniform throughout the fence.
5. The panels shall be supported on the inner side by stabiliser struts, which shall be clamped to the scaffold framework at a 45° angle and extend back into the CEZ and shall be attached to a base plate, which shall be secured to the ground with pins (Figure 3a).

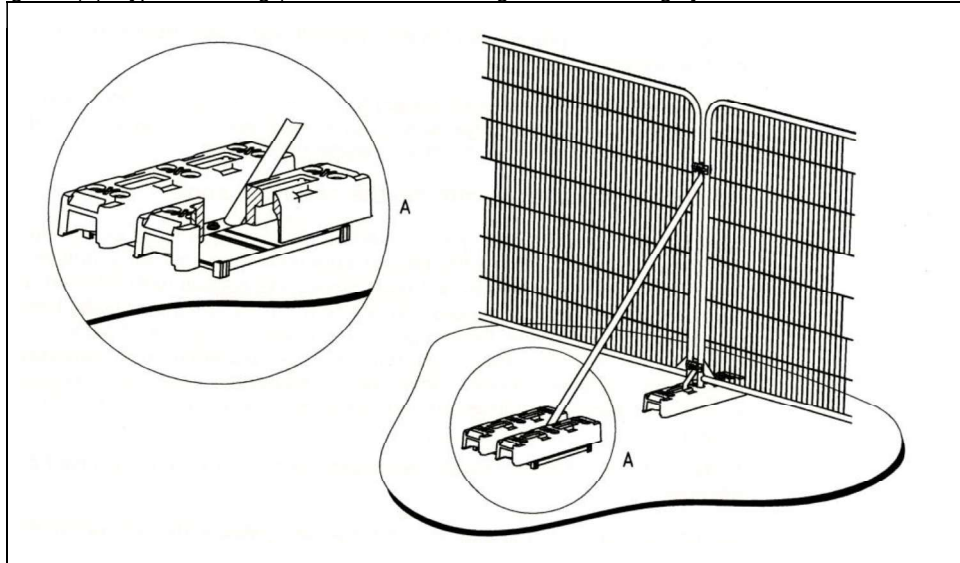
Figure 3(b): Type 3 Fencing (BS5837:2012 above-ground stabilising system with strut on block tray)

### **Type 3 Temporary Protective Fencing Construction** (see Figure 3(b), overleaf)

1. Temporary protective fencing panels shall be weldmesh "Heras" panels of at least 2.0 metres in height.
2. The panels shall stand on rubber or concrete feet.

3. The panels shall butt together, and be joined together using a minimum of two anti-tamper couplers, installed so that they can only be removed from inside the fence.

4. The distance between the fence couplers shall be at least 1.0 metre, and shall be uniform throughout the fence.
5. The panels shall be supported on the inner side by stabiliser struts, which shall be clamped to the scaffold framework at a 45° angle and extend back into the CEZ and shall be attached to a block tray base (Figure 3b).

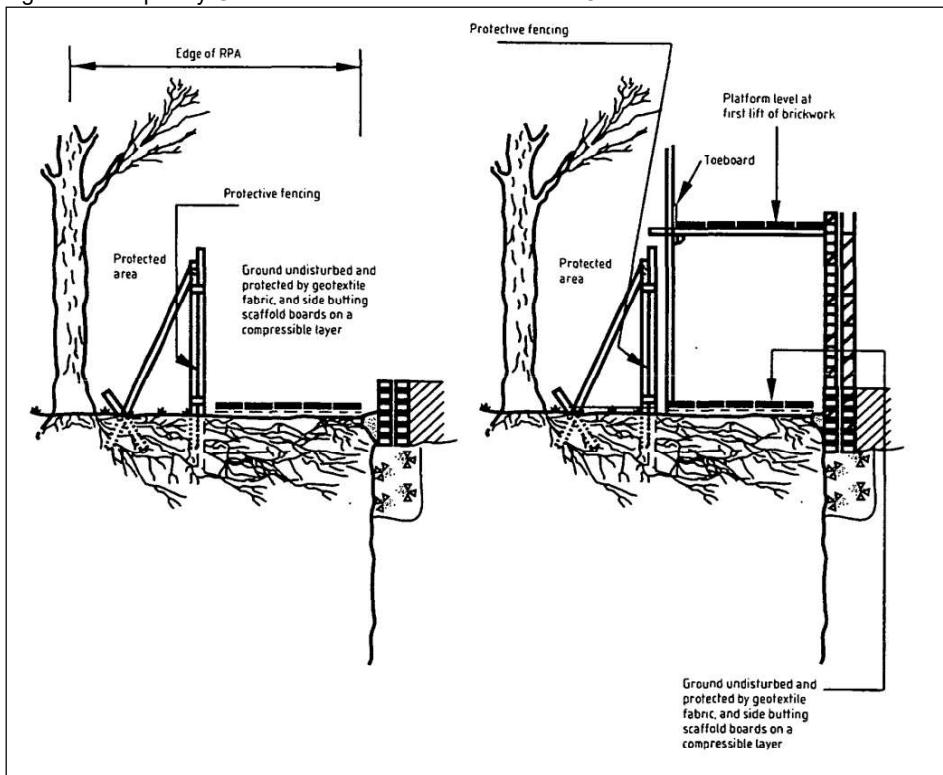
Figure 4: Temporary Ground Protection – Recommended Construction

1. Any necessary Temporary Ground Protection areas shall conform to Figure 4, below, unless otherwise agreed with the LPA.
2. The Ground Protection Area shall be left undisturbed and covered by a semi-permeable geotextile membrane which shall, in turn, be covered by a compressible layer consisting of a material such as woodchip.
3. Side-butting scaffold boards shall then be fitted to cover the Ground Protection Area.
4. On completion of installation, and prior to any demolition or construction works, site preparation, excavation or delivery of plant and materials, the Consulting Arboriculturist or the LPA Tree Officer, as agreed, shall inspect the Temporary Ground Protection.
5. The Temporary Ground Protection shall remain in place until completion of the project and only removed following receipt of written permission from the LPA.

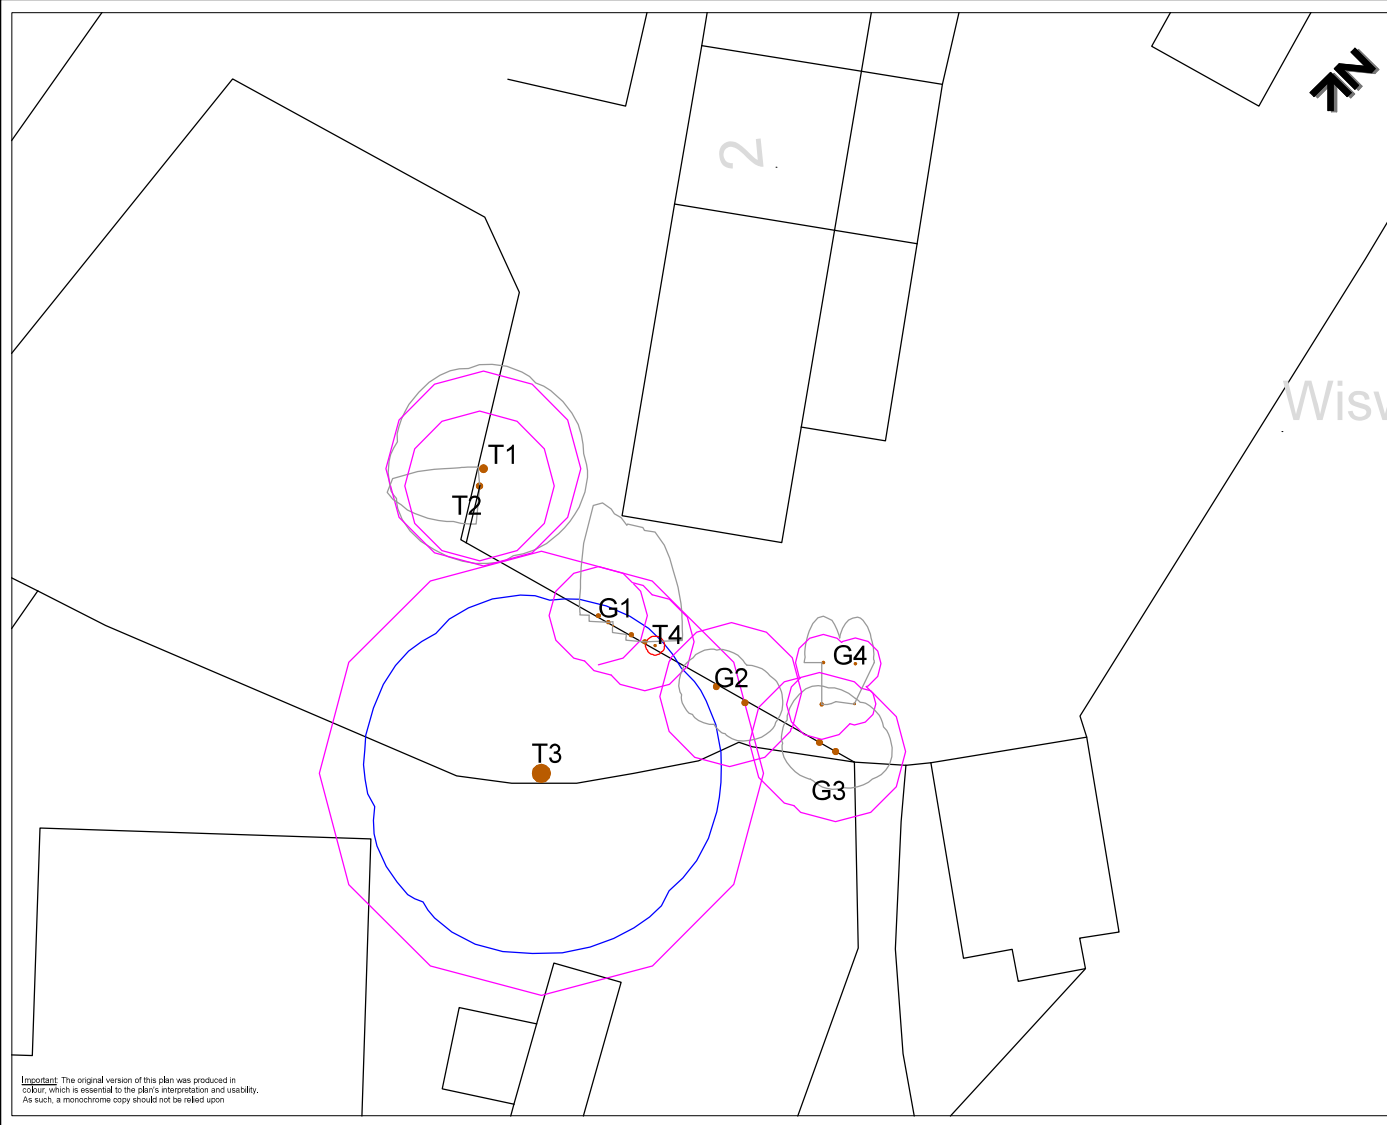
**Title:**  
TREE CONSTRAINTS PLAN  
in Relation to Proposed Extension

Note: The locations and extents of all trees and groups were not included on the Ordinance Survey map provided, and were subsequently derived by this appointment at the time of the survey using GPS and, where possible, measurement from existing site features, where not possible, estimation. As such, the locations and extents of this group cannot be taken to be considered to be entirely accurate

- RPAs: Areas of Ground Around Trees that Should be Protected Throughout Development Works with Temporary Fencing to form a Construction Exclusion Zone - see Temporary Protective Fencing Specification

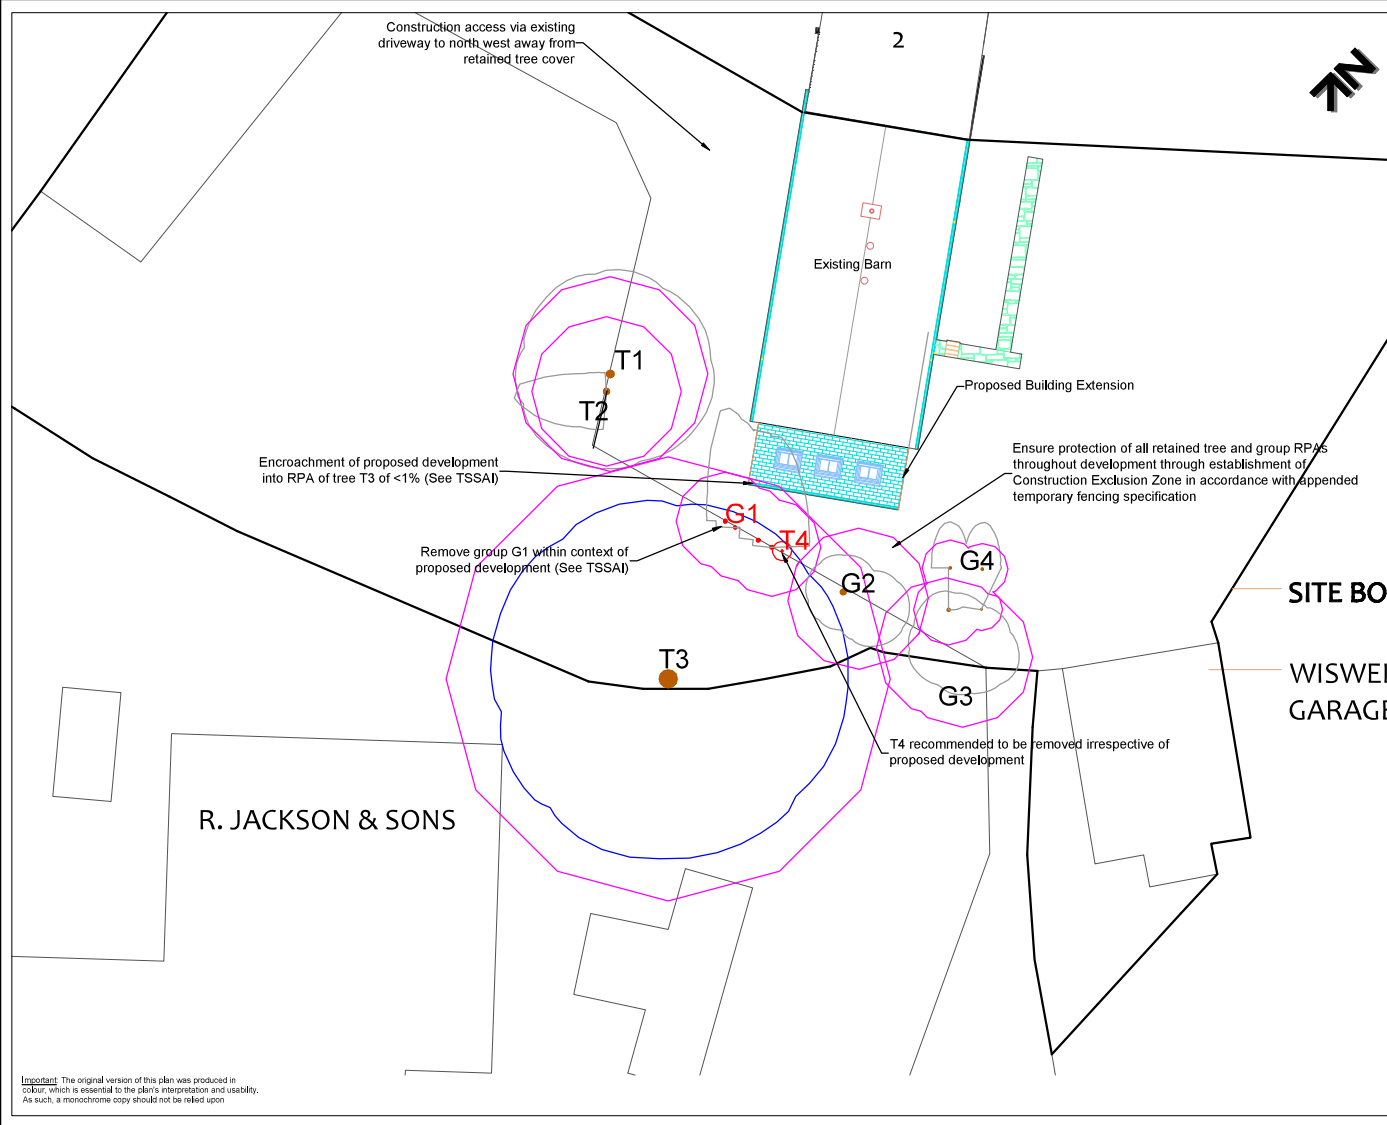
**Title:**  
**TREE IMPACT PLAN**  
in Relation to Proposed Extension

Note2: Trees with their identifying numbers and stems coloured in red are proposed to be removed in the context of the proposed development.

RPAs: Areas of Ground Around Retained Trees that Should be Protected Throughout Development Works with Protective Fencing to form a Construction Exclusion Zone - see Temporary Protective Fencing Specification
