Arboricultural Impact Assessment with Arboricultural Method Statement

- Bridgecroft, Longsight Road, Blackburn, BB1 9EX -

Clayton Hill Properties Ltd
Oaklea
Longsight Road
Blackburn
BB1 9EX

April 2026

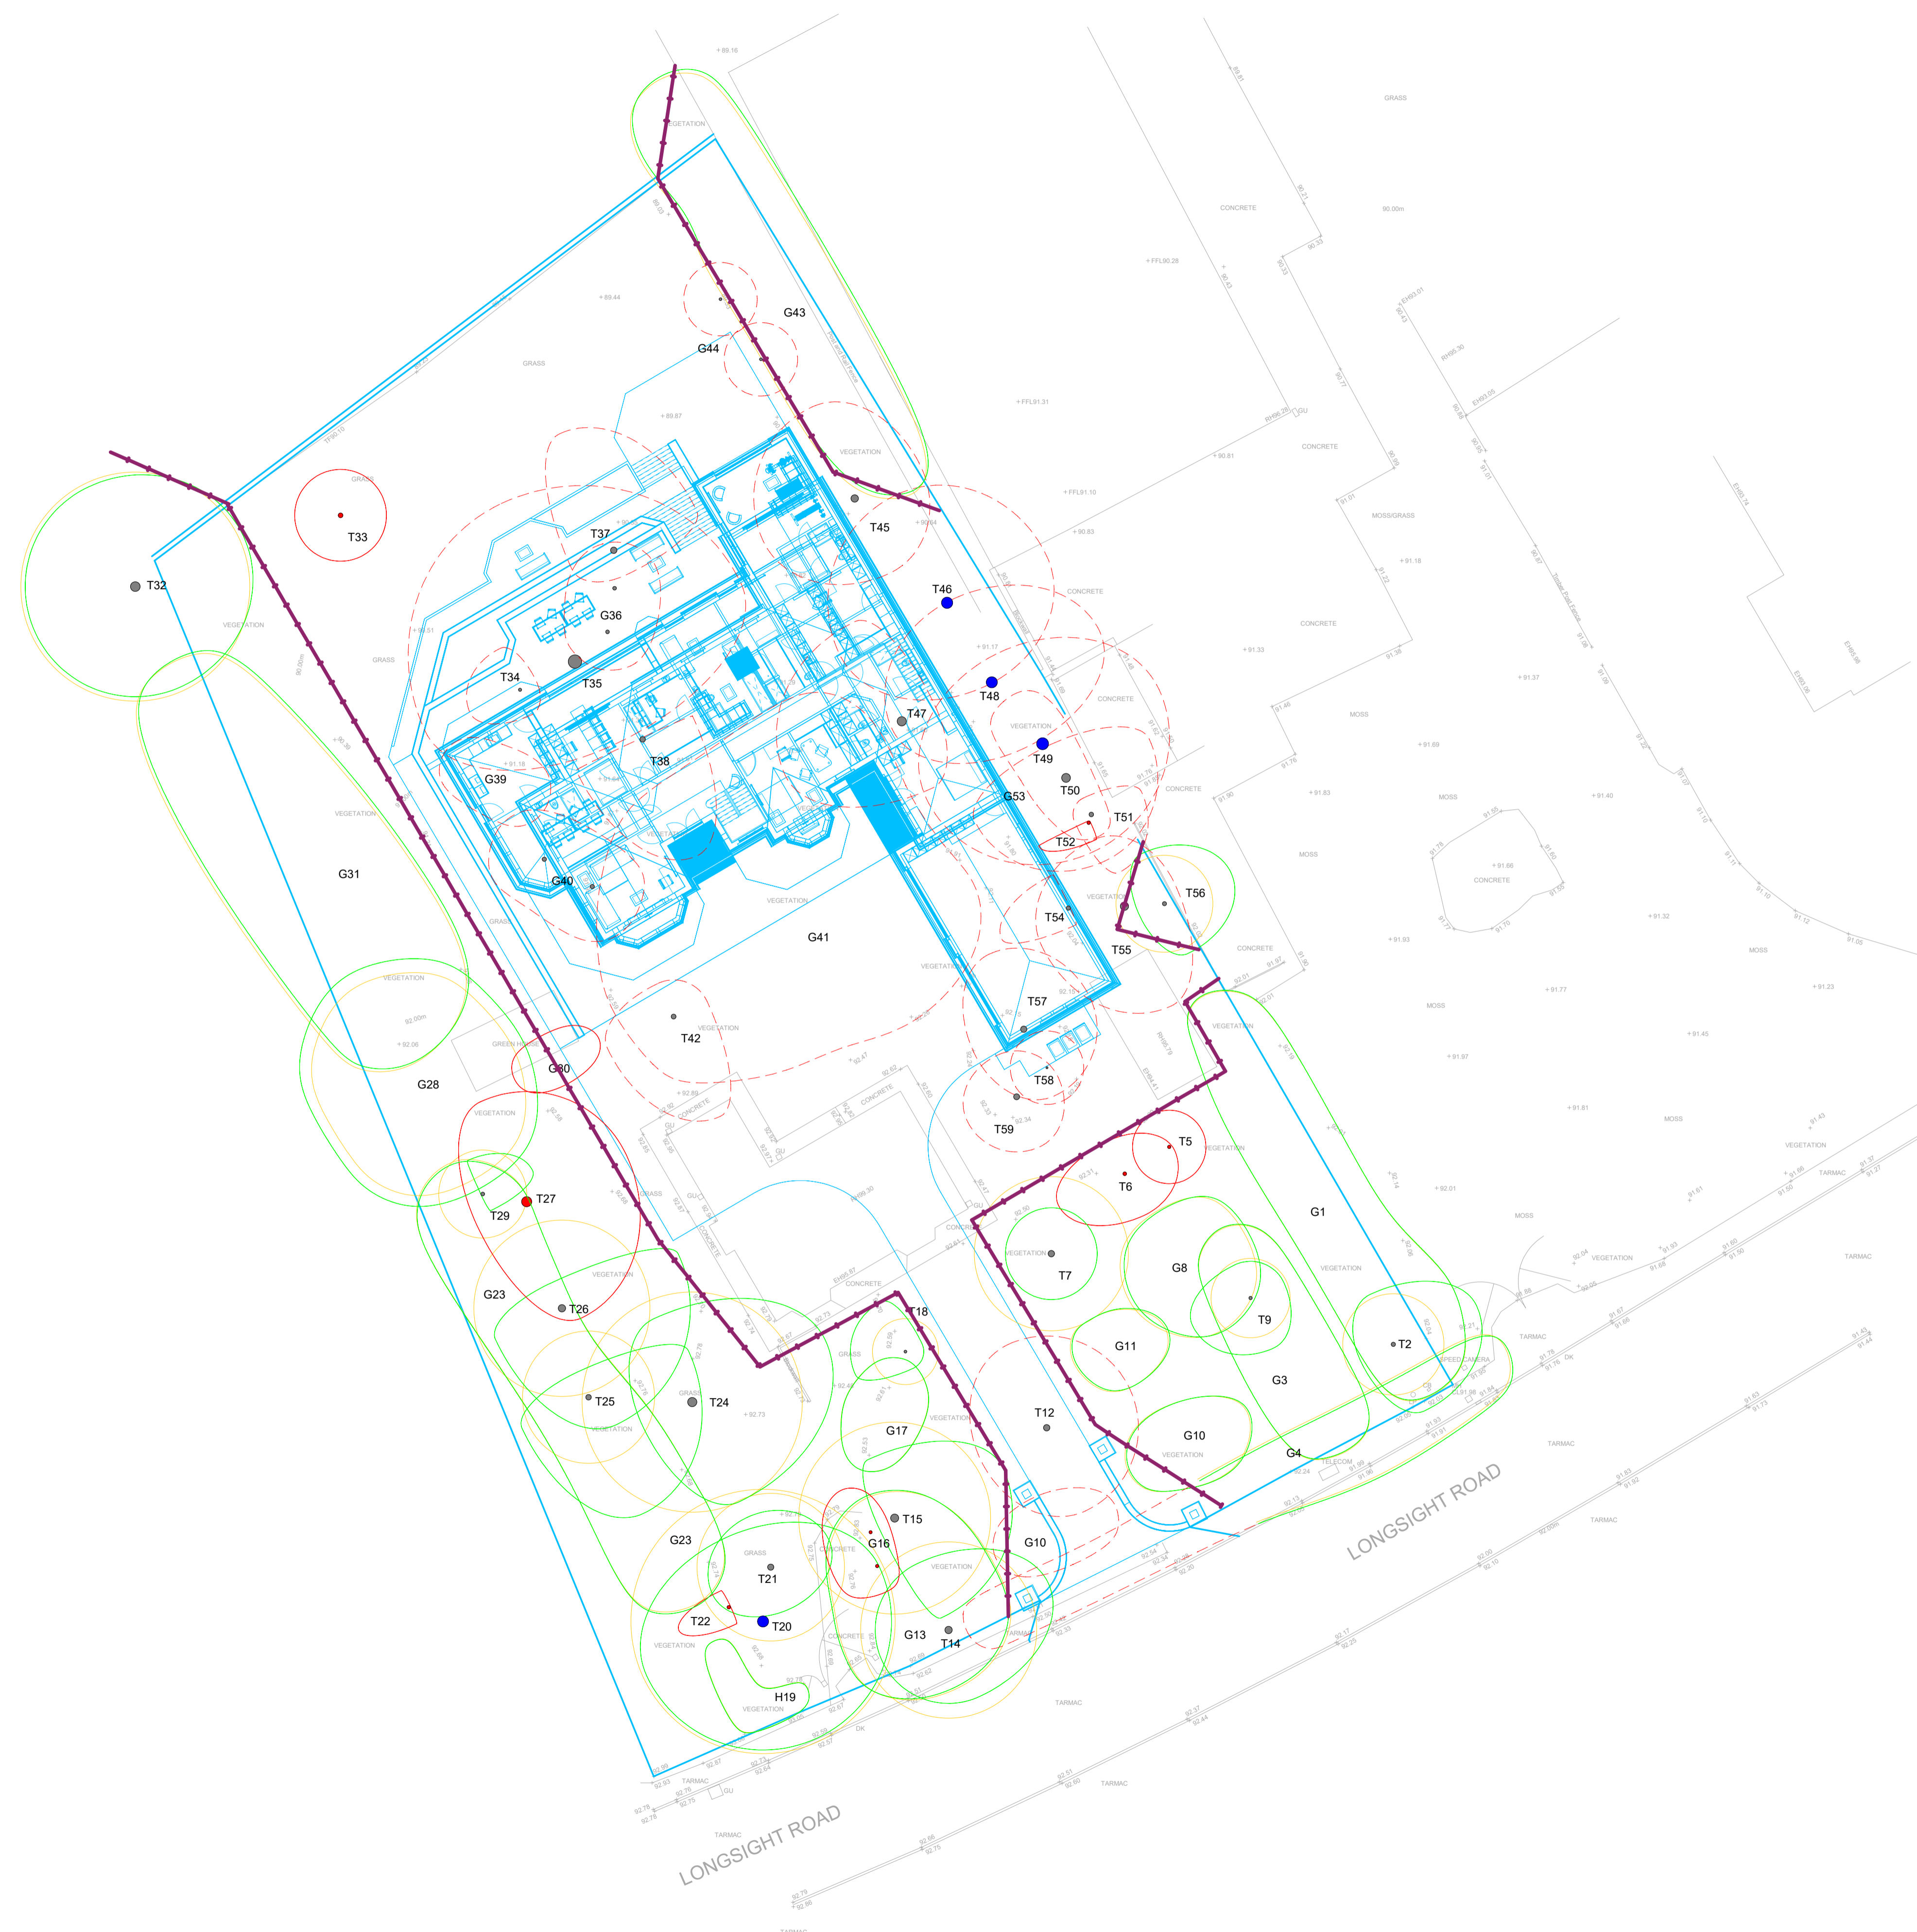
Drawing 2. Tree Protection Plan

TREE PROPOSED FOR REMOVAL (ARBORICULTURAL REASONS)
	T5, T6, G16, T22, T27, G30, T33 & T52

TREE PROPOSED FOR REMOVAL (TO ENABLE DEVELOPMENT)
	G4 (section), G10 (section), T12, T34, G36, T37, T38, G39, G40, G41, T42, G44, T45, T46, T47, T48, T49, T50, T51, G53, T54, T55, T57, T58 & T59

TEMPORARY PROTECTIVE BARRIER Refer to Appendix 4 of the Arboricultural Impact Assessment for specification details.

PROJECT TITLE: Bridgcroft, Longsight Road, Blackburn, BB1 9EX		
DRAWING TITLE: TREE PROTECTION PLAN	SCALE: 1:200 @ A1	ISSUE DATE: 31.03.26
DRAWING NUMBER: TPP.14135	REVISION: .01	DRAWN BY: RG

4.2.3. Please see *Appendix 4* for suggested barrier construction detail. It is recommended that in this instance the protective barrier shown in *Figure 2* would be appropriate. The suggested location for protective fencing is shown on the *Tree Protection Plan (Drawing 2)*.
