**Job No. 7125 - Rev. A**

**Proposed replacement dwelling at  
Markhor, Eaves Hall Lane, West Bradford,  
Clitheroe BB7 3JG**

**Planning Application Ref. 3/2026.0071, Decision Notice (dated 13.04.2026)**

**Condition 25 - No development shall commence until a detailed, final surface water sustainable drainage strategy for the site has been submitted to and approved in writing by the Local Planning Authority.**

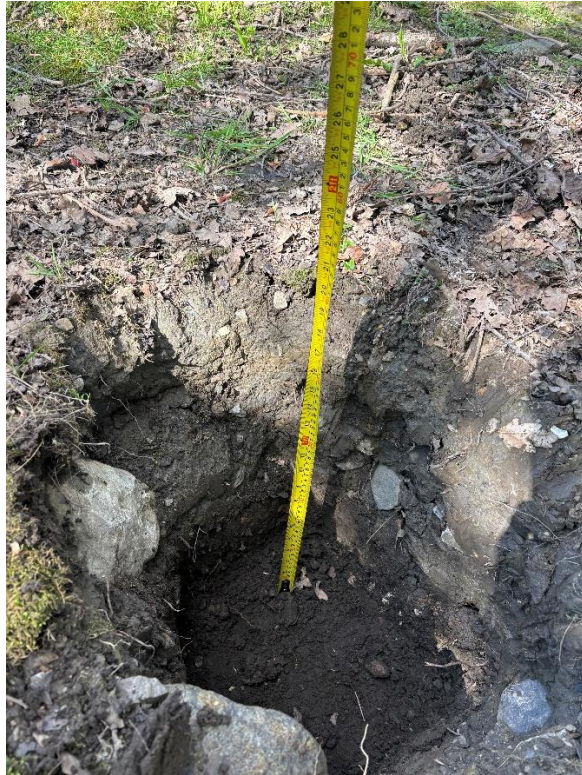
This trial pit highlighted that the ground consisted of a thin layer of topsoil (max. 200mm), overlying firm to stiff clay, becoming stiffer with depth. It is thought that this was consistent across the site, due to the lawn being saturated under foot, despite little recent rainfall. The trial pit also quickly backfilled with standing groundwater, during the period of the investigation.

*Image 1. Trial hole, showing nom. 200mm thickness of topsoil, down to stiff boulder clay.*

This soil type, with firm /stiff boulder clay, is associated with very poor infiltration rates and is therefore considered to be unsuitable for the discharge of water through infiltration (soakaways).

It is therefore concluded that as infiltration is not possible and there is no watercourse near to the property, discharging surface water to the combined sewer as it currently does, is the best course of action. The current design, on drawing 7125-P17A, shows a separate surface and foul water drainage system, combining at the final manhole within the site.

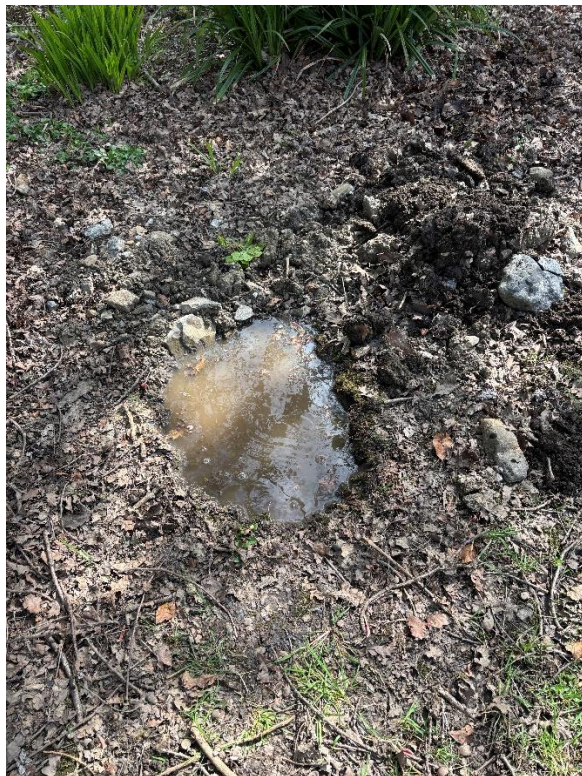
*Image 2. Trial hole, backfilled with standing groundwater.*
