# AR12

# Heritage Statement

The Old Printworks  
4a and 6a Back York Street  
Clitheroe  
BB7 1LT

Prepared by Aldrock  
Date: 27/02/26

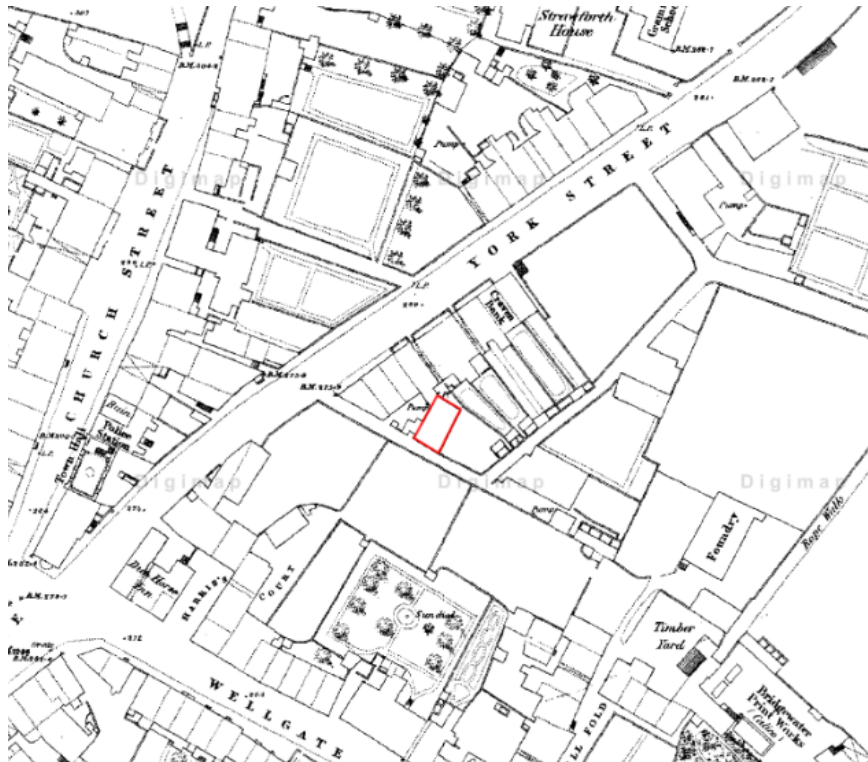
Appendix C1 – 1880s OS map showing the site without the brick extension.

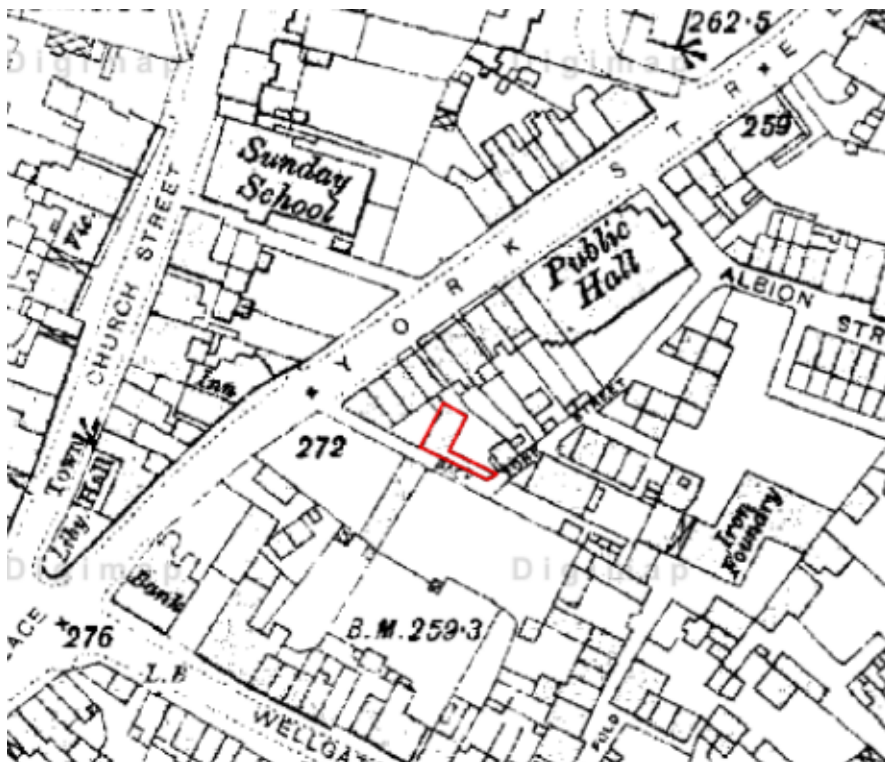
Appendix C2 – 1910s OS map showing the site with the brick extension.

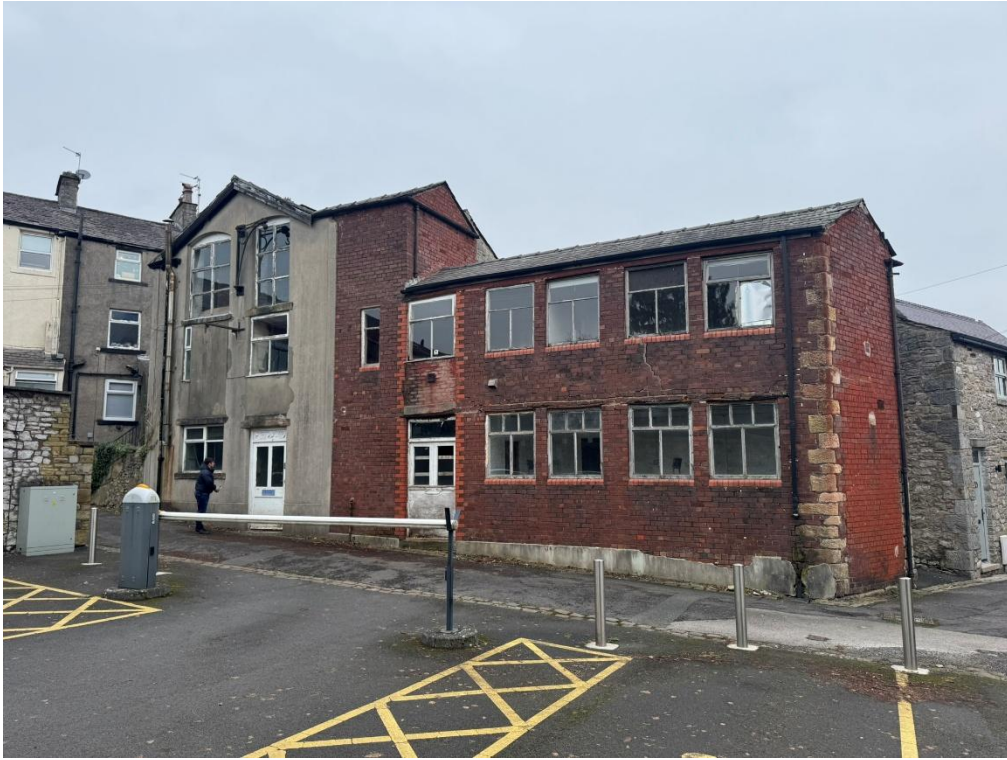
E1 – Existing Front Elevation (SW).

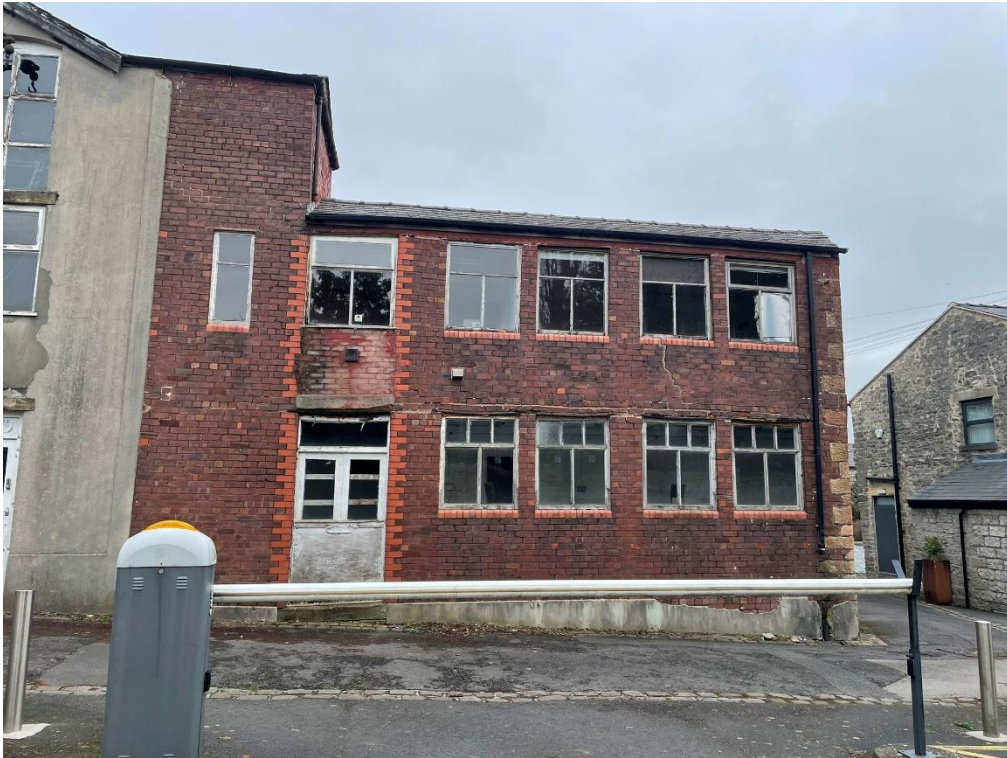
A Structural Report (Taylor Partington Design, July 2023) confirms that the most significant structural issues are confined to the later two-storey brick section. The report identifies structural movement and deterioration within this element and concludes that it is no longer structurally sound (See Appendix F and E7).

E7 – Brick Extension showing visible signs of deterioration.

Our inspection revealed that the primary structural movement is mainly limited to the two-story section of the building. Severe corrosion was observed on the existing lintels above all the openings, leading to displacement of the brickwork and cracks caused by the expansion of rusting steelwork. Please refer to Appendix A for photographs documenting these issues. Additionally, localized roof spread resulting from creep in the existing roof timbers has further contributed to structural cracks. The corrosion has significantly progressed and is now beyond a point where easy treatment is feasible.

The structural movement is primarily caused by the corrosion of the existing steel lintels, which extend over all the windows along the entire elevation. These lintels need to be replaced. Sections of cracked brickwork will require removal and rebuilding.

Due to the extensive amount of brickwork that needs to be removed and rebuilt, coupled with concerns about the stability of the structure during these works, we suggest demolishing and rebuilding this section of the building using cavity wall construction. The project should include a new slate or tile roof, as well as new roof trusses. The new floors should be tied into the new wall to enhance stability. It is advisable to assess the suitability of the existing wall foundations; however, new foundations may be necessary.

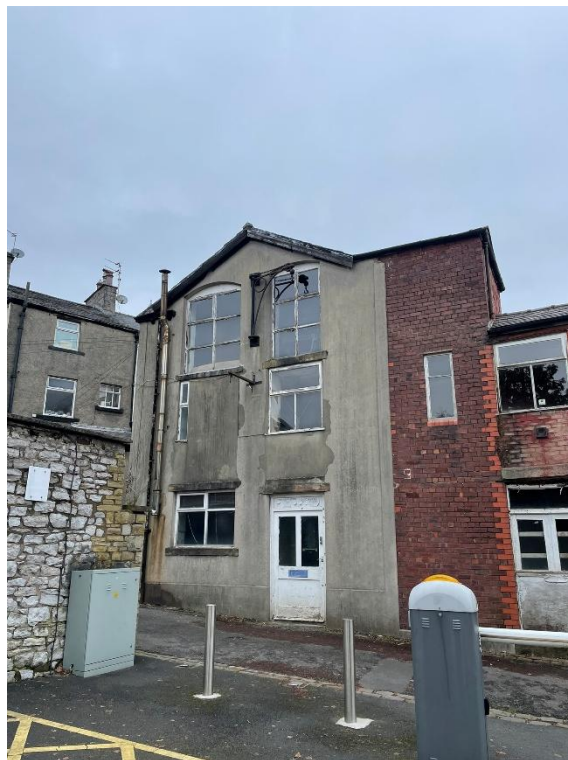
The building currently exhibits a mix of window types and proportions resulting from incremental alteration and infilling over time. Several openings on the principal south-west elevation have been reduced in size, with later insertions disrupting the original vertical rhythm of the facade.

E8 – Principal Elevation showing infilled openings, render, and jib crane.

The proposal seeks to rationalise and reinstate openings within the existing structural apertures. On the south-west elevation, vertically proportioned windows are reinstated within the visible stone heads to restore coherence to the facade. At first and second floor levels, the proportions reflect the existing structural openings. At ground floor level, a full-height opening is introduced within the existing stone head to align with the established vertical rhythm of the elevation.

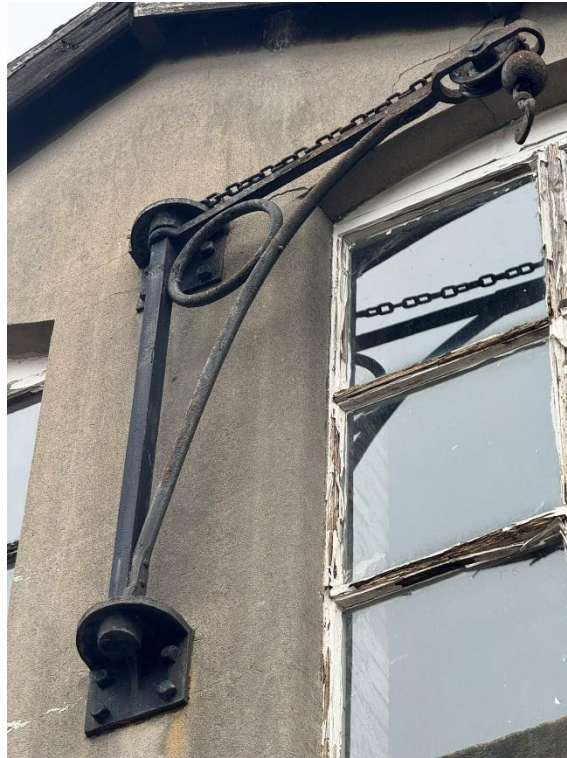
The retained limestone principal block makes a positive contribution to the character of the Conservation Area through its scale, materiality and industrial detailing. The vertically proportioned openings and surviving jib crane reflect the nineteenth-century industrial function of the site.

E9 – Jib crane to be restored/ retained.
