Catchment Sensitive Farming Assessment Form

Applicant name	Graham Robinson
Farm Business name	G & E Robinson
CPH number	
SBI Number	
Farm address and postcode	Lower Lees Farm, Cowark, Clitheroe, Lancashire, BB7 3DQ
WFD Water Management Catchment	The Ribble Catchment
River Basin District	North West
Form completed by: (CSFA or external supplier)	
Name	Stephen Watson
Company if applicable	RSK ADAS Ltd
E mail address	
Telephone number	
Any additional comments	Application to roof manure store is supported
Pollutant priorities and pressures:	
<p>Pollutant priorities in the catchment as targeted by CSF:</p> <ul style="list-style-type: none"> • The farm is located in a high priority area for water quality, the main issues are faecal indicator organisms (FIOs) and phosphate. • The farm is located within the Bowland Fringe and Pendle Hill NCA, where the priorities are hedgerows, hedgerow trees, stone walls, and permanent grassland. • The farm is not within an NVZ. • Lapwing and Curlew are priority species where some of the land qualifies for UP2. • The farm is within the Forest of Bowland Area of Outstanding Natural Beauty (AONB). • The farm is located 3,670 metres away from the Bowland Fel

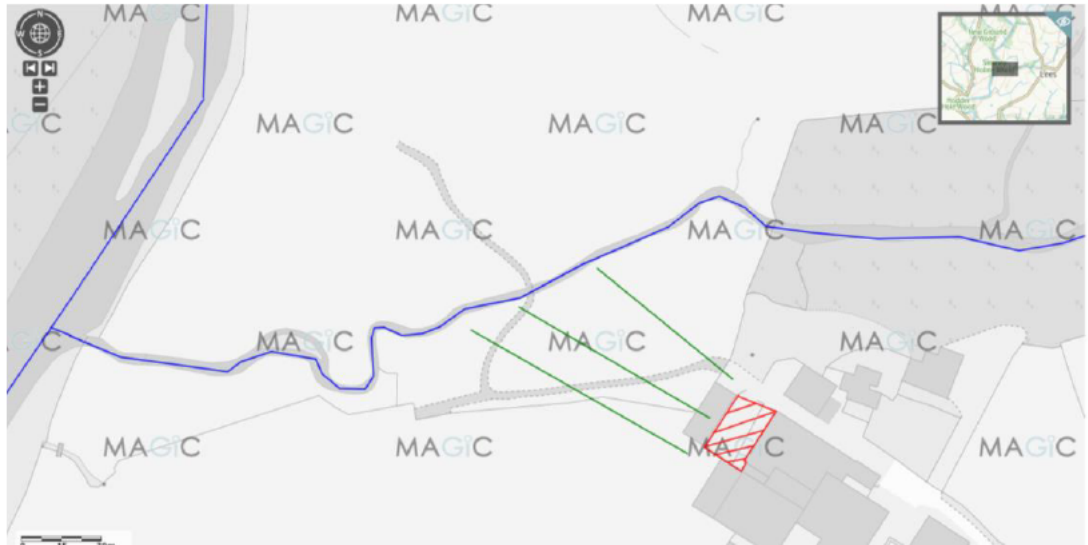
Map 1 shows the proposed roofing in red, the current drains in green and the watercourses in blue. The drains are discharged into Pale Wood Brook and eventually drain into the river Hodder.

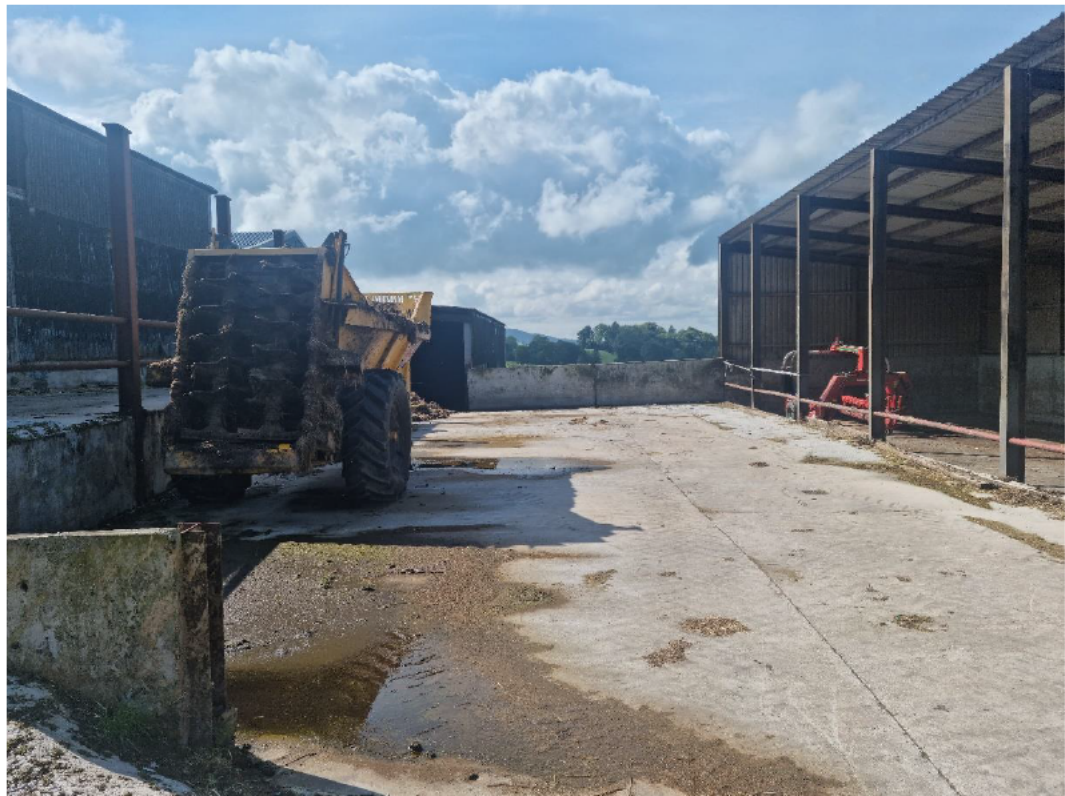
The farm is located within a high rainfall area at 1,460mm, this is a large volume of water that must be kept separate from cattle and sheep FYM that is on farm, especially as the area priorities are FIOs and phosphates. Due to the manure store not being roofed, this is causing a slurry issue, if the area was roofed no rainwater would be falling on the FYM, thus reducing the likelihood of FIOs entering Pale Wood Brook, which is located around 80m away from the manure store.

Currently, the slurry is caught in an effluent tank, during excessive rainfall events this is harder to manage which causes some slurry to be lost in the direction of the brook which flows into the river Hodder, which is located 250m away from the manure store. Without this area being roofed, it has the potential to contribute to the high levels of FIOs already within the river Hodder and the local watercourses. If the roof is erected, it will dramatically reduce the amount of dirty water generated thus decreasing the likelihood of this farm contributing to FIOs within the watercourse. Clean water from the site is drained as per map 1 below.

Photo 1: shows the proposed area that is to be roofed

Ensure that the manure store when roofed has the end wall across the rear in photo one filled in with Yorkshire boarding to reduce the level of rainfall potentially being blown into the store.

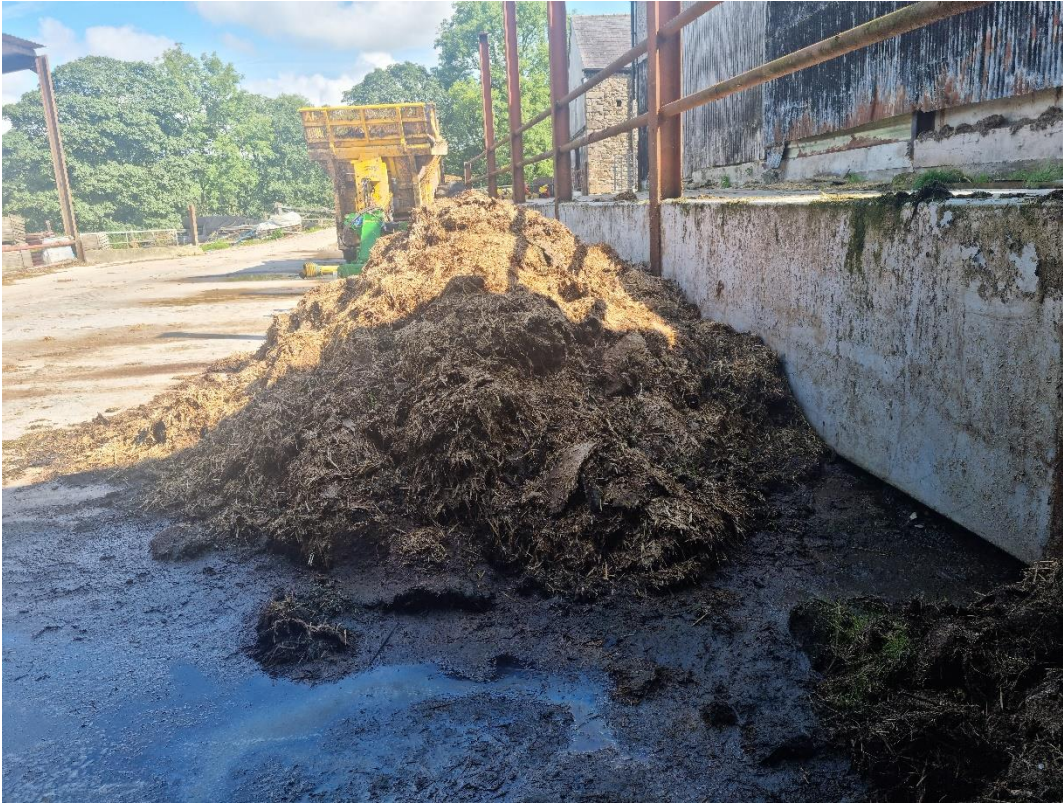
Photo 2: shows the FYM there already, this will increase over the winter months.

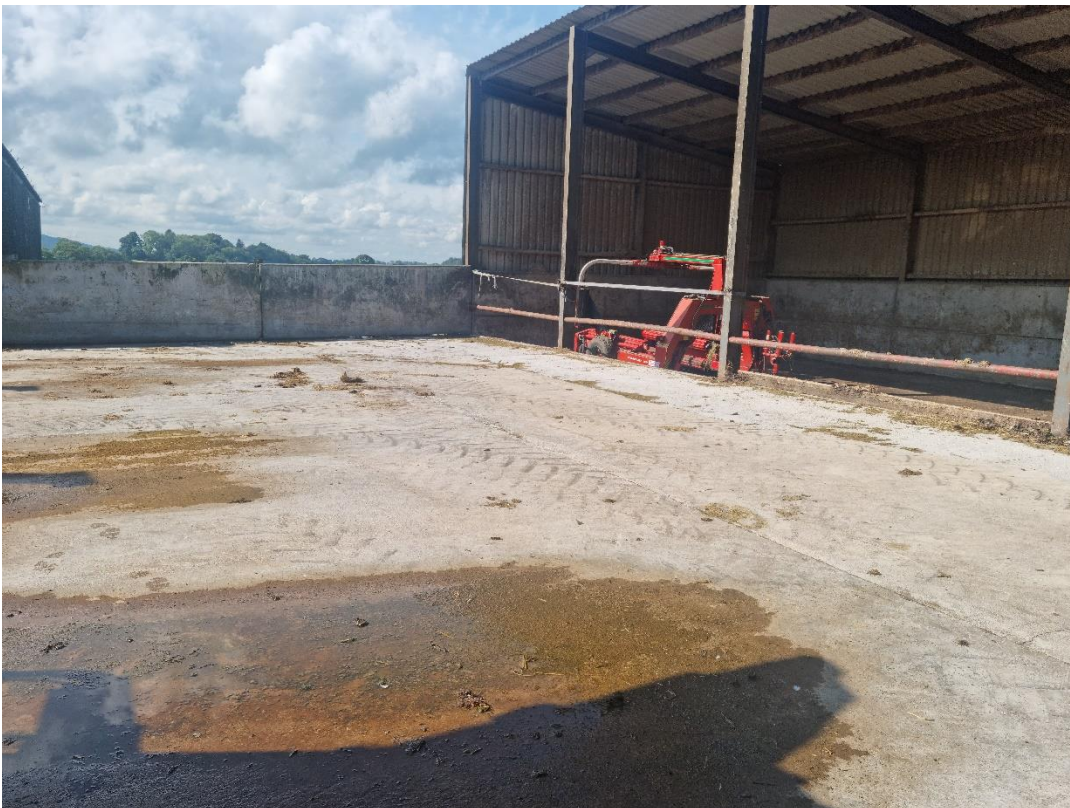
Photo 3: another image of the proposed area for roofing
