| revision | date | note |
|---|---|---|
| A | Sept 2026 | Submitted for demolition consent |

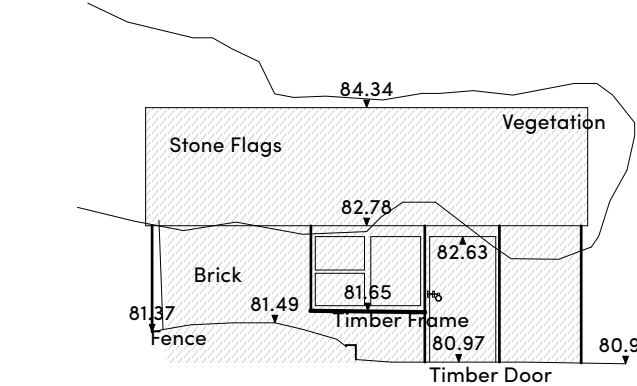
**A Outbuilding - North West Elevation**  
Scale: 1:100

Hatched area extent to be demolished, salvage masonry to be used to infill garage doors

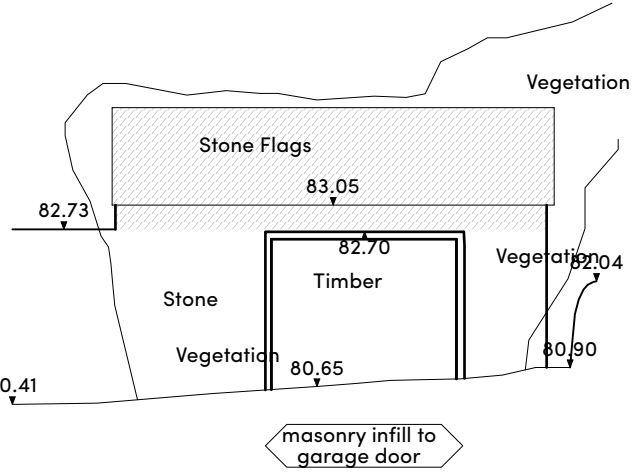
**B Outbuilding - South East Elevation**  
Scale: 1:100

Hatched area extent to be demolished, salvage masonry to be used to infill garage doors
