# **GROUNDS OF APPEAL**

## The Stables rear of King Street, Whalley, BB7 9SP

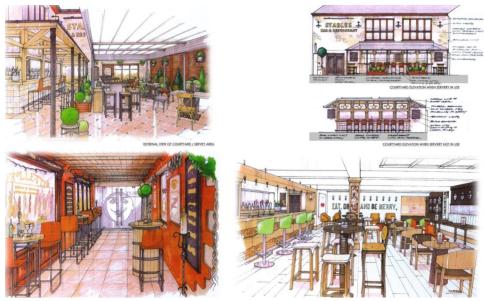
Image 2 – an artists impression of the interior/exterior of the restaurant

4.1 - Many of the local historic buildings are now public houses, namely the three former coaching houses, which are now The Whalley Arms, The Swan Hotel and The Dog Inn. The development wants to add to the significant views and appearance of Whalley, the applicant wants a visually appealing restaurant that will be in keeping with the locality. This will also take the current disused building and create an ambient and welcoming restaurant, offering more amenities for lunch and dinner to the local residents. See image 2.

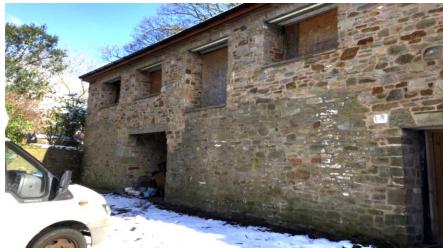
Image 3 – the rear of the site, showing the lack of windows on the first floor and anomalies with the brickwork

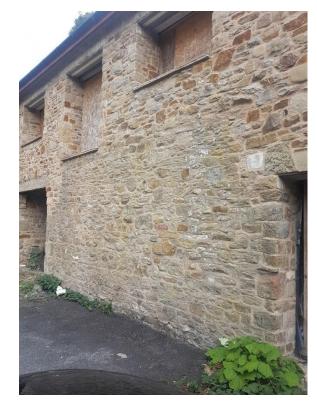
Image 4 – the rear of the site, showing irregularities in the stone and mortar

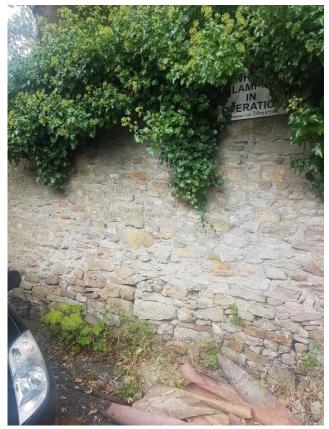
6.1 - Referring to the first point of refusal regarding the harmful effect on the Whalley Conservation Area, the current structure is in a state of disrepair. There are areas which are dangerous as they are unfinished from the previous refurbishment (see image 5 & 6), which was never completed and has therefore been left in an unhabitable state for a long period. Most of the first floor has not had windows installed (see image 3, 4 & 6), so it is open to the elements. This has resulted in alleged reports of squatters residing in the property and there has also been evidence of drug use on site, due to paraphernalia being found on site visits. The proposed use of the building would eradicate the potential for this to continue, as the building would be refurbished to a high standard and continually maintained, allowing it to be closed to the elements. This would eradicate the potential for squatters and drug users to utilise the property. In short, the development would have a positive impact on the locality and potentially reduce crime.

Image 5 – showing debris on site and the rear of the courtyard wall

- 6.3 -In relation to the courtyard boundary wall, it is surprising that this is an issue with regards to the design and materials. On further inspection, it is evident the wall has had major remodelling, making it dubious as to whether much or any of it is original (see images 5, 8, 9 & 10). Large areas of the building appears to have been re-skinned (see image 3, 4, 11 & 12) and had new foundations and stonework from the previous unfinished works done. The mortar that has been used also doesn't seem in keeping with the previous appearance of the stonework. Originally it appears to have had a lime mix mortar, however the new mortar appears to be gypsum based, and has no relationship to the original lime mix mortar. The wall to the front has been designed to sensitively combine the new and old elements in a sympathetic way. We have ensured the two elements are separated by a steel channel, so the 'old' brickwork and the timber framework have a distinct boundary and do not encounter each other, allowing the existing wall to remain in place and untouched by all new material elements.

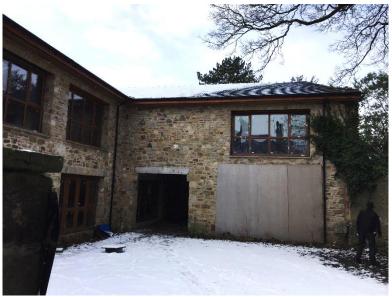
Image 6 – courtyard area, showing raised manhole left from previous works, along with boarded up area on the ground floor

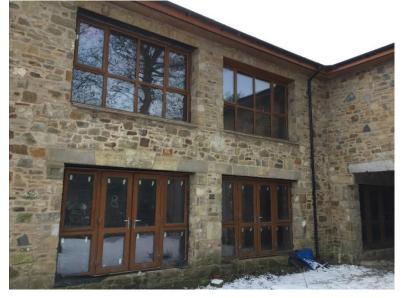
Image 7 – current UPVC windows and doors, approved on previous application

6.2 - The fenestration concerns have been addressed in the pre-application meeting with Adrian Dowd. The application was initially done to be inkeeping with what was existing on the property (UPVC oak finished windows, image 6 & 7), which was allegedly approved on the previous application. However, due to the current concerns with what was proposed, it has been agreed that the applicant will remove the current windows and re-fit the windows and doors with glazed aluminium units in a more heritage style, at a further cost to himself.

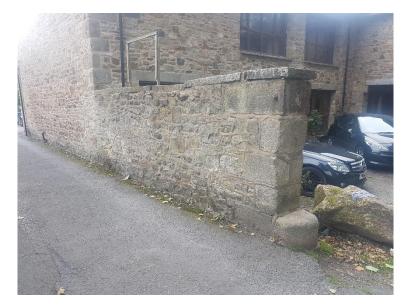
Currently, the car park and courtyard are being utilised without permission due to the building being empty (see image 8), allowing public access to an unfinished and dangerous construction site. This is therefore losing potential revenue for the local pay and display car park.

Image 8 – the courtyard wall, also showing car parked without authorisation

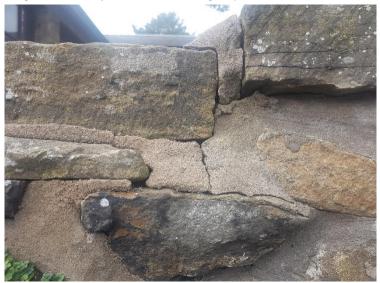
Image 9 – further evidence of the courtyard walls alterations

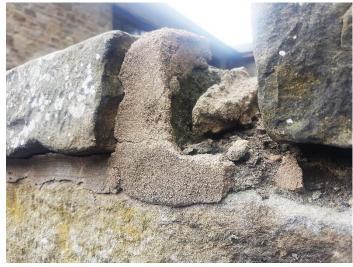
Image 10 – close inspection of courtyard wall showed new mortar applied on top of old and much of it had evidently been re-built

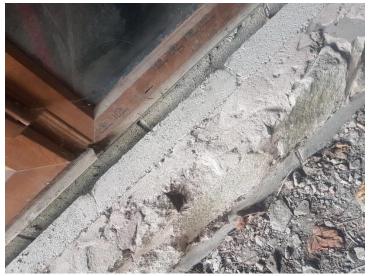
Image 12 – As image 11

Image 11 – Evidence of the building being reskinned, as there is a new layer of concrete blocks behind the existing stone. The bottom layer of stone has new mortar, which is differing in colour to the old.
