TIMBER FENCE DETAIL

KNEE RAIL FENCE DETAIL

ESTATE RAILING DETAIL

METAL RAILING DETAIL

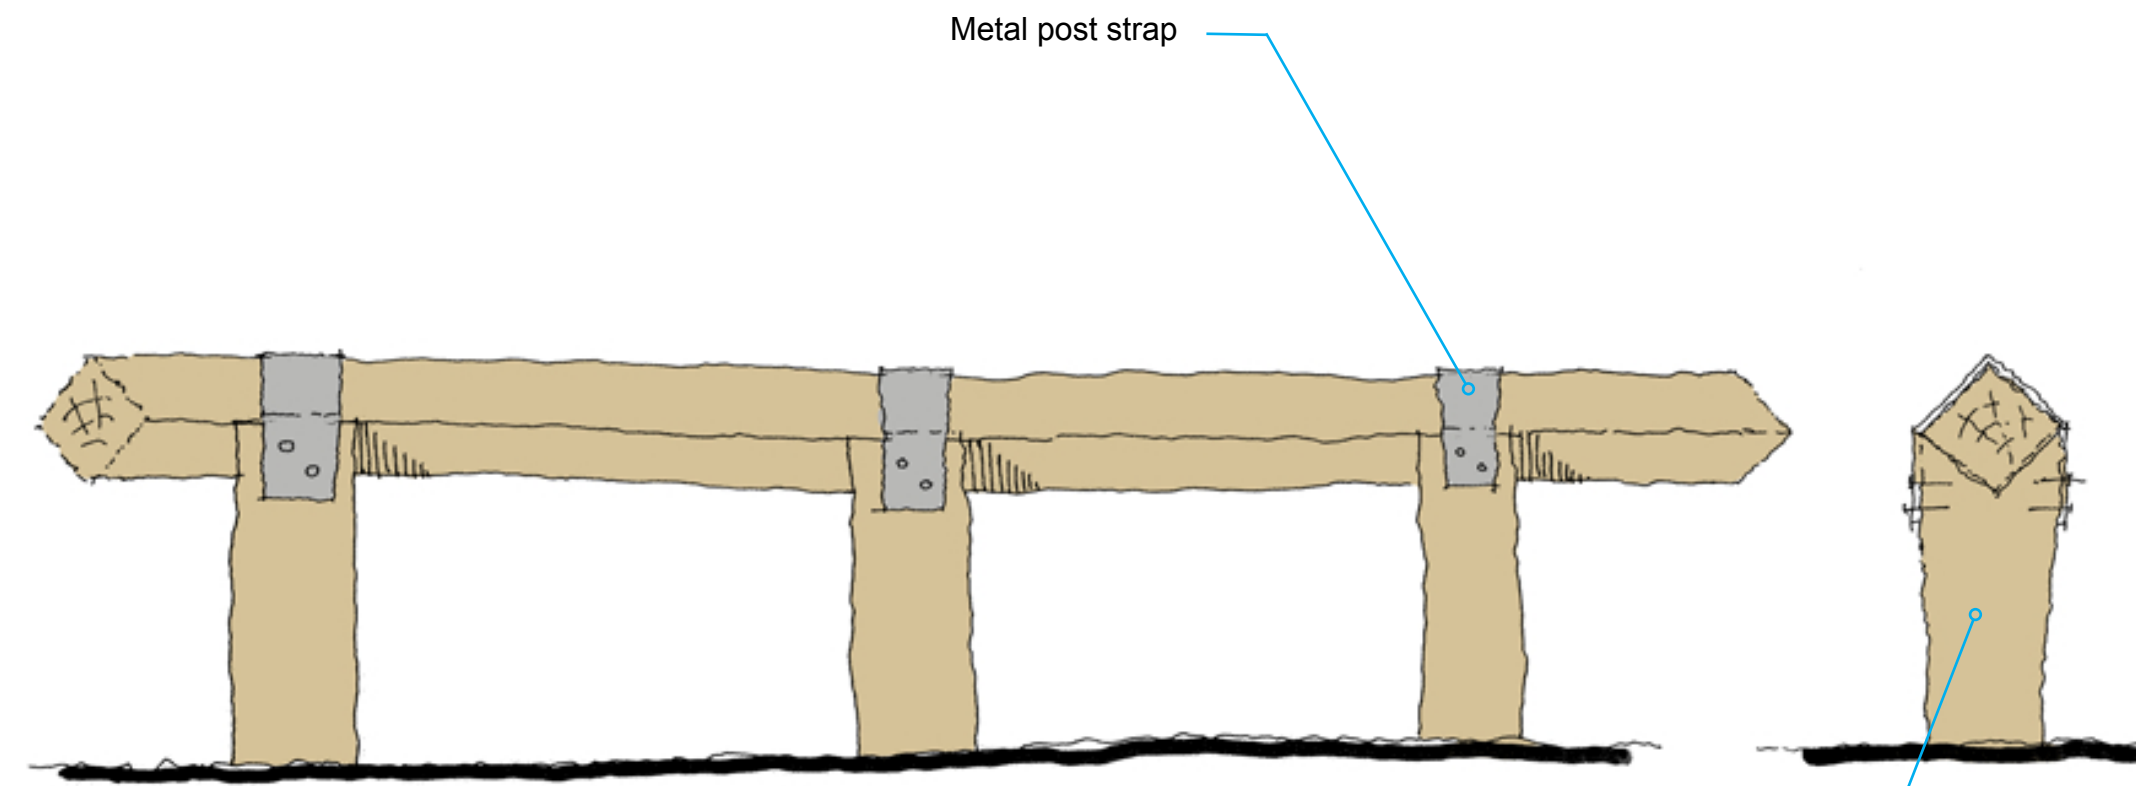
Stained knee rail fence

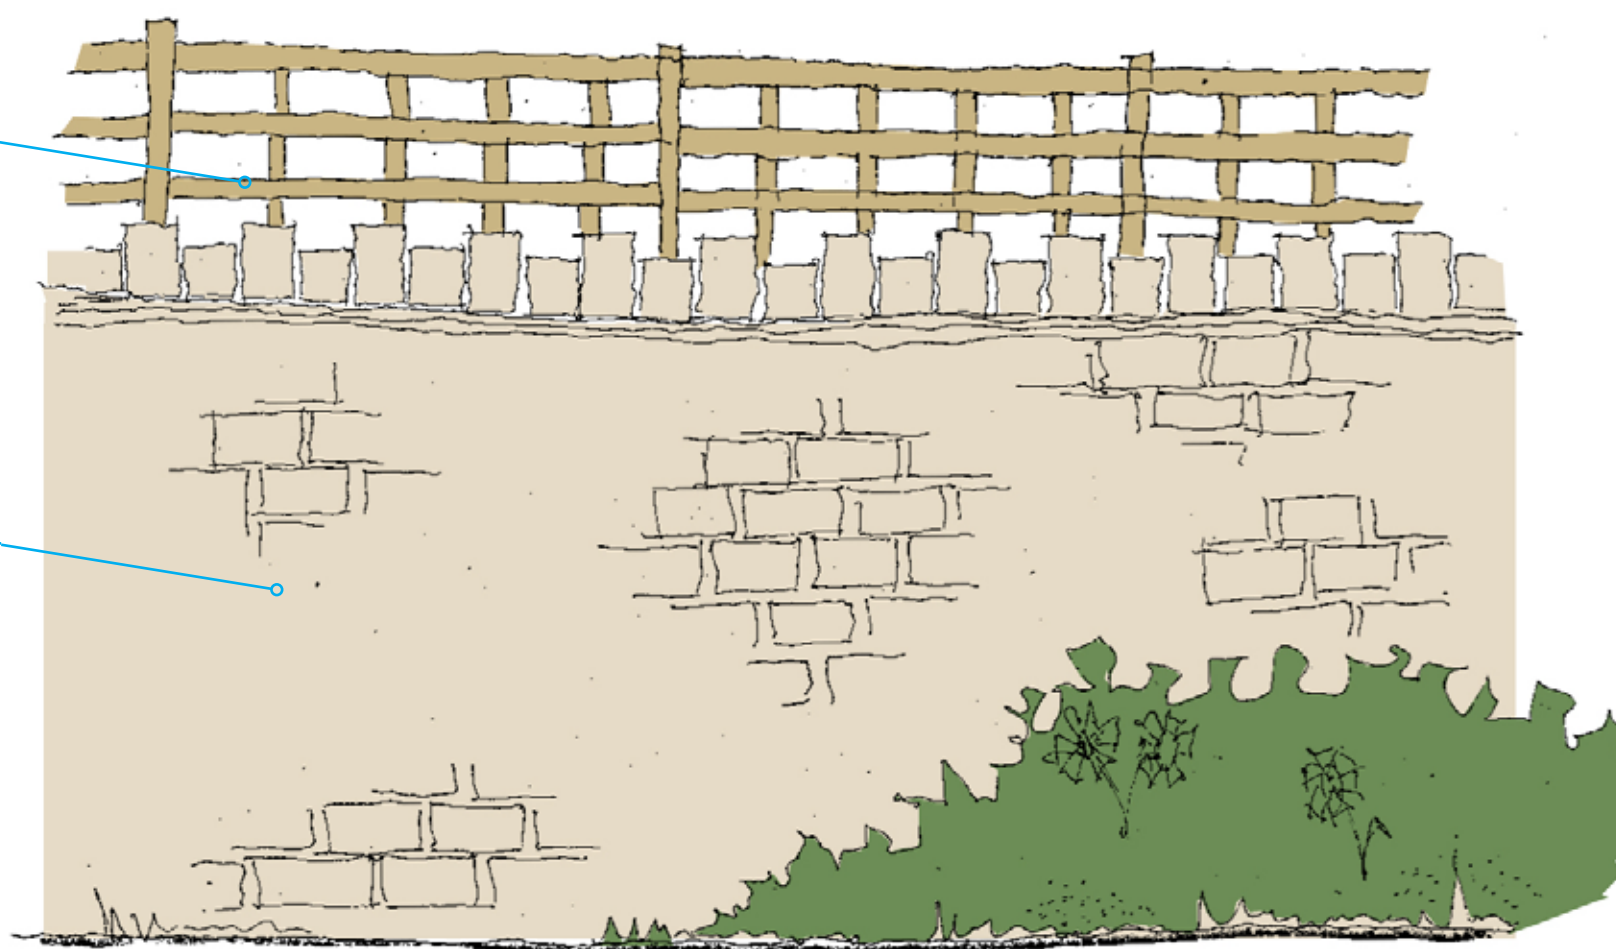
1100mm high reconstituted stone wall
