**Heritage Asset Statement**  
**Higher Flass Barn, Settle Road,**  
**Bolton by Bowland**

1. Introduction

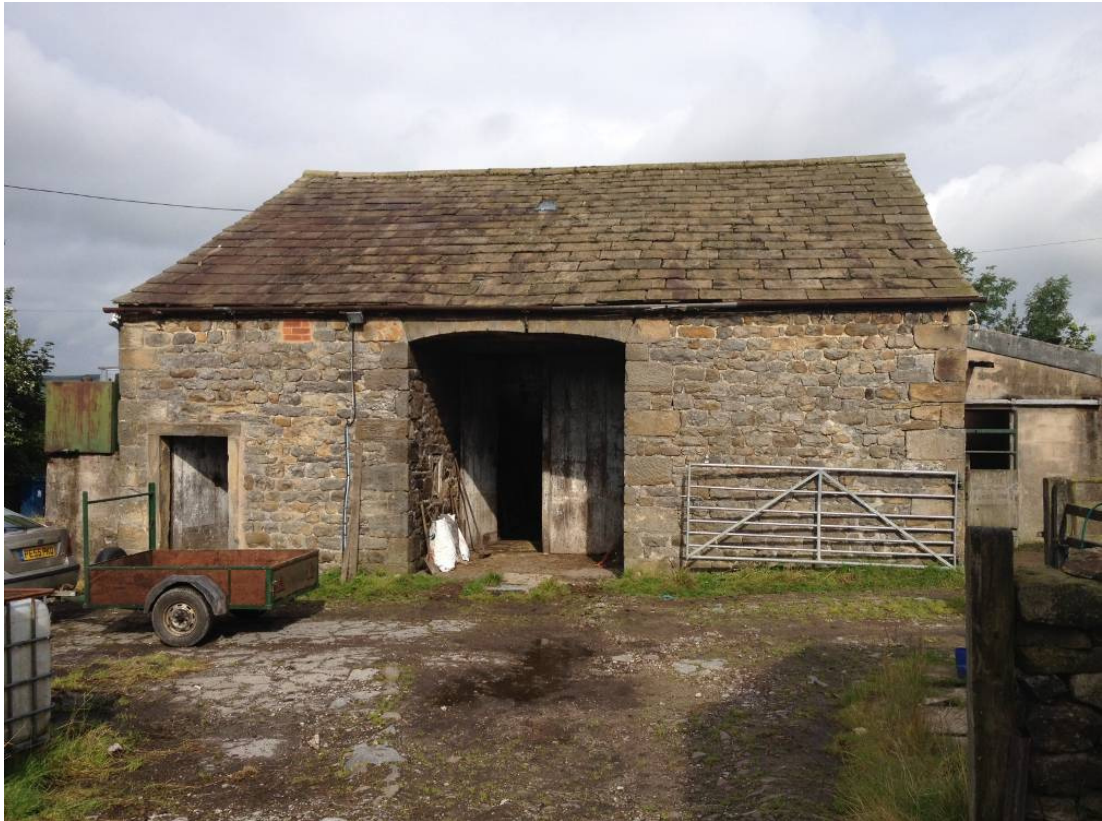
Figure 1: Eastern Elevation

- 2.5 The principle structure is 7m to ridge height and features an unbroken slate roof at 3.3m to eaves on the eastern elevation and 4.5m on the western elevation. The service yard of the farm is located to the east of the site and therefore the main features of the barn are located to the eastern elevation. This includes the large barn doors which are inset, providing an external porch. The porch also provides access to a small, storeroom which is separate to the main internal area. A further doorway is present to the southern part of this elevation which appears to have been created at a later date. The roof of the eastern elevation features only one small opening.

- 4.6 To the principle eastern elevation, the wagon entrance will be glazed to allow light into the property. A door has been required here to meet Building Regulations standards, although given the nature of the business, it is anticipated the most commonly used access will be to the north (leading into the utility rooms). The wagon entrance glazing has been inset very slightly, however the extent of this has been limited by the need for internal space to allow for a hall and stairwell. Two new rooflight openings will be created (also retaining the existing opening). The rooflight serving the bedroom has again been required to meet 'escape requirements' under Building Regulations. It is perceived that these are still minimal enough in size and number to respect views of the barn from the public footpath to the north-east.

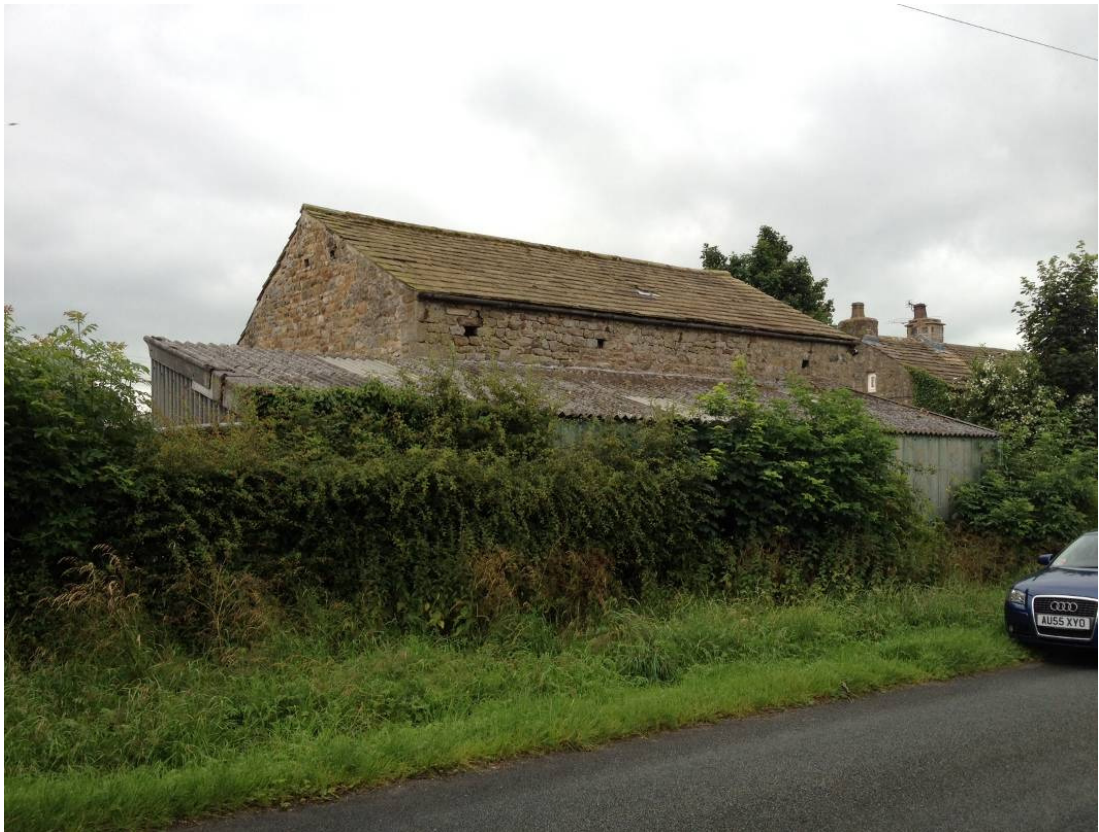
Figure 2: Western Elevation

- 2.6 The western elevation is less exposed due to the presence of a tall hedge along the boundary of the highway and the modern extension. The roof again features only one glazed opening but to the elevation, four air vents historically existed at a height of 4 metres from the ground. Whilst three of these vents are visible, it is apparent that one has been covered. At ground level, this elevation features a single doorway (not externally visible) which currently leads into the extended part of the barn.
- 2.7 The north gable elevation features only two small high level vents. These are also present on the south gable, along with three ground level windows. Due to the presence of the modern side addition, only one of these windows is currently exposed.

- 4.5 Pre-application discussions concluded that the LPA would prefer for the first floor windows to the western elevation to be of an 'arrow slit' style. It was brought to the Applicant's attention however that these openings would not satisfy Building Regulations and openings to these bedrooms have been redesigned to comply with these requirements. Despite these alterations, the openings have been kept to a minimum in order to preserve the buildings historic agricultural appearance. A

window will also be created to the ground floor kitchen at the western elevation to ensure a satisfactory level of daylight for occupants.

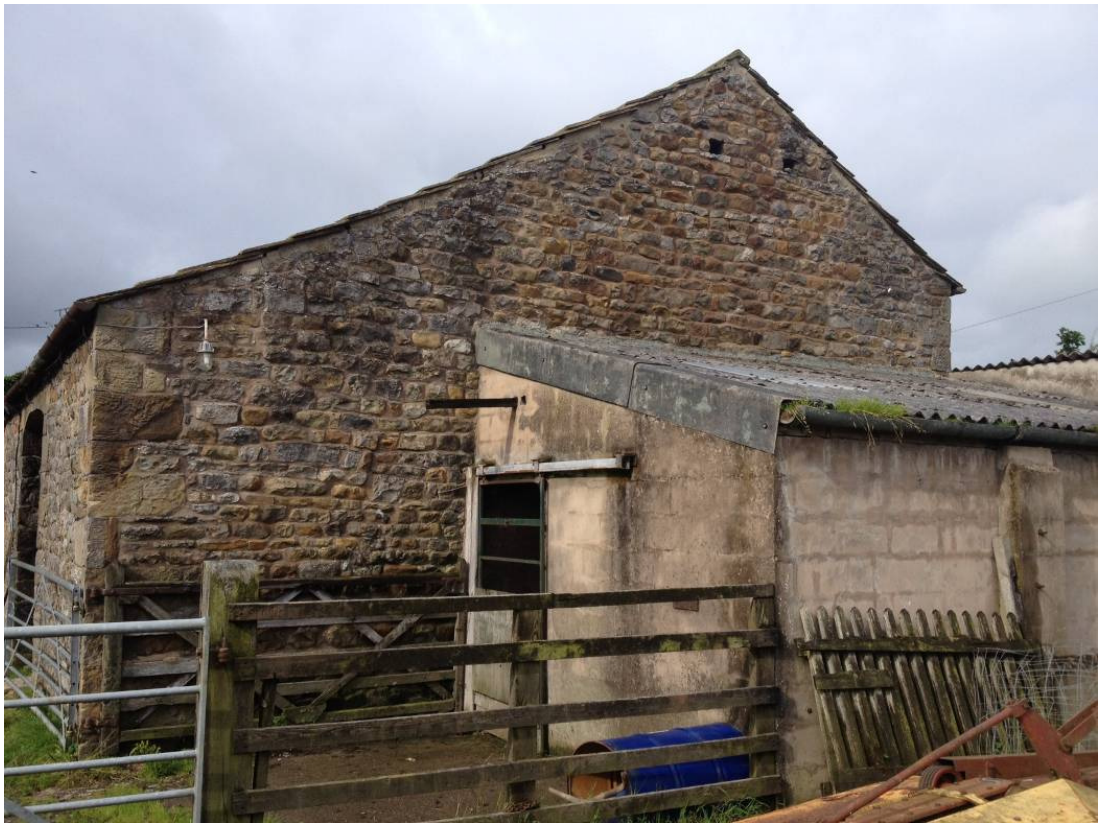
Figure 3: North Elevation

- 2.9 Looking at the recent extensions, the addition to the northern elevation is accessed externally and is only 6 metres in depth and 3.5m in height with a shed roof. Materials consist of breeze block walling coated in external render and the roof is corrugated asbestos. Asbestos sheet roofing is also a feature of the western extension which is slightly taller at 3.5 metres and stretches the length of the elevation.

- 4.4 The extension to the north will be re-built to form a garage using stone and slate roofing to match the materials and character of the main building. This addition will be inset from the rear elevation to ensure that it does not appear as an original feature.

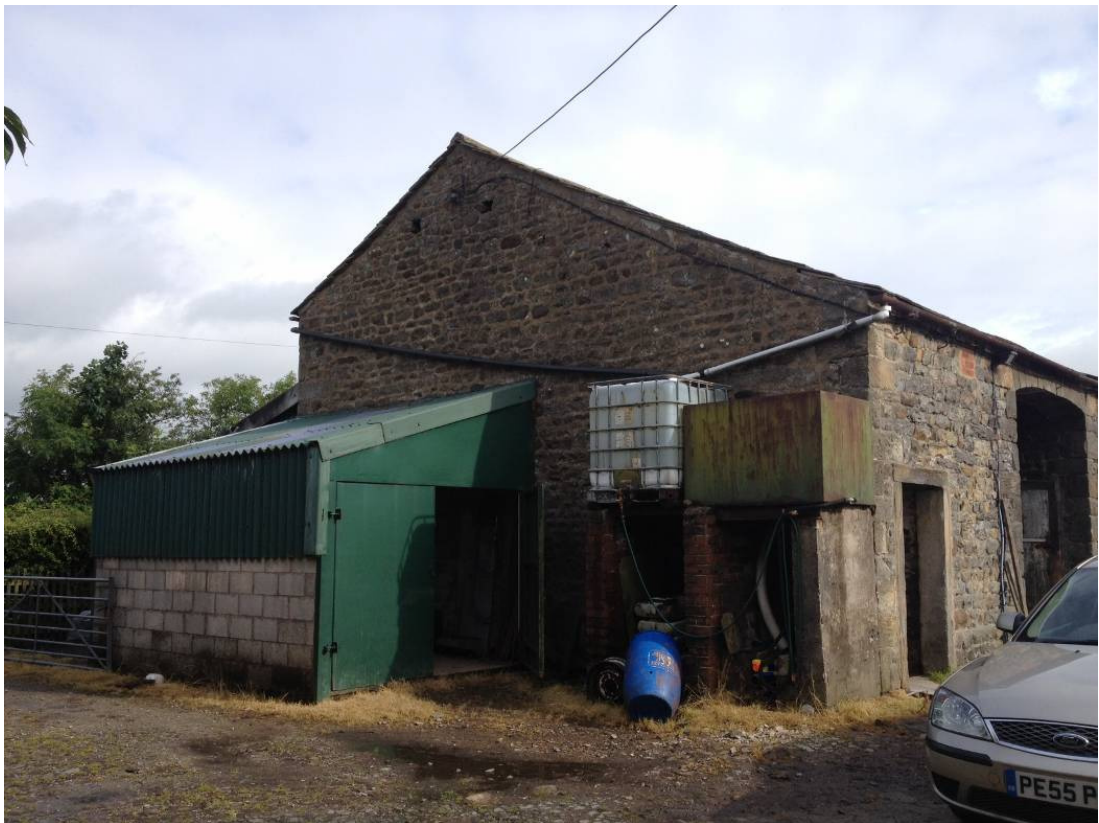
Figure 4: South Elevation

- 2.10 The rear extension (to the west of the barn) is accessed by two large gates to the north and south and is principally constructed of corrugated iron. The third and most recent addition is to the south of the barn is at 5m in depth and 3.5m in height. The structure is constructed of breeze blocks with corrugated iron roofing which also covers the upper half of the elevation. Access is made externally.

- 4.3 The various extensions that have been added throughout the barn's history are seen to detract from the traditional rural characteristics of the principle structure. The submitted application drawings intend to remove these elements to the south and west in order to restore the barn and increase its prominence as a Heritage Asset. This will be of substantial benefit to the wider AONB setting which is promoted through Local Plan Policy ENV1. To the south, this will expose existing ground floor windows.

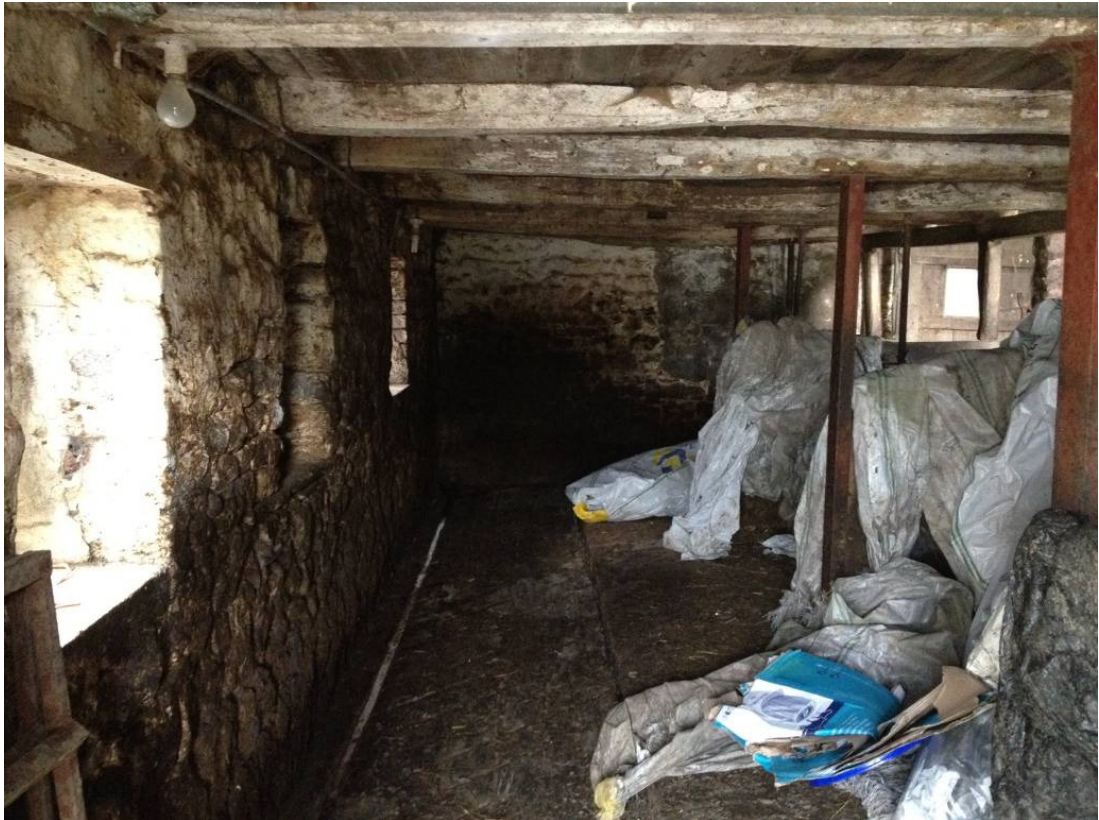
Figure 5: Internal View

- 2.8 It is apparent from internal inspection that the agricultural use of the barn has evolved over time. The use for hand threshing eventually ceased and the layout was divided for handling of livestock. Due to its age and condition the barn now serves a very limited purpose, being utilised for the storage of hay and some farm equipment.
