BARN · 1 ·

mck associates limited
 architecture • building surveying • project management

Project: proposed development
 ELMRIDGE FARM ELMRIDGE LANE
 CHIPPING PR3 2NX

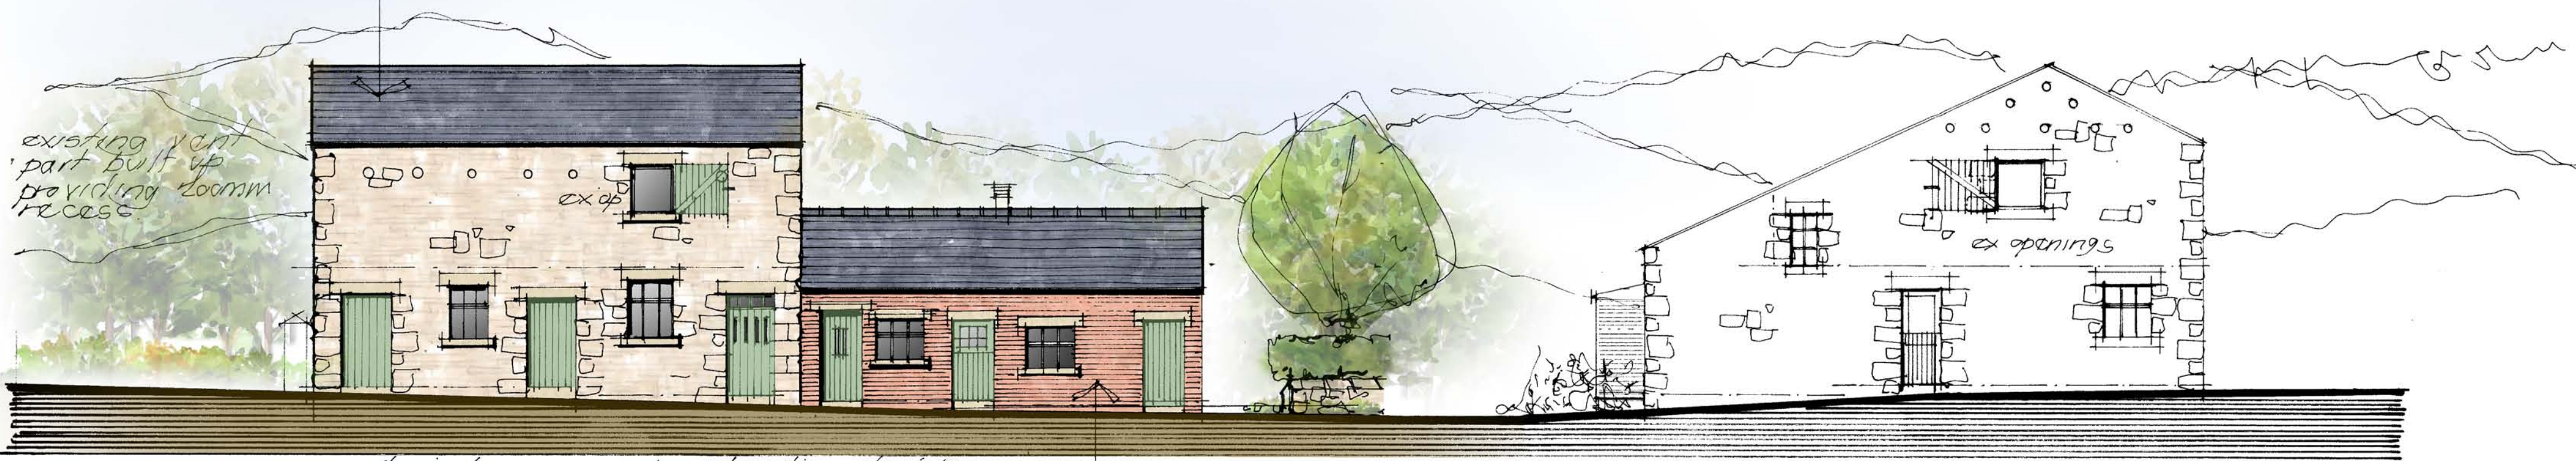
existing natural slate roof. strip & reslate using existing slate make up number as necessary in matching slate. reuse existing ridge tiles

- new windows painted sash (timber) set in reveals as existing style generally as existing
- new doors vertical timber boarded with paint finish all set back in reveals

all existing openings to this elevation
 NORTH EAST

existing stone & brick walls to be repaired using sand/lime mortar flush & bagged with sample panel/area to be prepared by contractor & approved by planners before proceeding

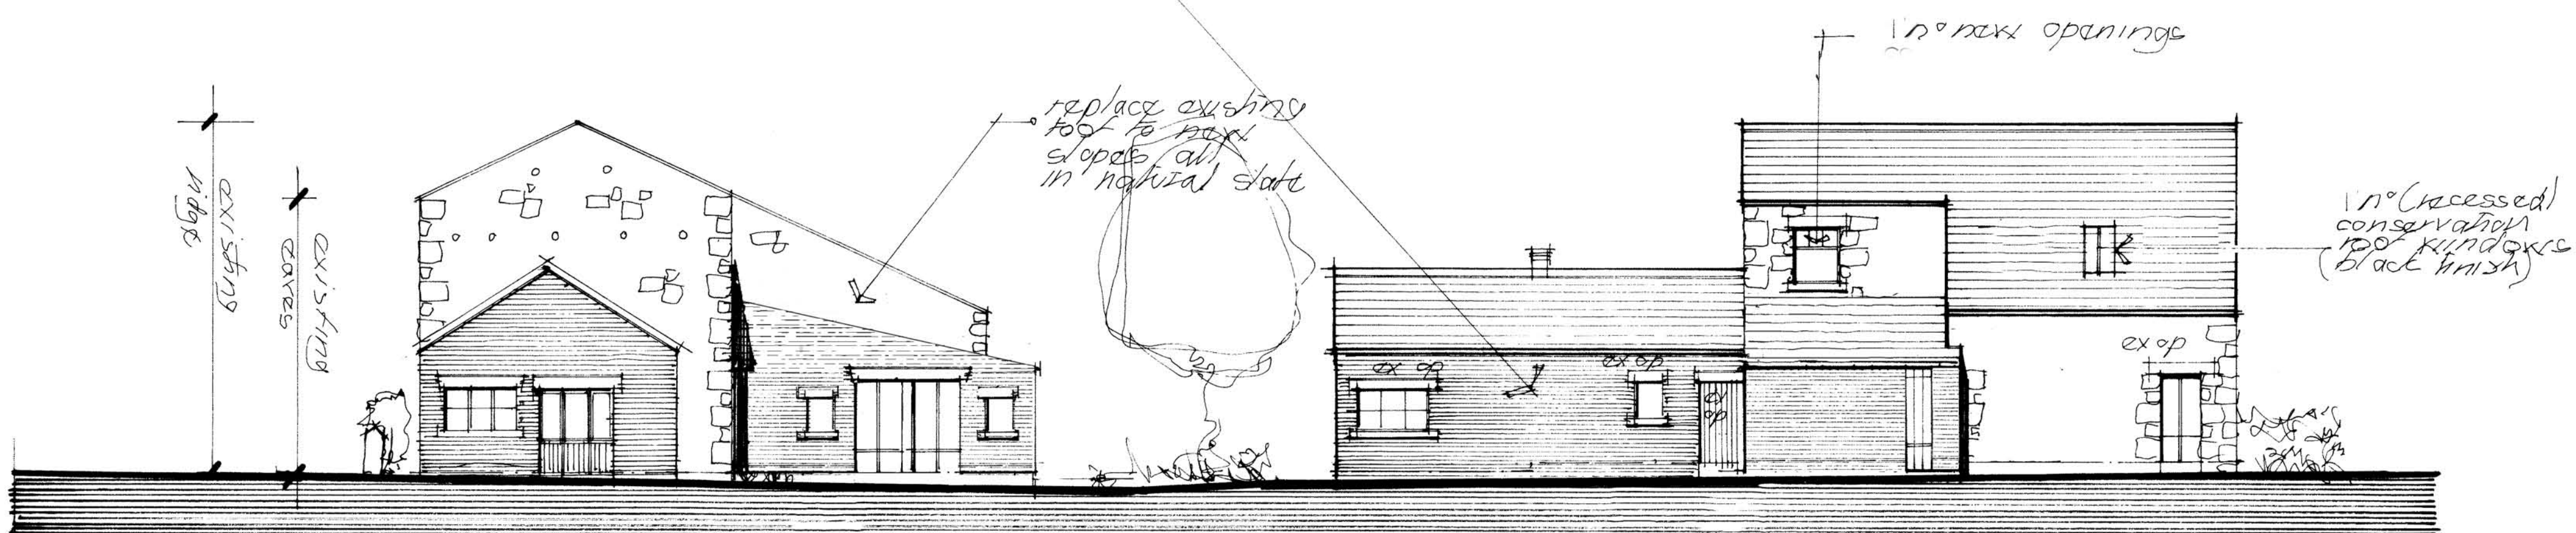
existing windows to this elevation
 WEST SOUTH
