# Design and Access Statement

Reinstatement of Existing Travel Agency  
Shop, Repair of Shop Front and Internal and  
External Repairs.

6 Castle Street  
Clitheroe  
Lancashire  
BB7 2BX  
United Kingdom

# **Design and Access Statement for Internal and External Repairs.**

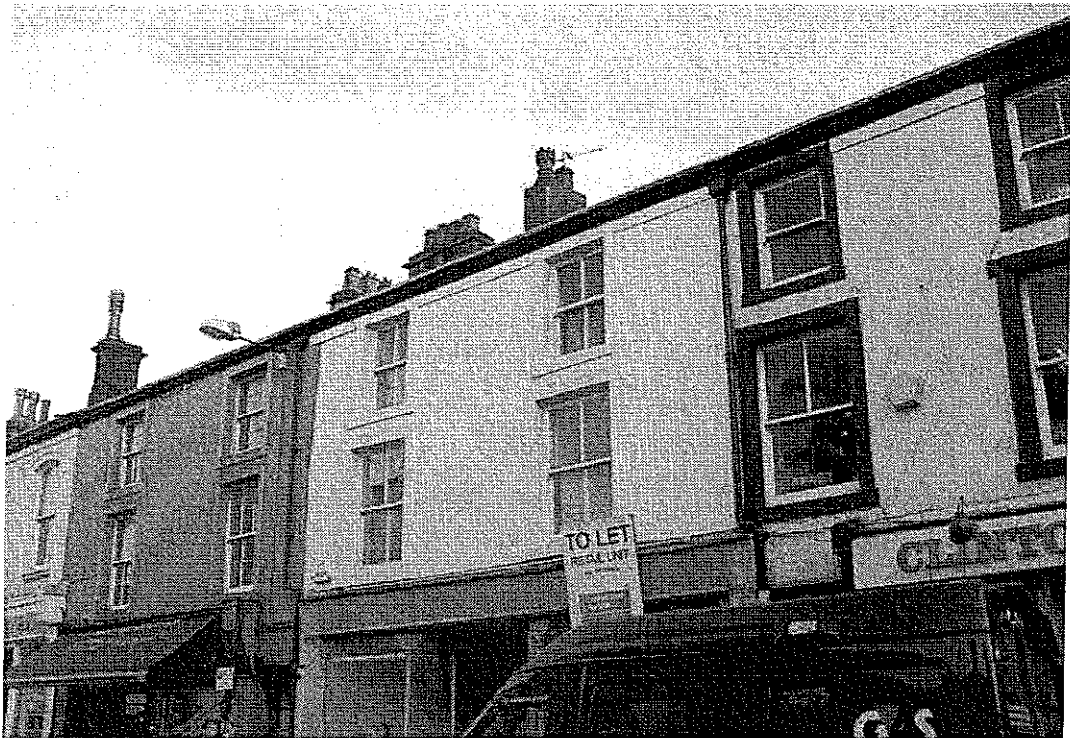
1. Front elevation showing 1<sup>st</sup> and 2<sup>nd</sup> floor windows

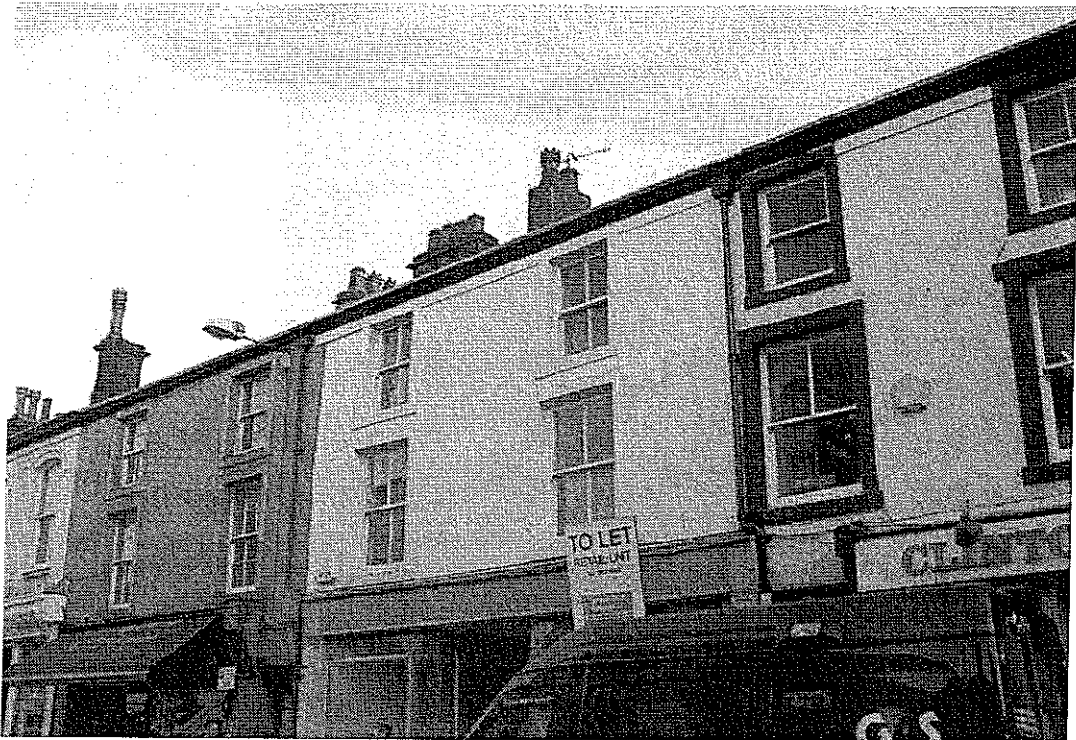
1. Front elevation showing 1<sup>st</sup> and 2<sup>nd</sup> floor windows
