**ANDERTON GABLES**

Main Barn/Outbuildings -  
Dwelling 2 and Garage  
Greengore Farm  
Hurst Green  
Cliteroe  
BB7 9QT

PREPARED FOR: Mr and Mrs Kay  
PREPARED BY: Daniel March  
DATE: 11<sup>th</sup> May 2012  
REFERENCE: AG637 Rev A

Barn 1, 2 and Outbuilding  
Greengore Farm  
Hurst Green  
Cliteroe  
BB7 9QT

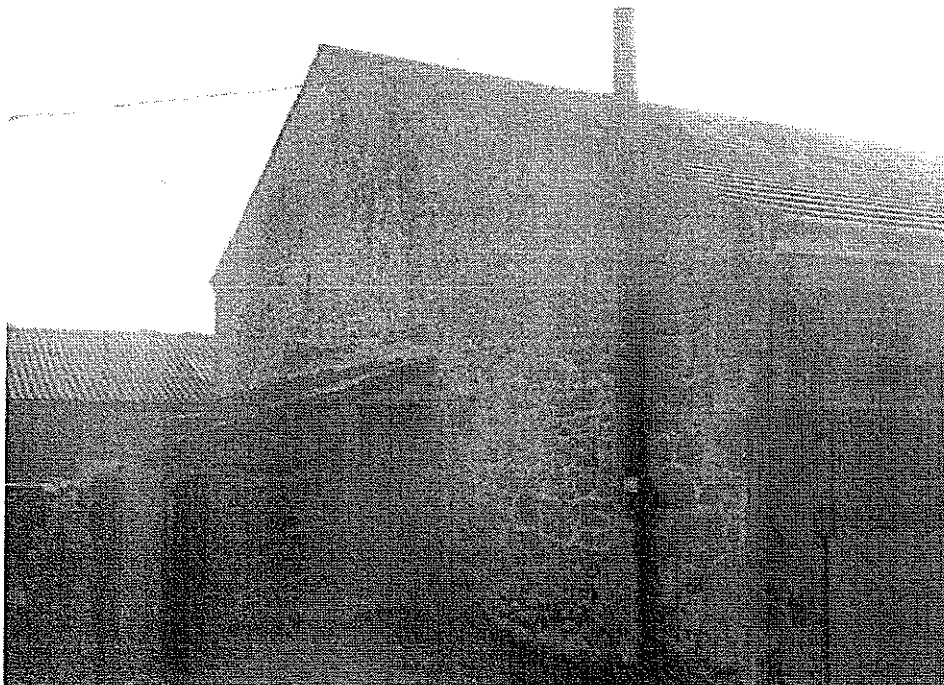
Extension with lean to corrugated tin roof to be removed
