**BARN ONE, ELMRIDGE FARM, ELMRIDGE LANE, NR.  
CHIPPING, LANCASHIRE, PR3 2NY**

**Building Record of Barn One**

**Job No: 16/197**

January 2017

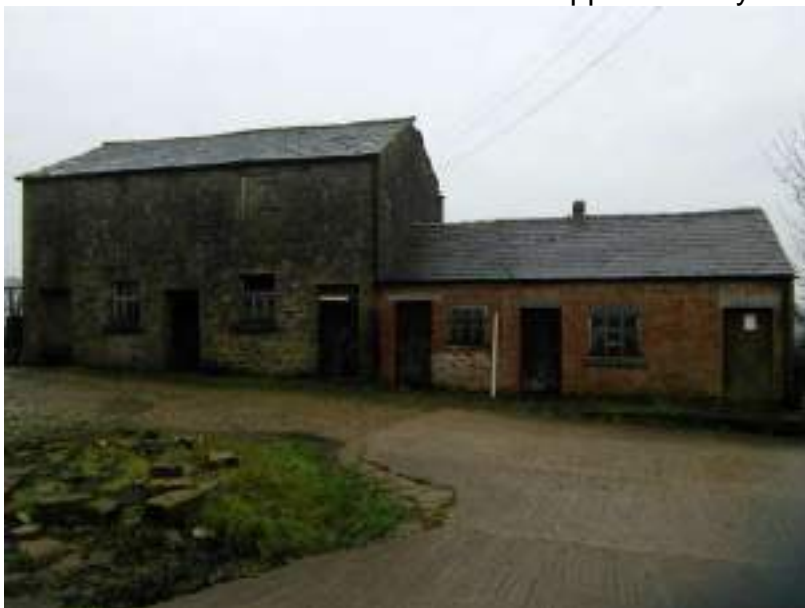
Figure 8 The north-west elevation of Barn One showing the two distinct structures.

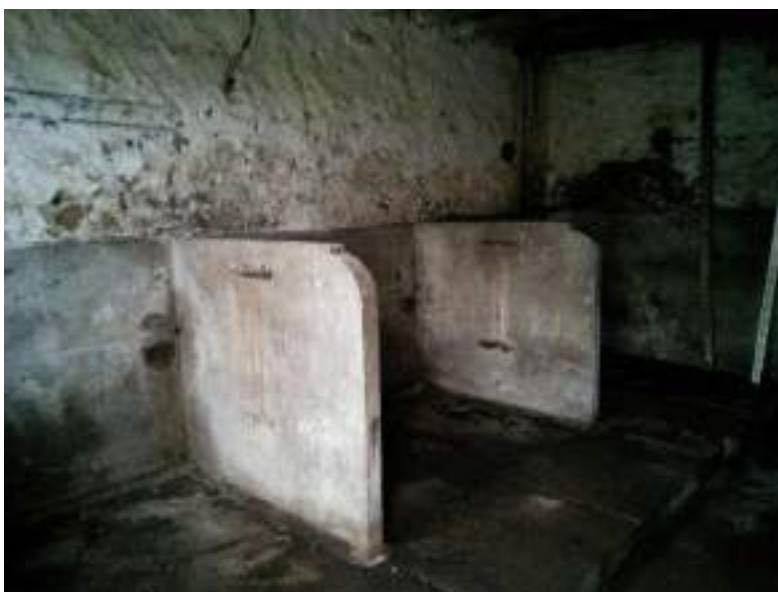
Figure 15 Internal view of the small shippon

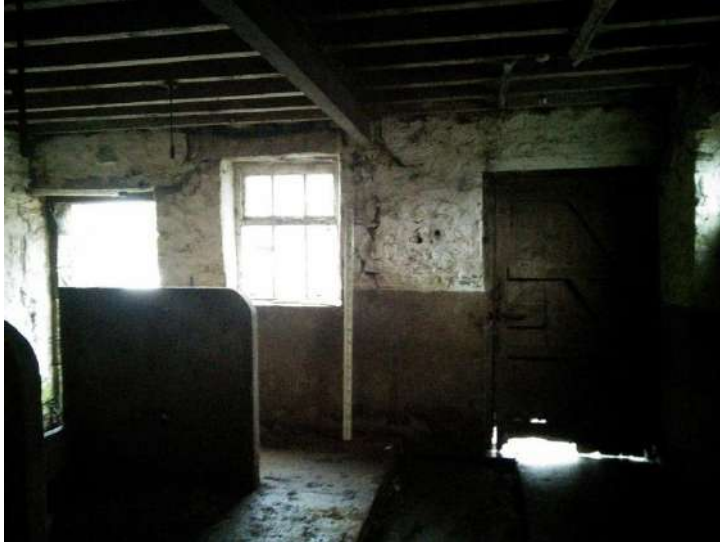
Figure 16 Internal view of the large shippon

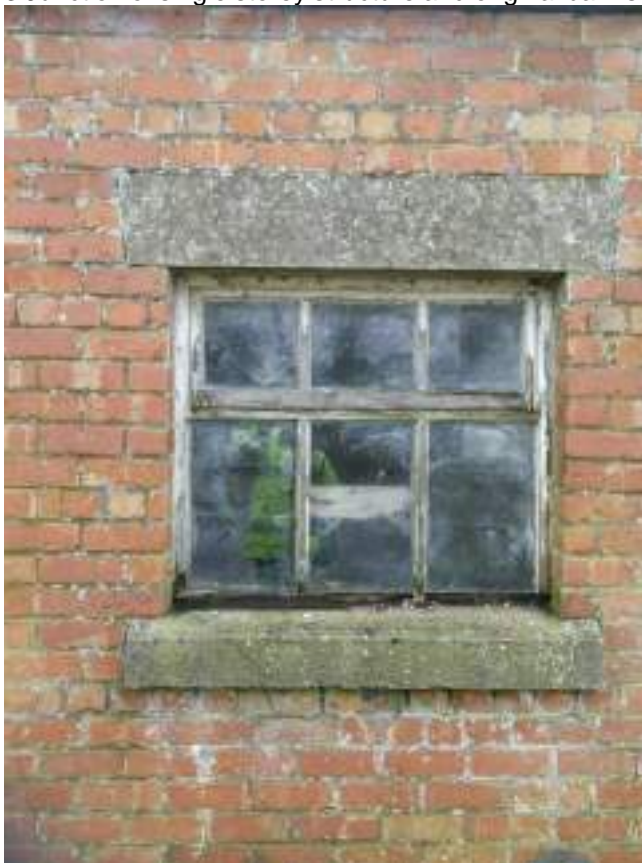
4 Detail of timber window to dairy with precast head and cill

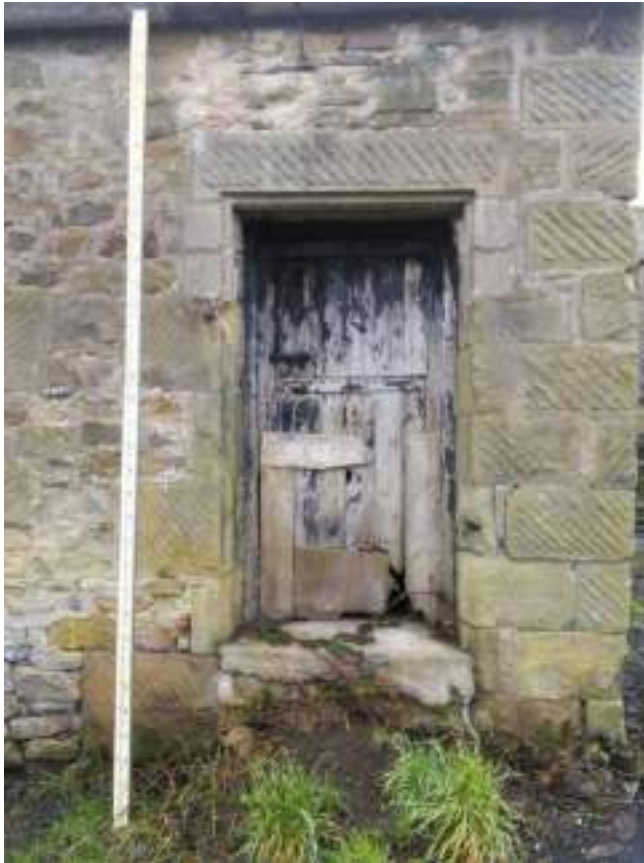
21 Rear door to outshut, note level difference.
