Structural Assessment for Planning

Property Address:	Brockhall Farm Brockhall Village Old Langho BB6 8BB
Report for:	Mr and Mrs Willan
Inspection Date:	18 th December 2019
The Surveyors:	Michael Holden FRICS FCABE RICS Number 0084831 Joe Holden AssocRICS RICS Number 6792345 William Holden MSc John Blackmore MSc
Report Reference	190-535.1*

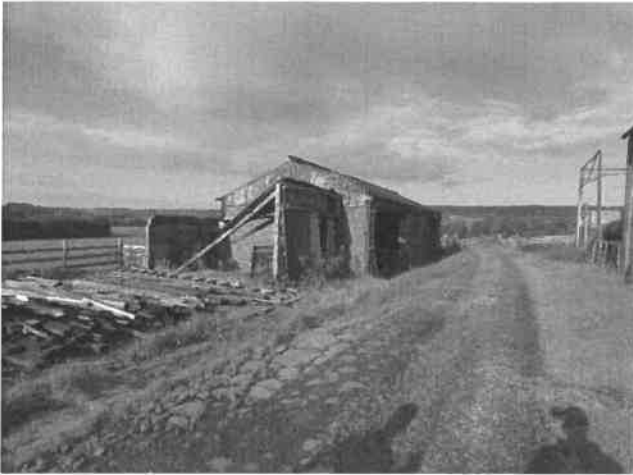
Image 1 – Building 1 Overview

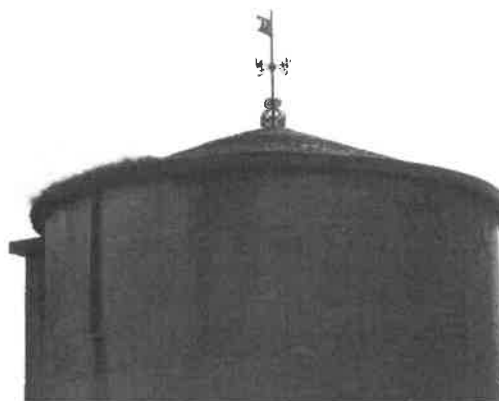
Image 8 – Roof covering

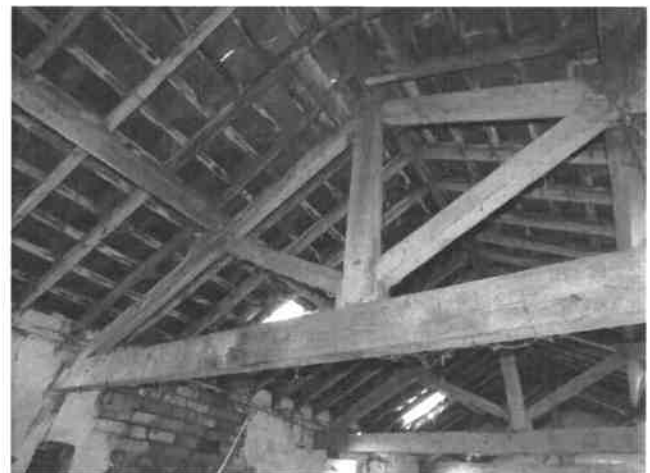
Image 18 – King post truss

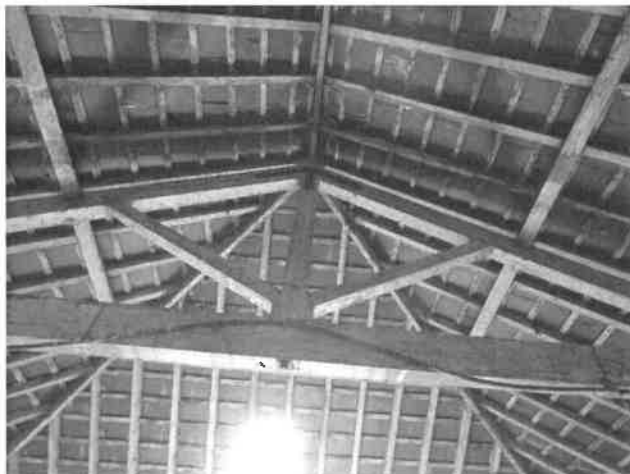
Image 23 – King Post Truss Roof Structure

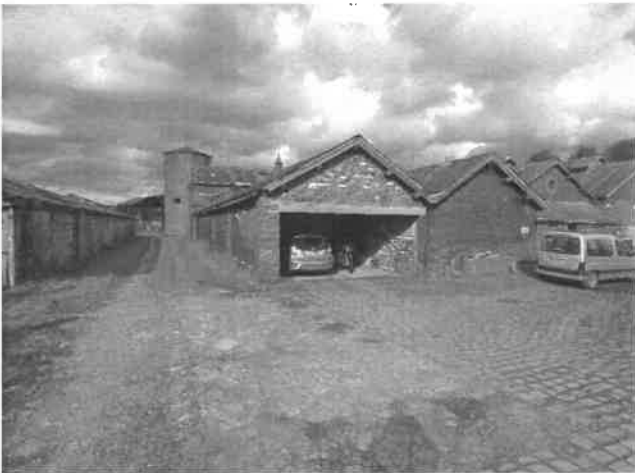
- Comprises of 13-inch solid brick construction with a pitched slate roof supported by a rafter purlin method of construction.
- Evidence of rebuilding works to the front parts of this building.
- Large steel lintel installed to the front wall garage section and some cracking is visible above (Image 31). This is easily repairable and is not significant.

- This section of building has suffered from the effects of water ingress over the years and the condition of embedded timbers (trusses etc.) have been affected by beetle infestation and rot/decay.
- Overall, this front section of building is viable for the development.

Image 27 - Building 5, Section A, Front Building

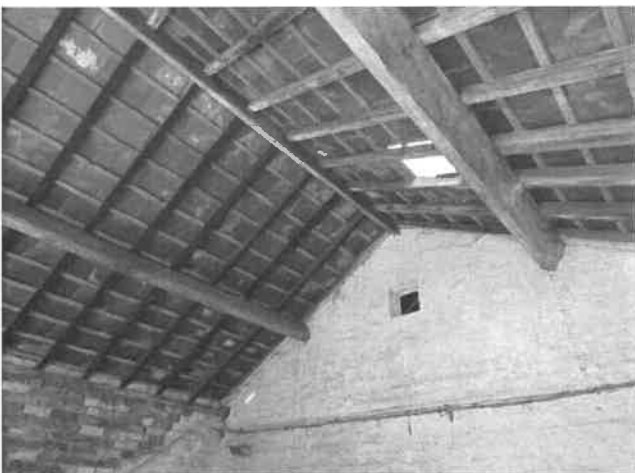
Image 29 – Roof Structure

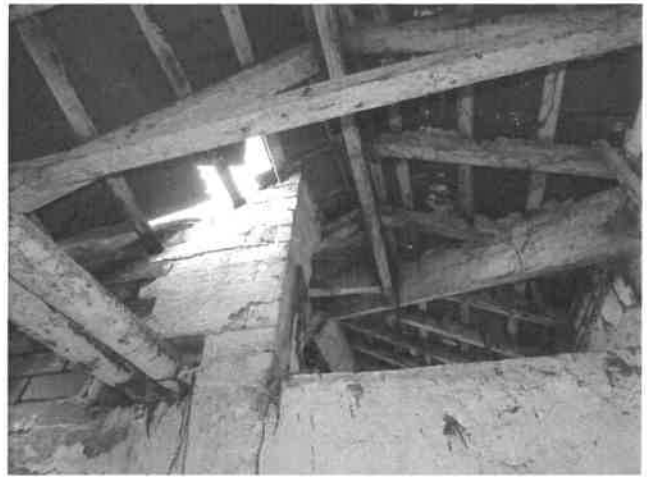
Image 38 – Roof Structure
