THE ARCHAEOLOGY CO.

Barn at 5 Talbot Street, Chipping

Historic Building Survey

October 2023

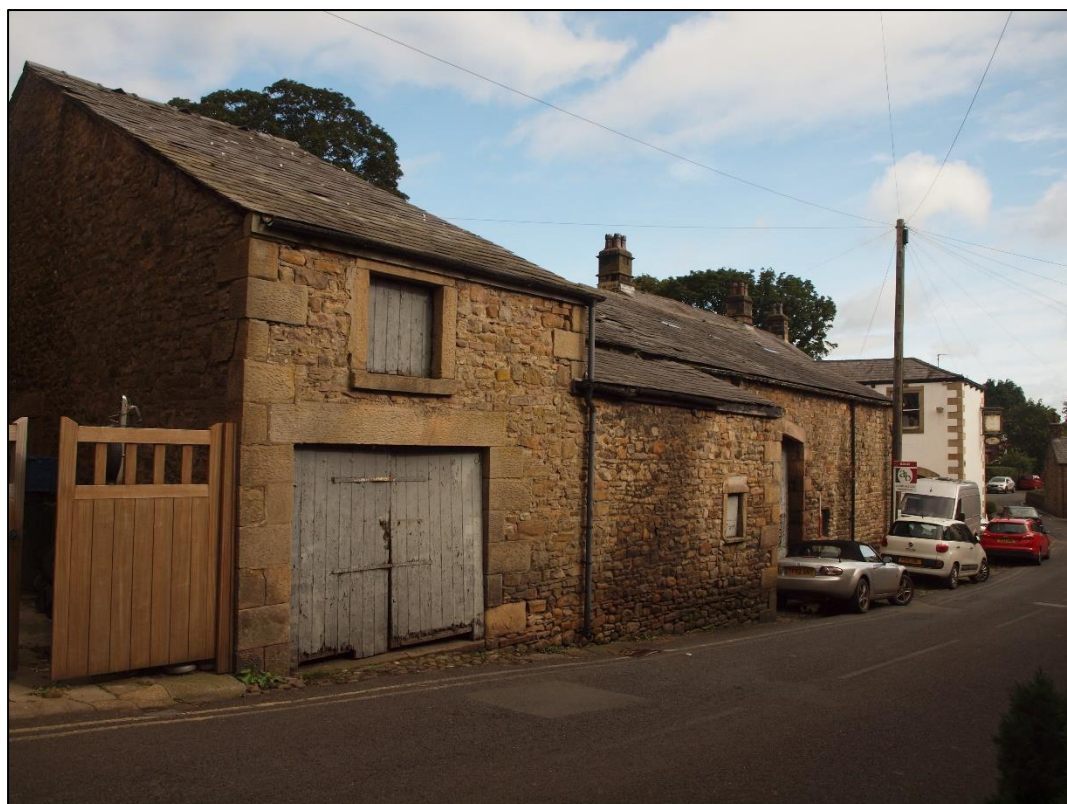
Plate 2: Western end of south elevation

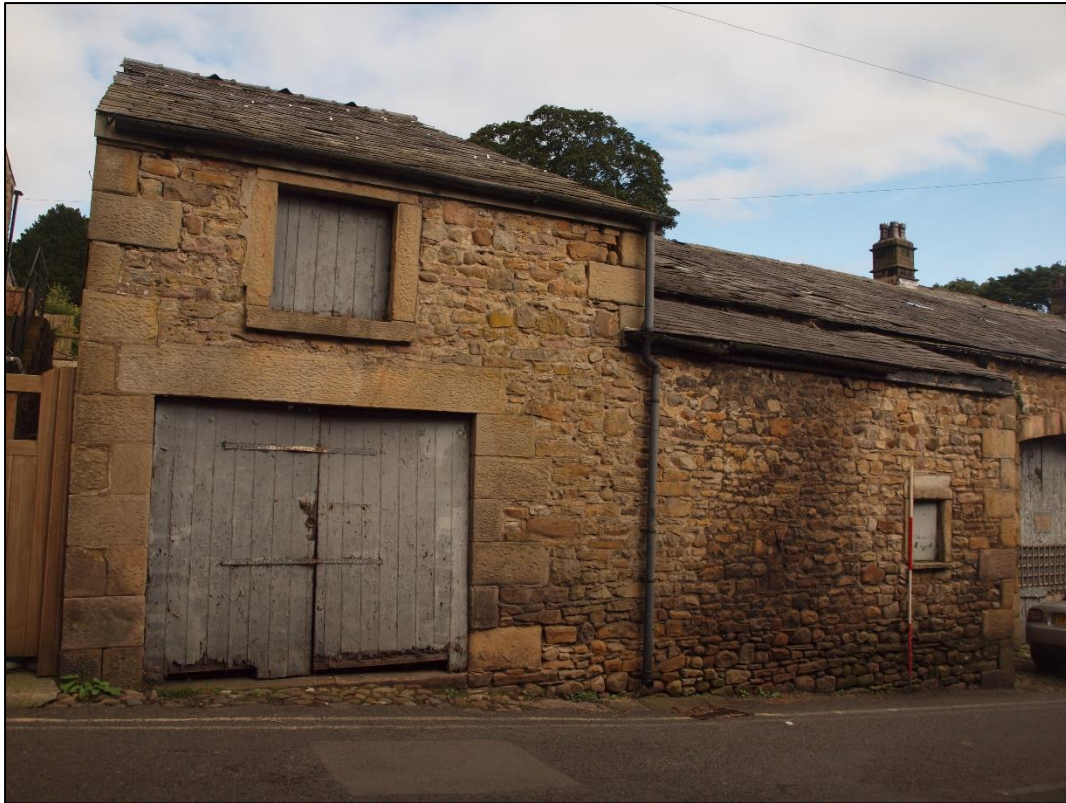
Plate 3: West end of south elevation showing out shut

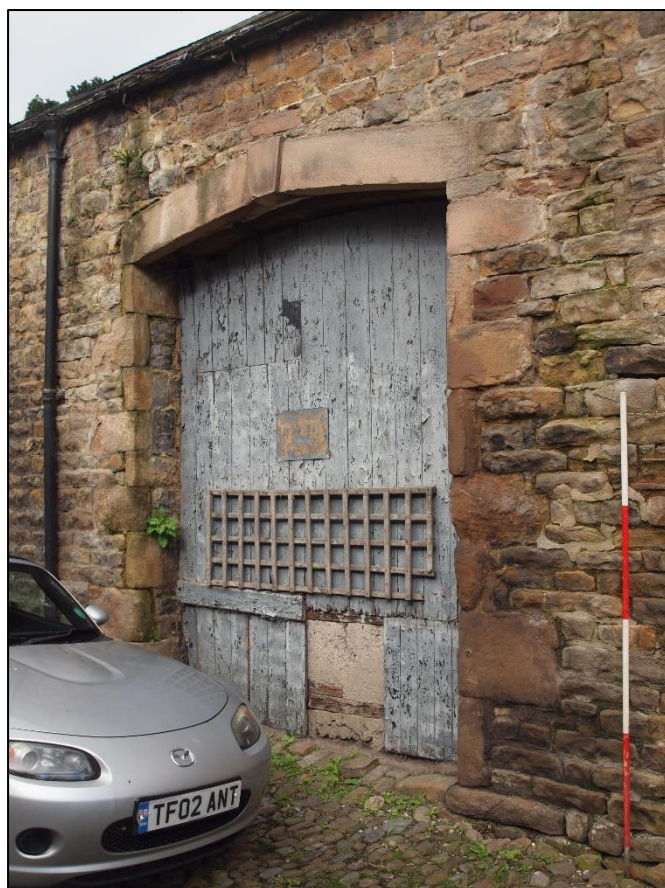
Plate 10: barn door detail

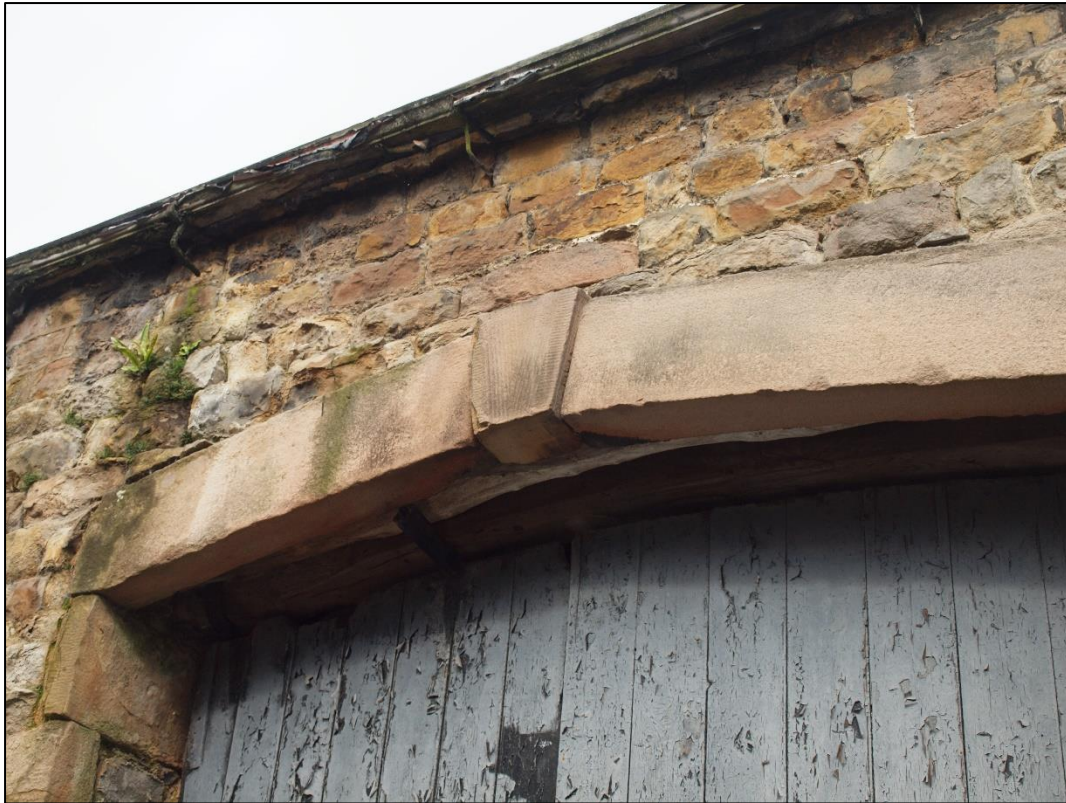
Plate 11: Lintel of ban door

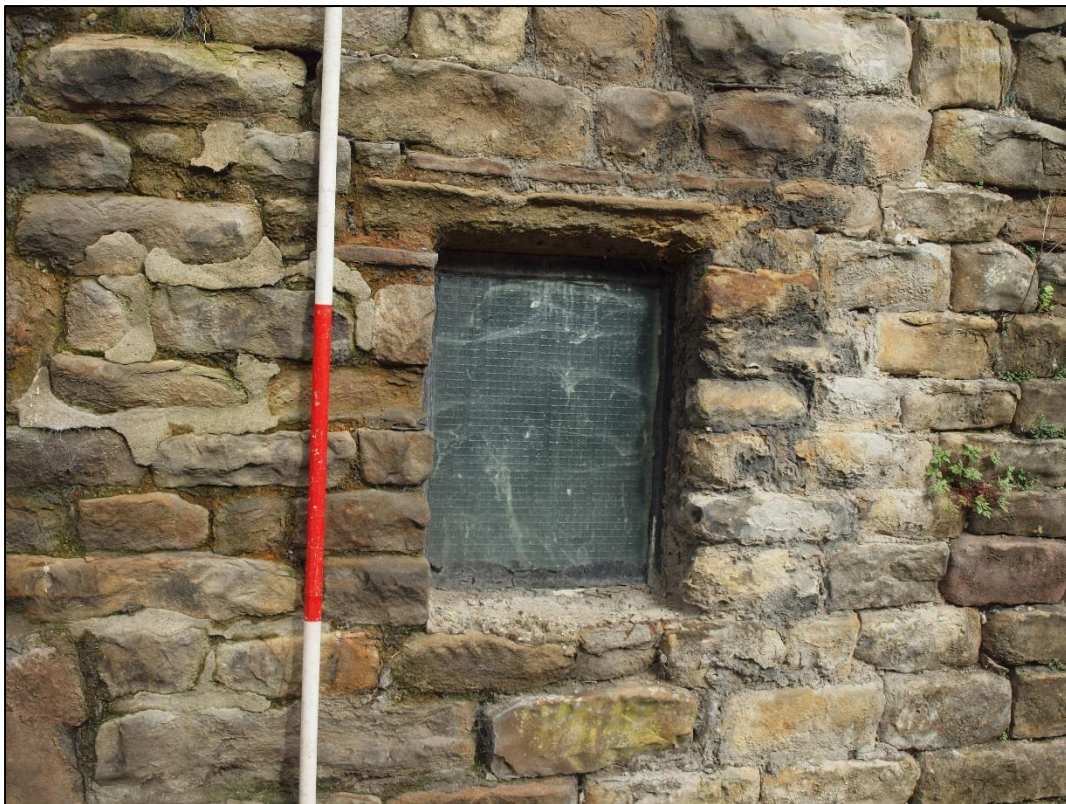
Plate 12: Window detail

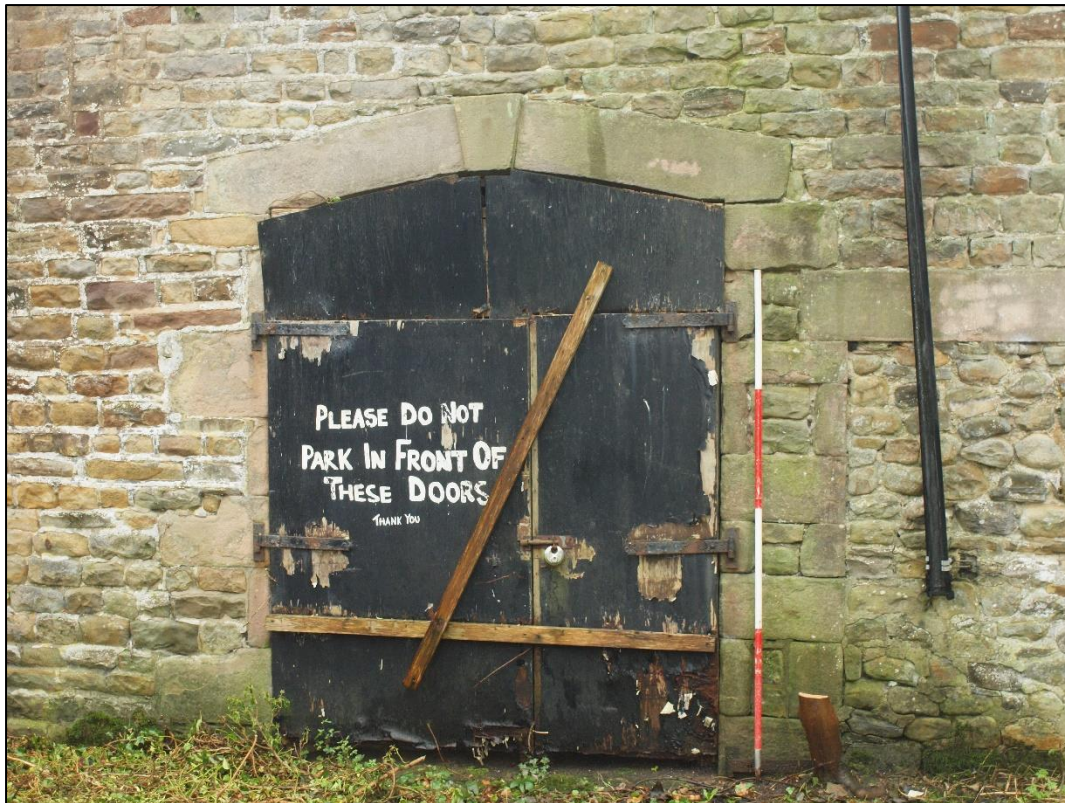
Plate 25: Detail of barn door
