Barn 1 at Cuckoo Farm, Higher Road, Longridge, PR3 2YX

Structural Condition Survey for Conversion to Dwelling

PSC-872 – B1

April 2024

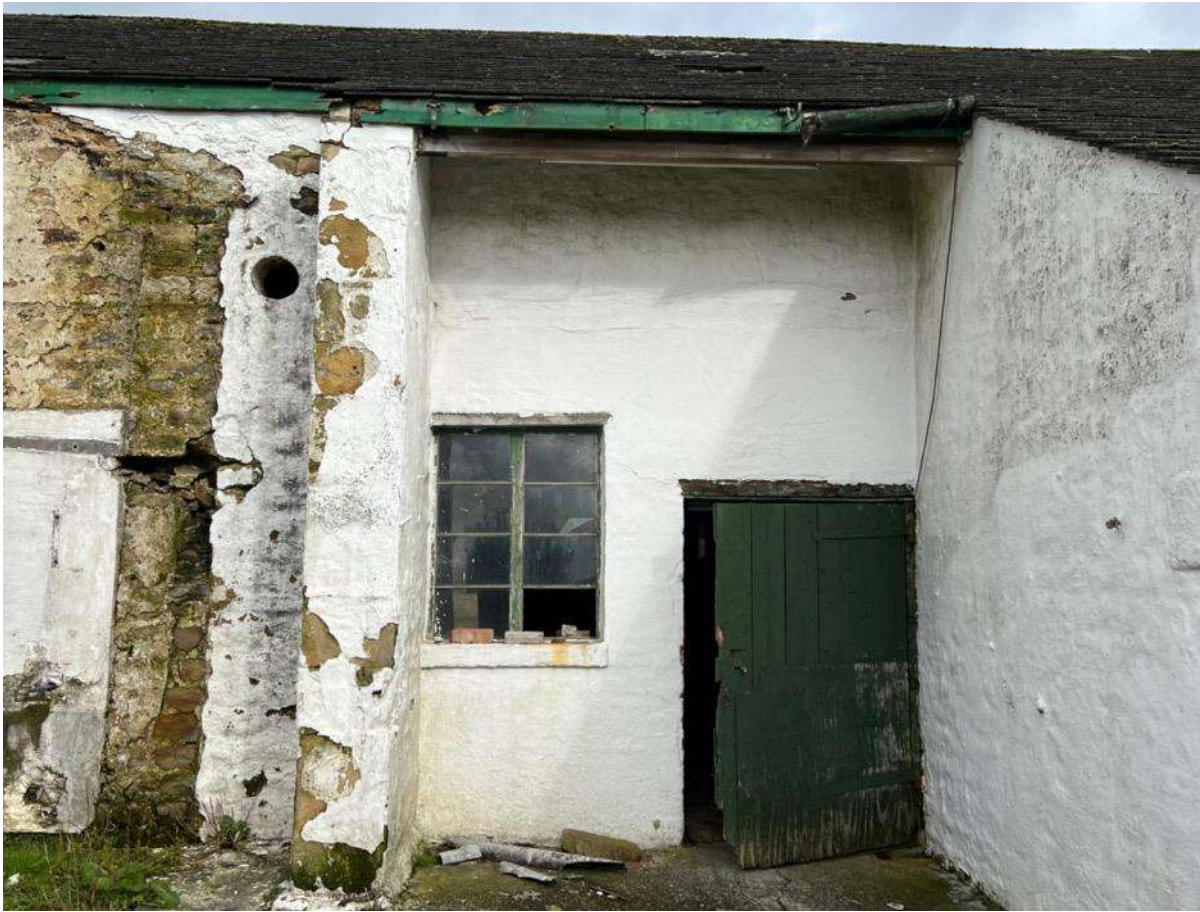
Photo 2 – South Elevation

This elevation is built in random sandstone, which has been painted white, and the wall is 470mm to 500mm thick. There is a single storey outrigger at the east end (photo 1) and there are signs of a former extension adjacent to the house which has been removed (photo 7). All the walls are in reasonable condition. They are plumb, reasonably pointed/painted and there are no signs of previous or ongoing movement. There is some localised damage where the previous building was removed but this is minimal in area (1 to 2 m²). There are three openings at ground floor level, one window and door to the main section of the barn and a large sliding doorway to the outrigger. The recessed area with shelves immediately to the east of the farmhouse (photo 7) is probably a former doorway. The door and window to the main section of the barn is located in a recessed area which is likely to have been a former traditional large barn door. This has been infilled with brickwork as evidenced in photo 46. This elevation has the benefit of guttering and downspouts which are in reasonable condition to the outrigger but in poor condition or missing to the main roof (photo 1).

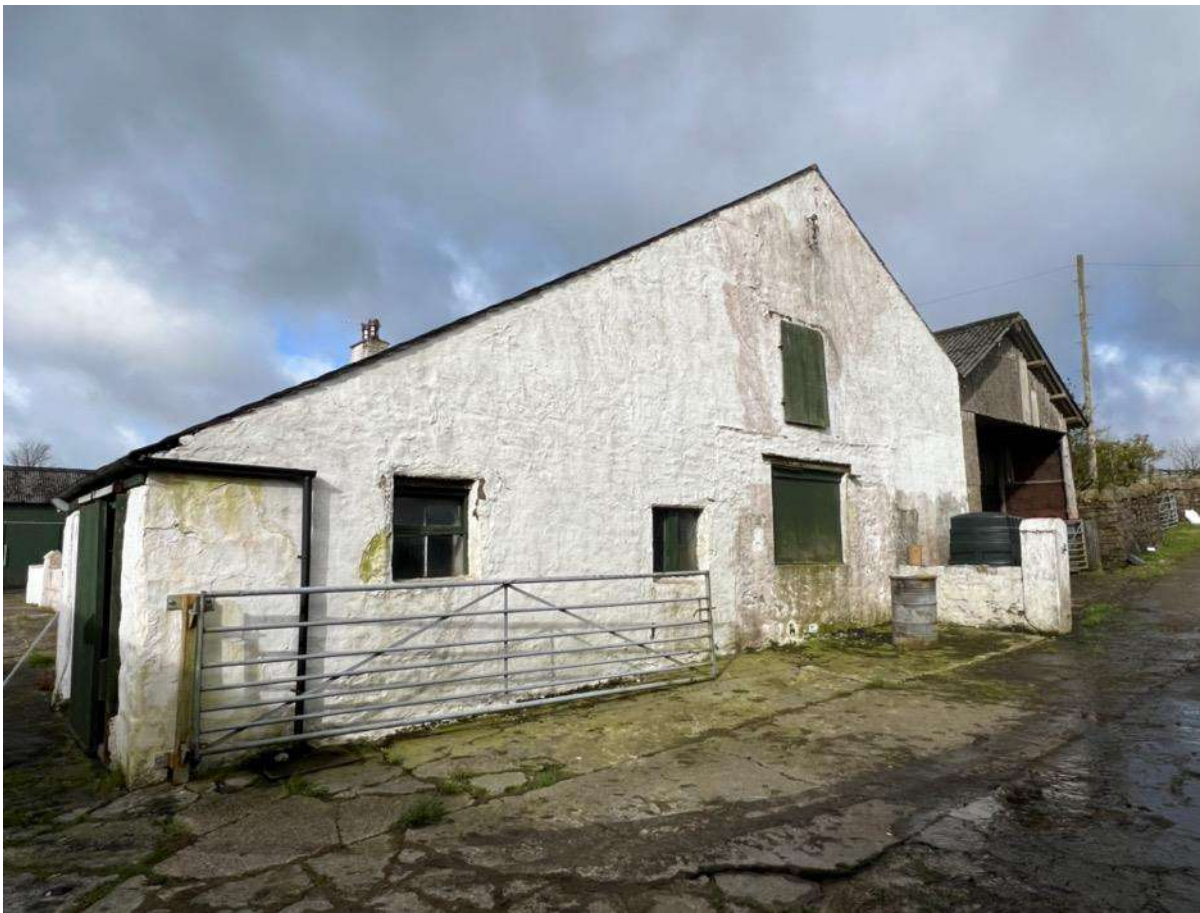
Photo 9 – East Elevation

This gable elevation is built in random sandstone and the wall is 500mm thick. The wall is in reasonable condition. It is reasonably plumb and reasonably pointed/painted. There are no signs of previous or ongoing movement. There are three window openings at ground floor level with a further opening to the loft or feed hopper above (photo 9). This section of the elevation has a short section of guttering and a downspout serving the outrigger roof (photo 16).

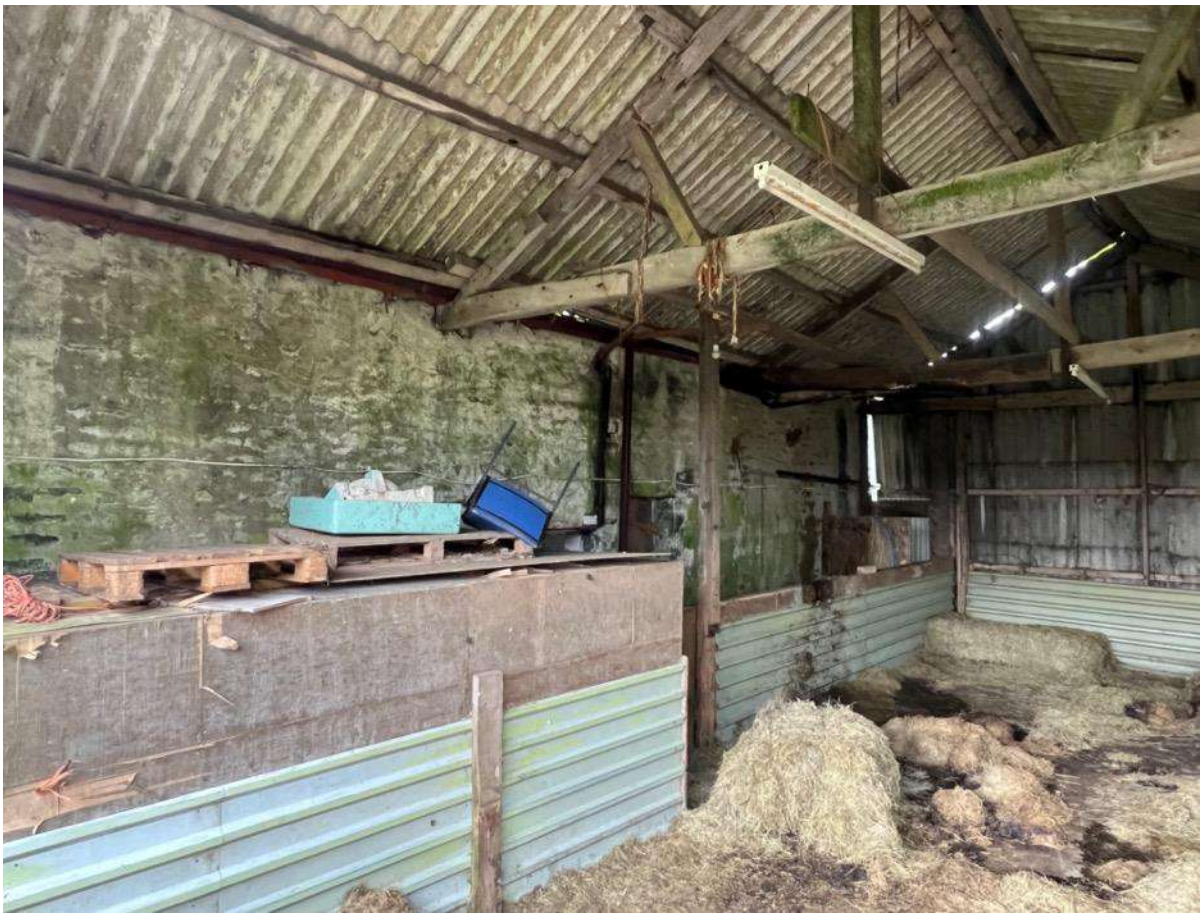
Photo 13 - North Elevation within adjoining building

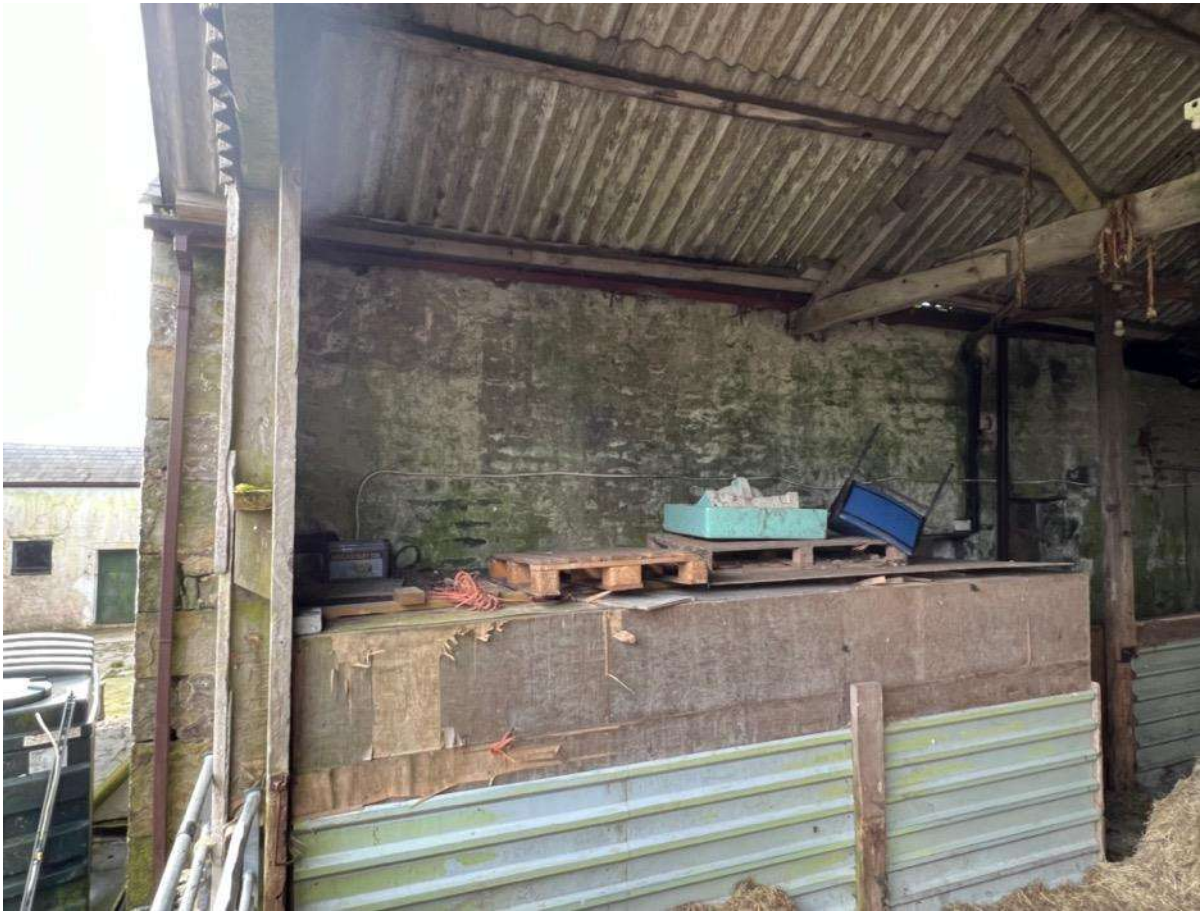
Photo 14 - North Elevation within adjoining building

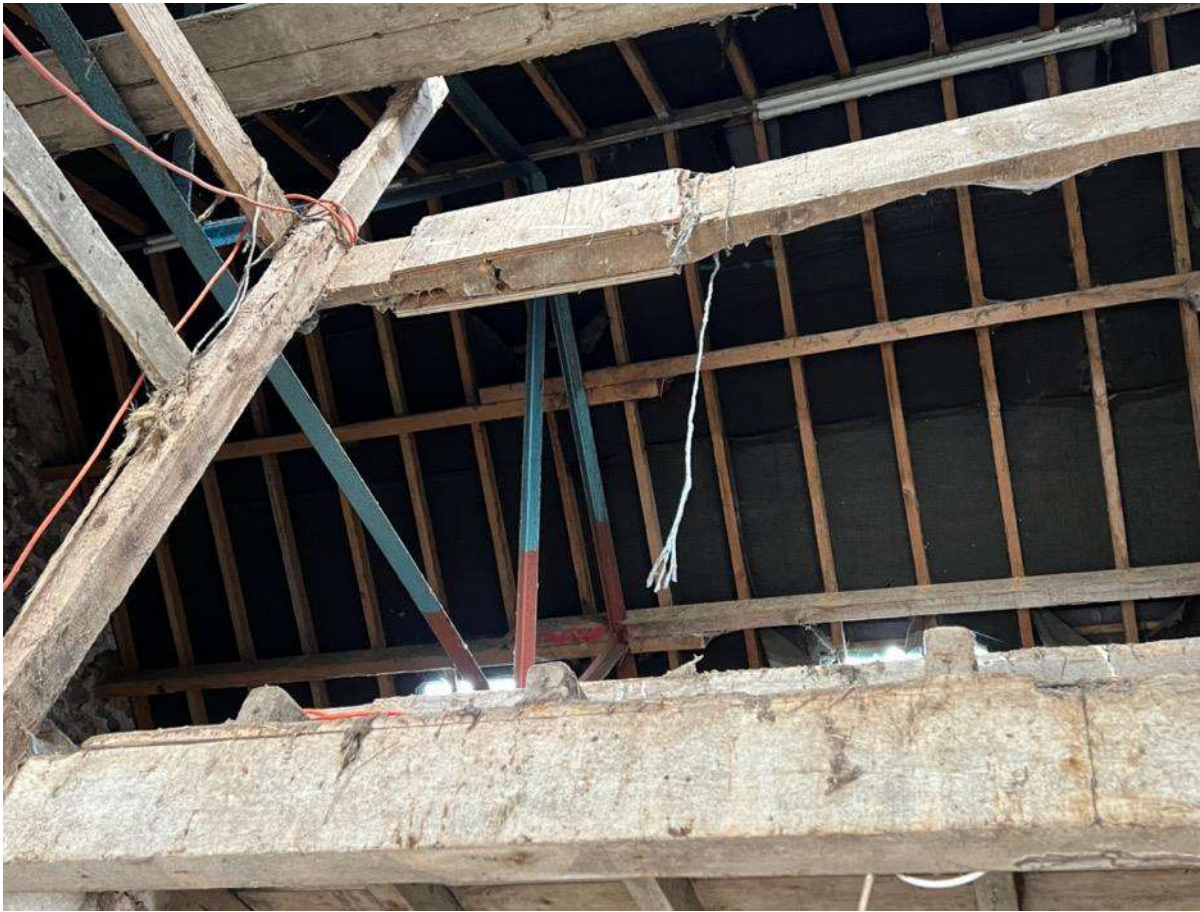
As noted above, the roof to the barn has been recovered and has felt in place. The felt is damaged in several areas and there are signs of water ingress (photo 43). The roof structure appears to be a replacement structure consisting of lightweight steel trusses and timber purlins and rafters. The structure appears to be in a reasonable condition with no sign of excessive deflection or movement. The timber purlins and rafters appear in reasonable condition with no clear signs of extensive rot or infestation. As noted, there are areas of water ingress which may have damaged the timber.

Photo 44 – Internal roof
