Barn at 5 Talbot Street, Chipping

Historic Building Survey

October 2023

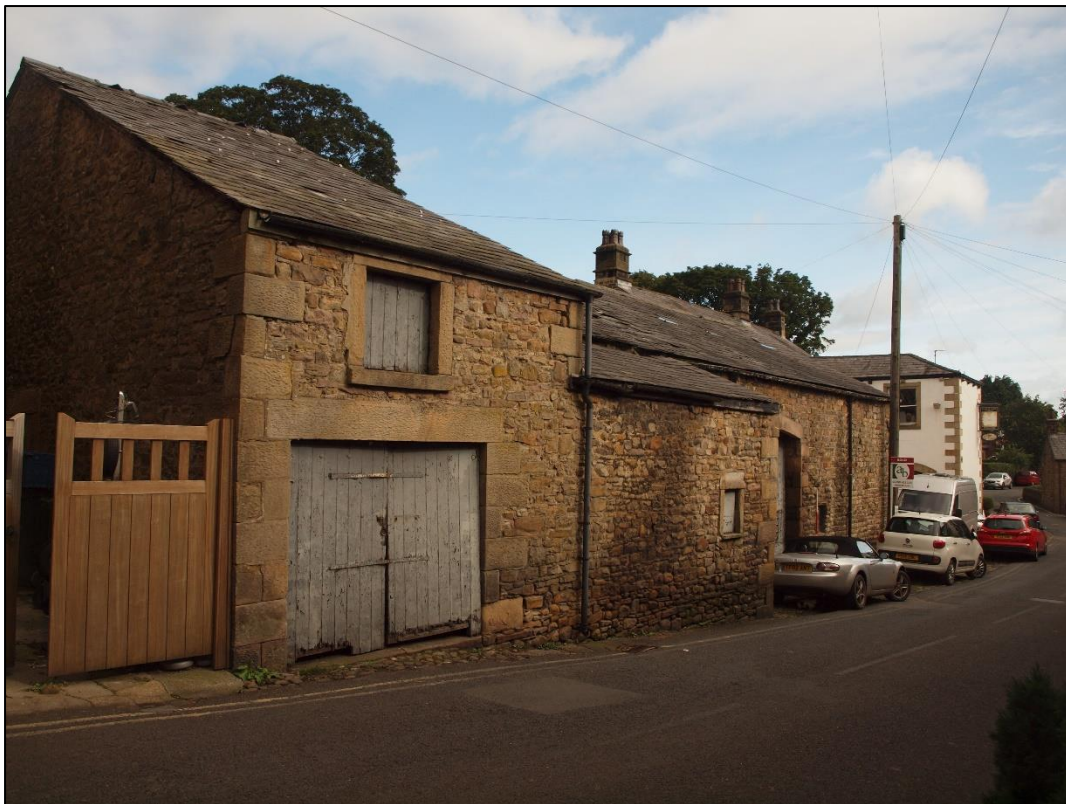
- 6.2 South Elevation (Plates 2 - 14). This forms the main frontage of the building, facing onto Talbot Street. At the western end is the face of the extension (plates 2 – 8). This projects from the rest of the face and has a loading bay door at ground floor level a pair of double doors hung internally on iron pins. The lintel is a single sandstone block and the jambs are large sandstone blocks, matching the quoins to the corners. Above this is a square pitching eye with a timber shutter. The lintel, cill and jambs are all formed of single large sandstone blocks. To the east the extension is lower and contains a small portrait window at ground floor level. This is blocked with timber and the surround is sandstone. The whole of the face of this extension is constructed in a rough uncoursed rubble. To the east is the face of the barn proper (plates 10 – 14). This contains a large barn doorway (blocked internally and with the exterior boarded) with an angled lintel formed of two large sandstone blocks, with keystone. The jambs are formed of large

Plate 2: Western end of south elevation

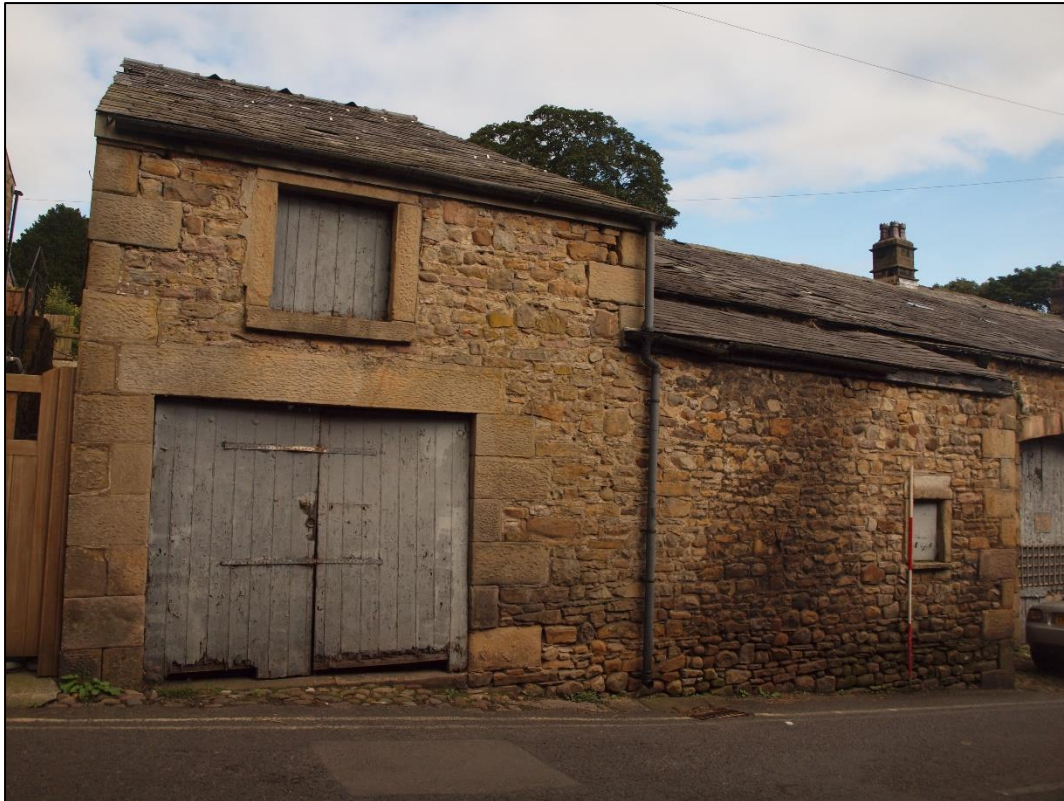
Plate 3: West end of south elevation showing out shut

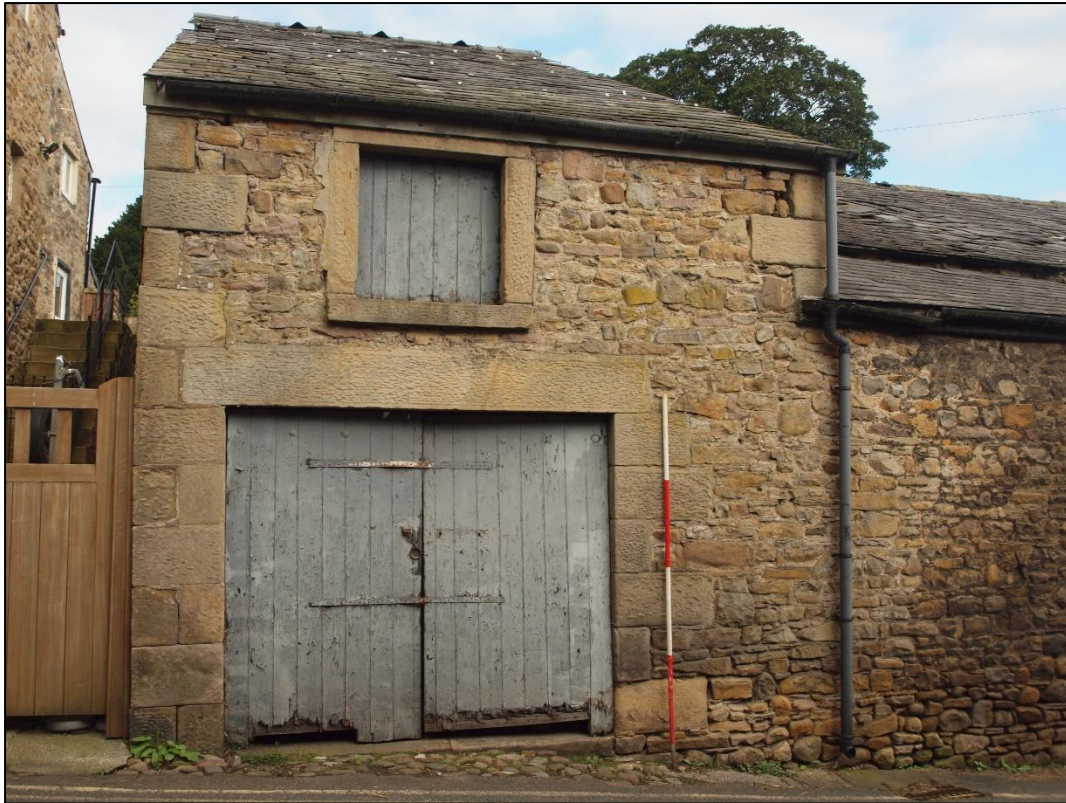
Plate 5: Loading doorway with pitching eye over

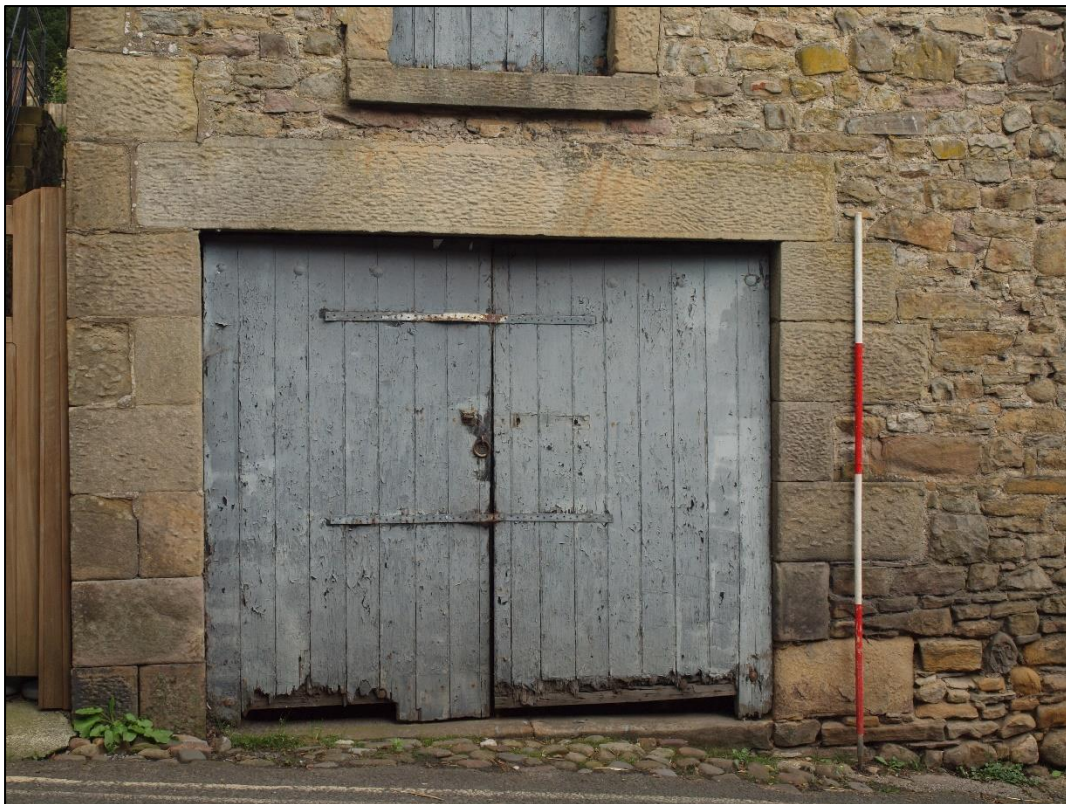
Plate 6: Loading door detail

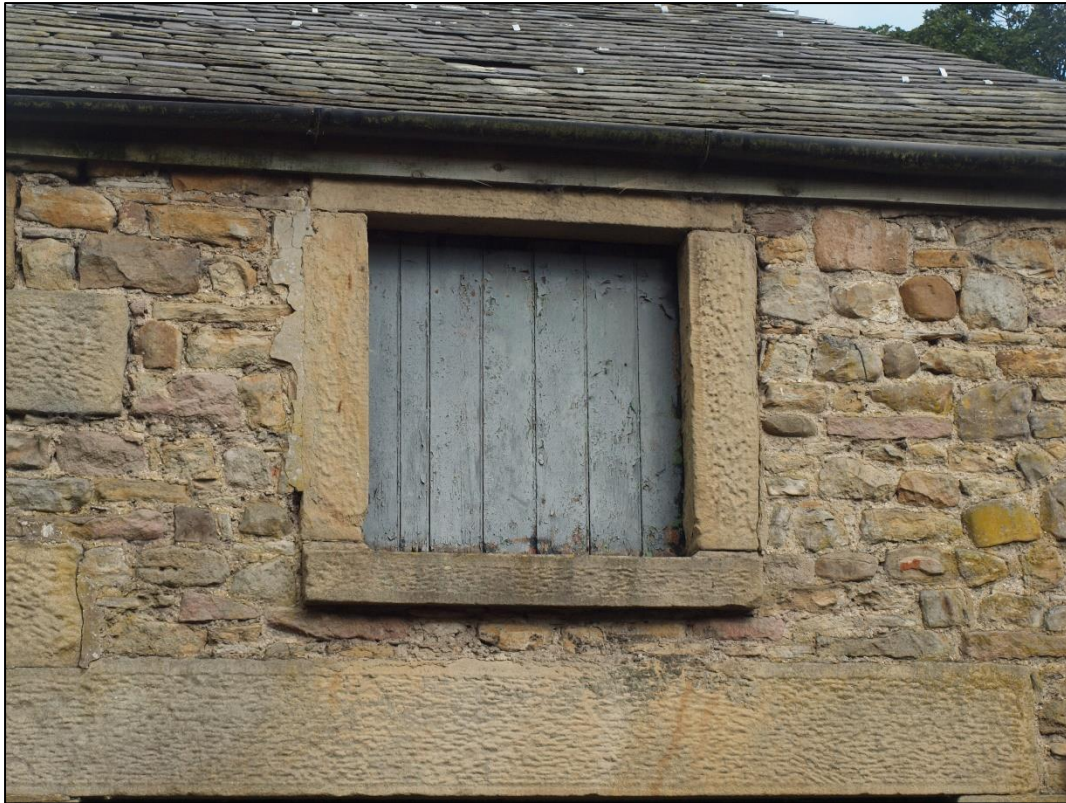
Plate 7: Pitching eye detail

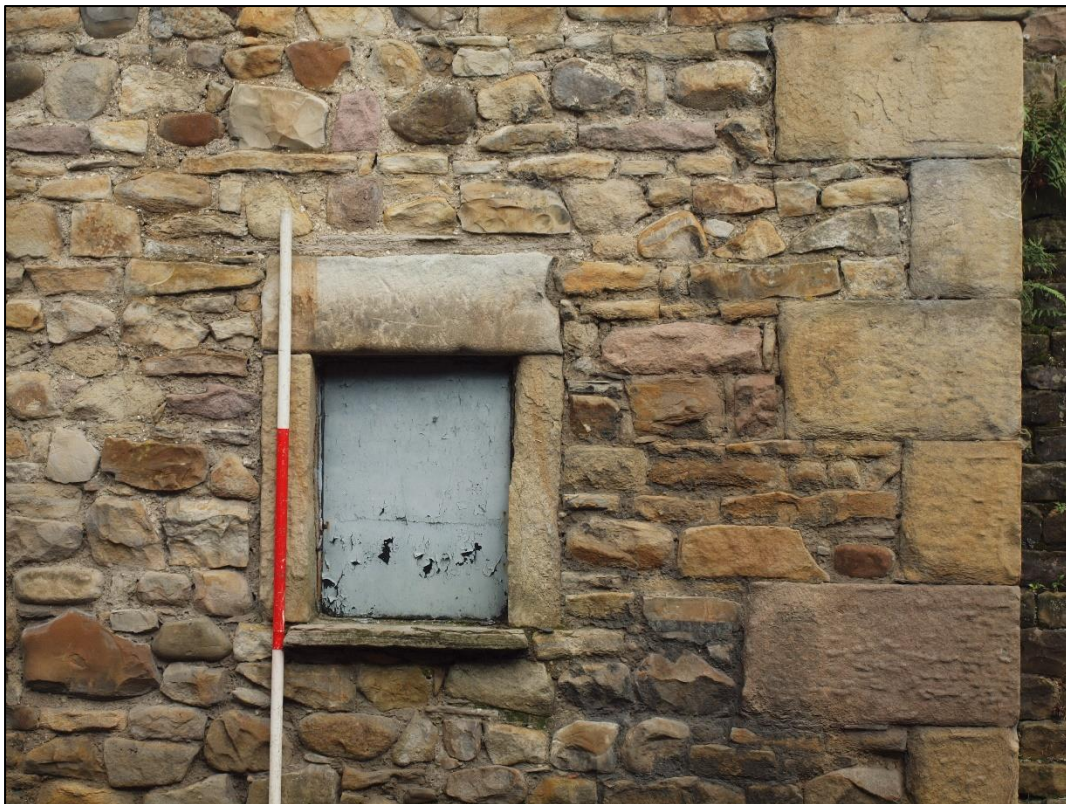
Plate 8: Window to east end detail

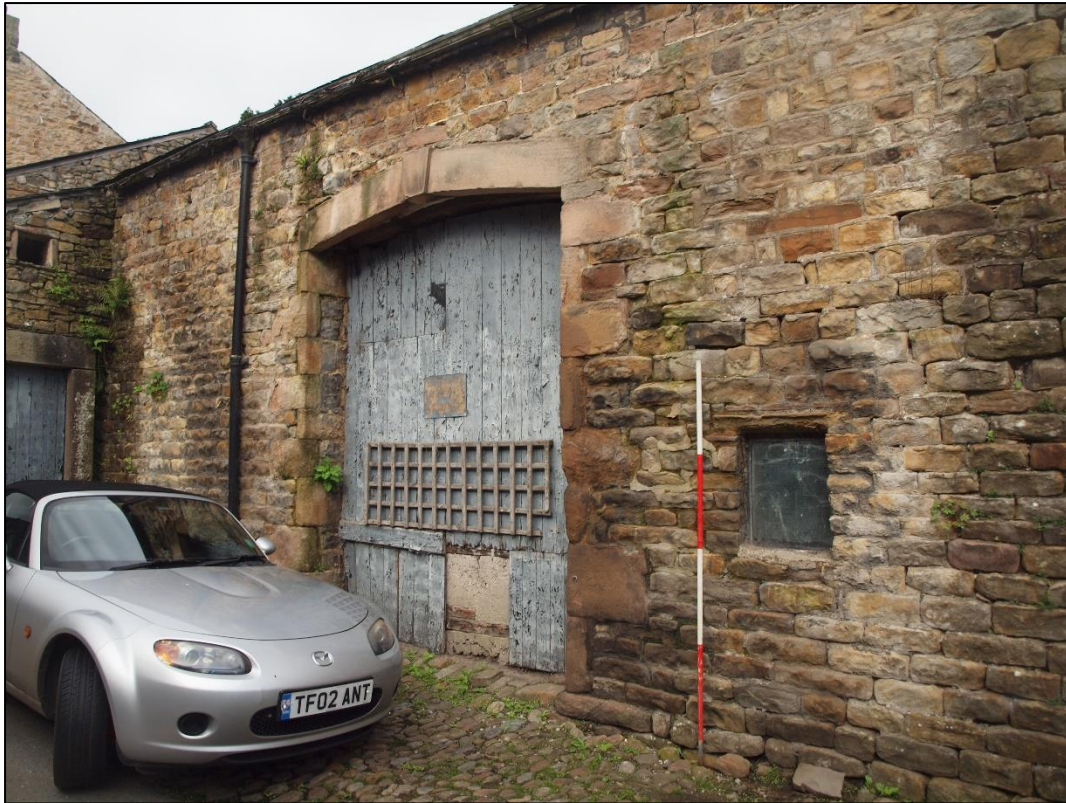
Plate 9: East end of south elevation showing barn door and window

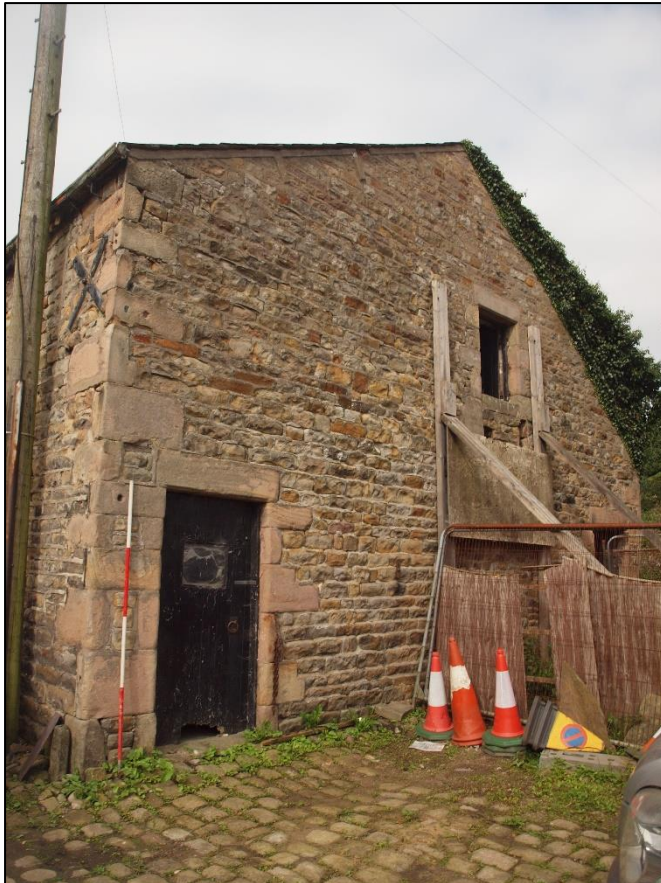
- 6.3 East elevation. (Plates 15 - 18). This forms the gable end of the building, facing the Talbot Inn. To the south side is a doorway, with large sandstone blocks to the jambs and a sandstone lintel over. To the north is a matching doorway and at first floor level, set slightly north of centre is a similar pitching eye. The southern jamb of this continues lower than the opening itself, suggesting it has been partially blocked at the base. Both doorways have timber doors hung internally on iron pins, with a timber shutter to the pitching eye, similarly hung. The gable is in a very poor condition, with a large hole near the centre and external temporary timber shoring to prevent further collapse. To the south, and set back from the gable is the face of the outshut (plate 19). This contains a doorway with dressed sandstone surround and a small square opening above it.

Plate 15: Eastern gable

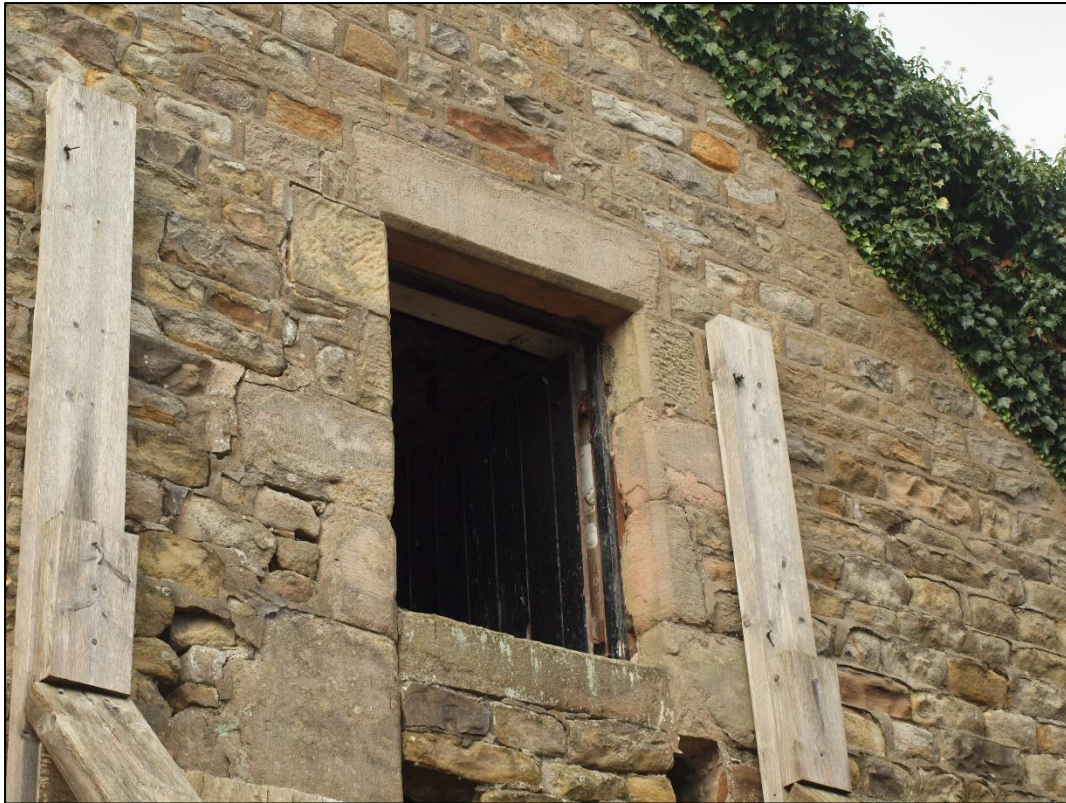
Plate 17: First floor pitching eye

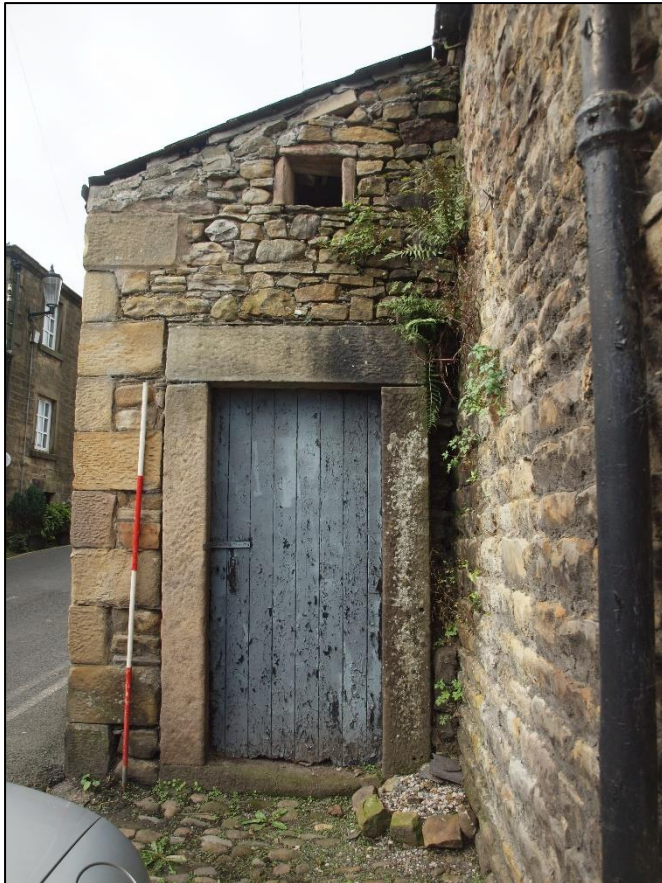
Plate 19: Doorway into out shut

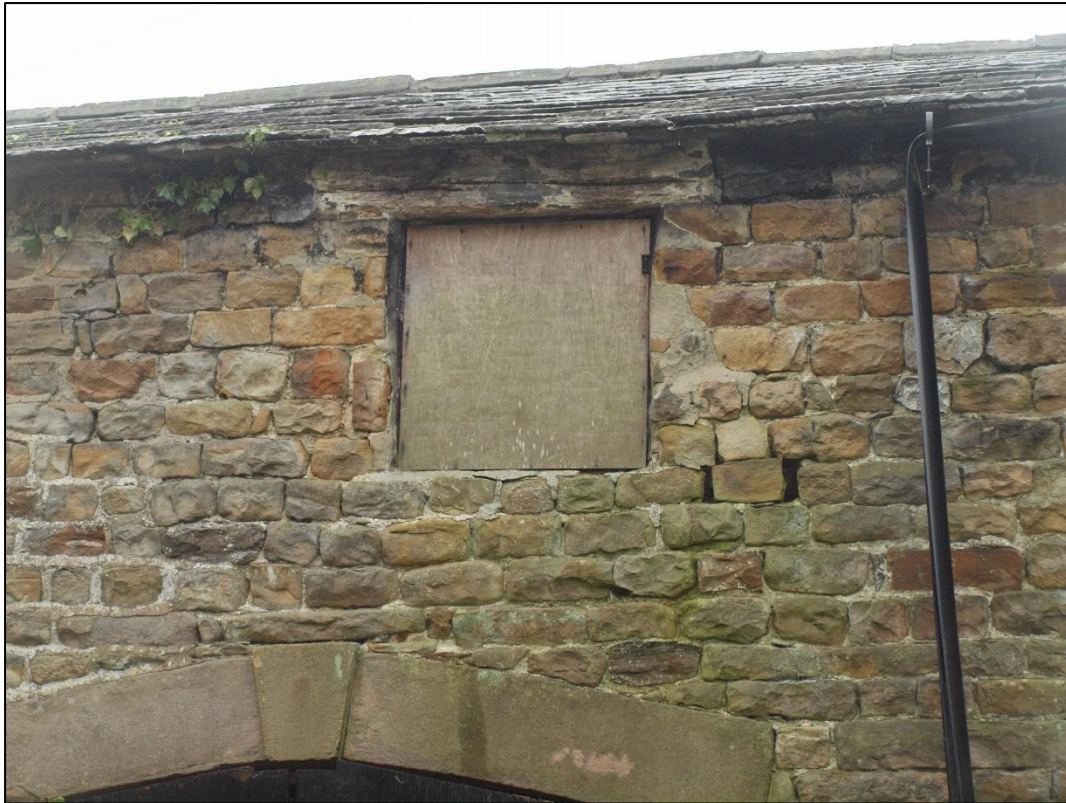
Plate 27: Detail of pitching eye

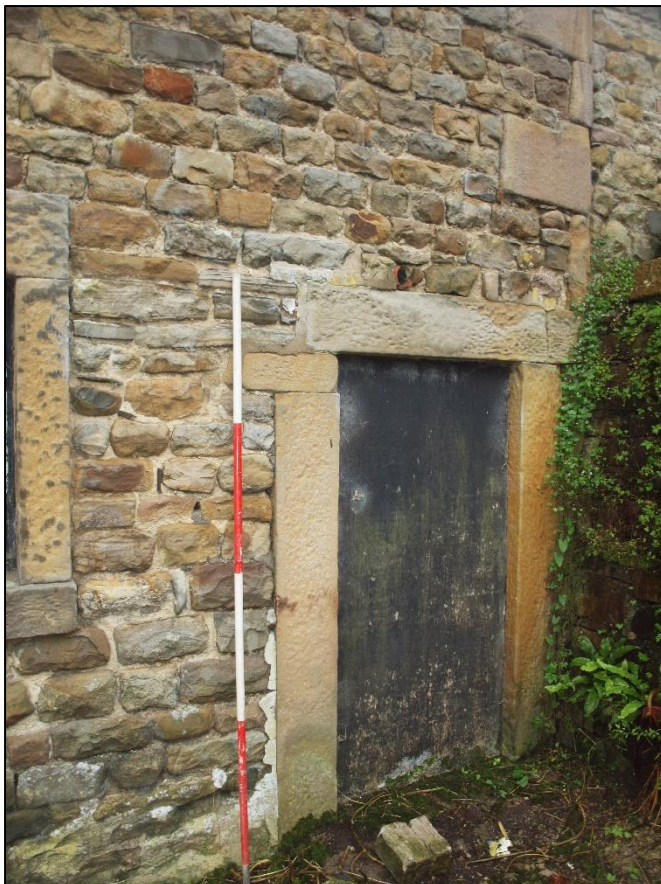
Plate 30: Doorway at western end

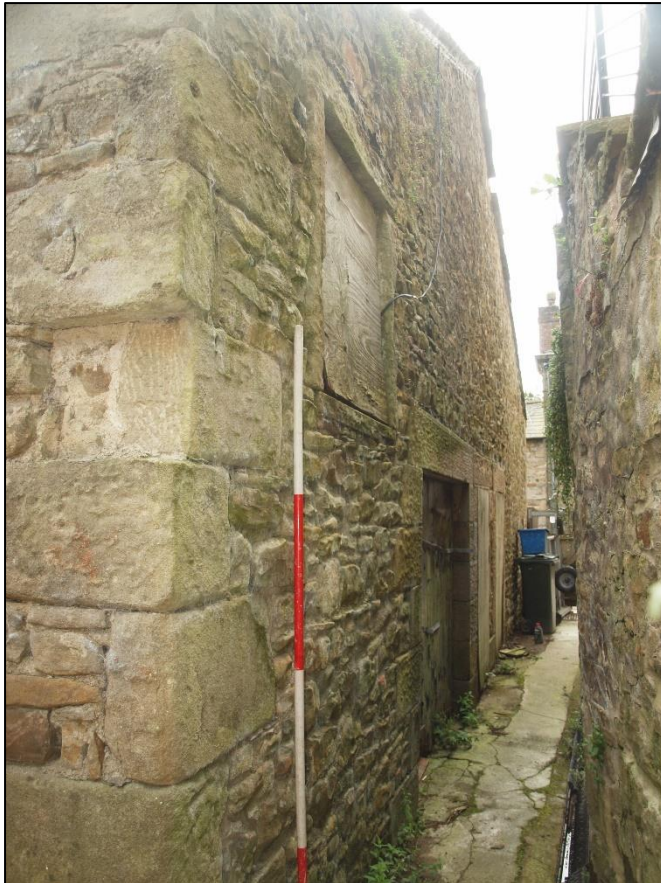
- 6.5 West elevation (plates 33 - 39). This forms the other gable end of the building, with only a narrow walkway between this and the adjacent building. At the northern end, at first floor level, is a square pitching eye with sandstone cill, jambs and lintel, blocked with ply. At ground floor level, are a series of three doorways. The northern is a wide loading doorway with dressed sandstone block jambs and a dressed sandstone lintel over. A timber double door is hung with strap hinges. The southern jamb forms the northern jamb of the central doorway. This likewise has a dressed sandstone lintel and the southern jamb is formed of a single dressed sandstone block., with dressed block above and below it. These blocks form a part of the northern jamb of the southern doorway, which again has a single sandstone block between. The lintel of this southern doorway matches the others and the southern jambs is a single sandstone block reaching from ground level to lintel. Both the central and southern doorway are blocked with ply.

Plate 33: Western gable showing narrow passage to adjacent building

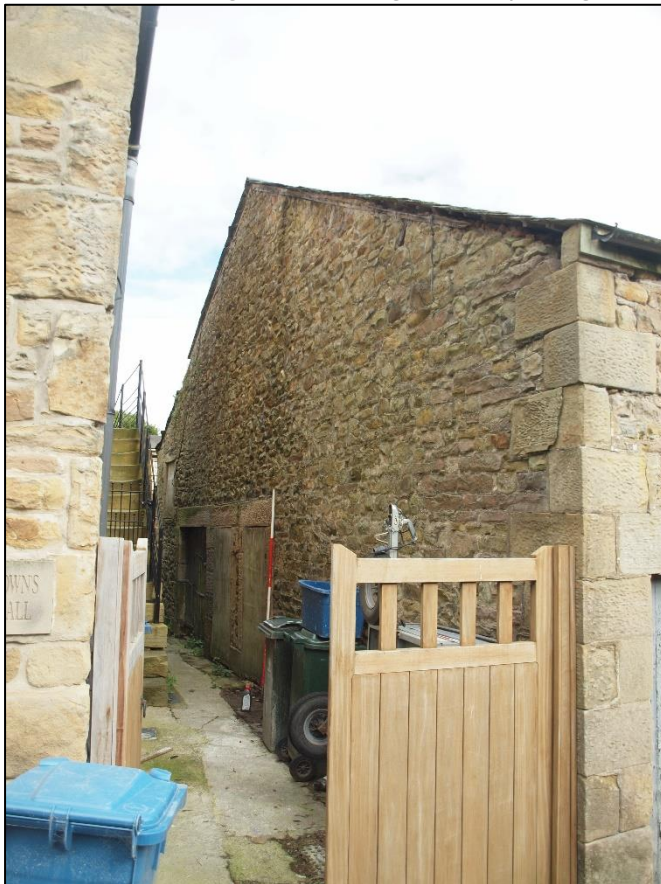
Plate 34: Western gable

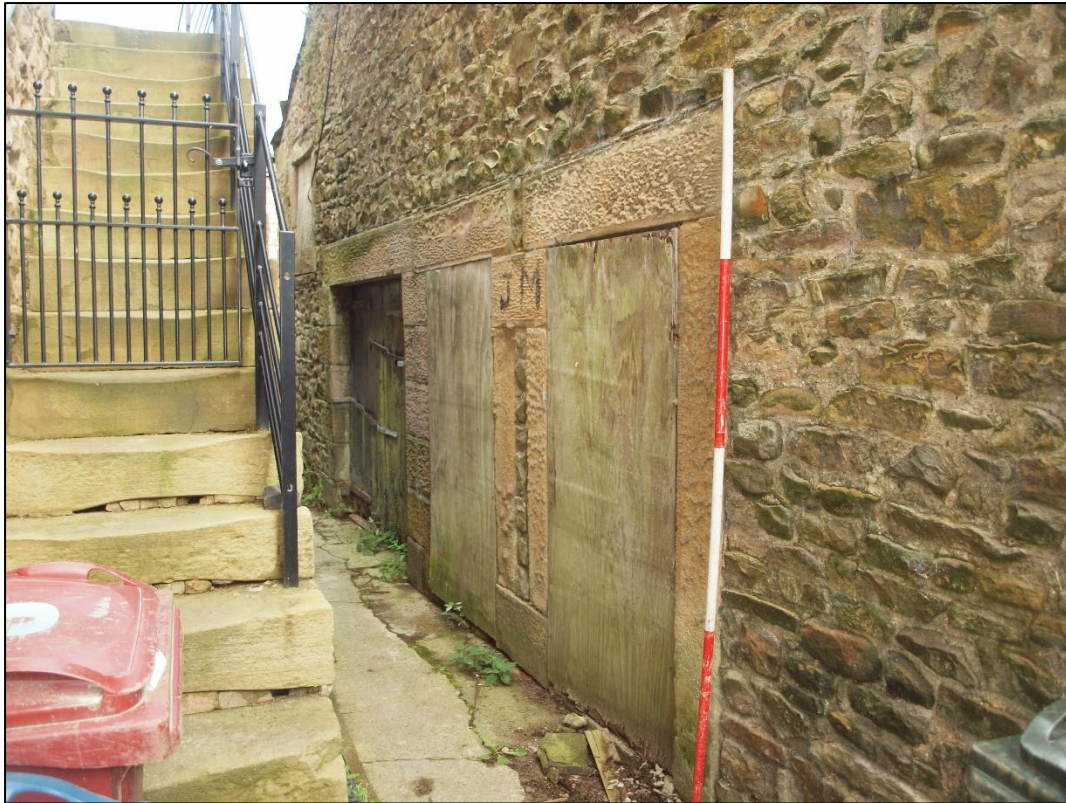
Plate 35: Three doorways to west gable

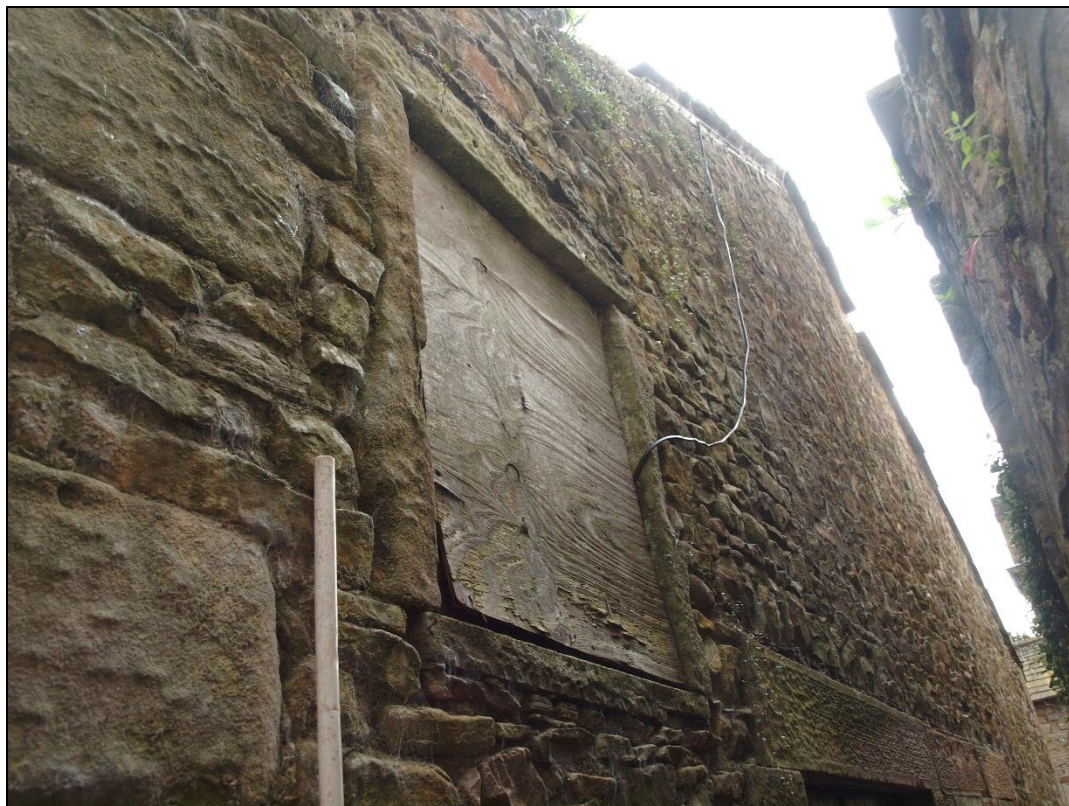
Plate 36: Pitching eye to northern end

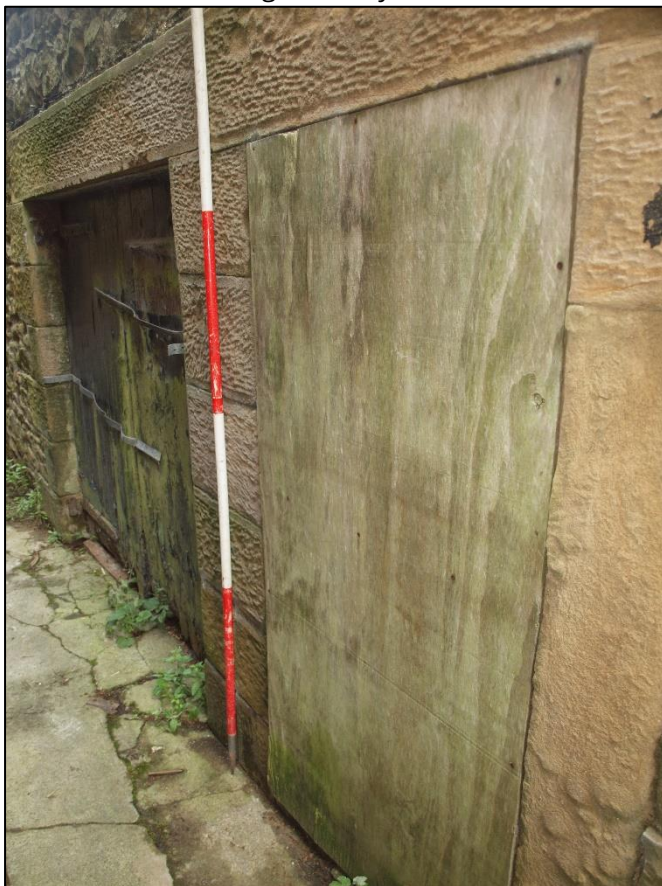
Plate 38: Central doorway

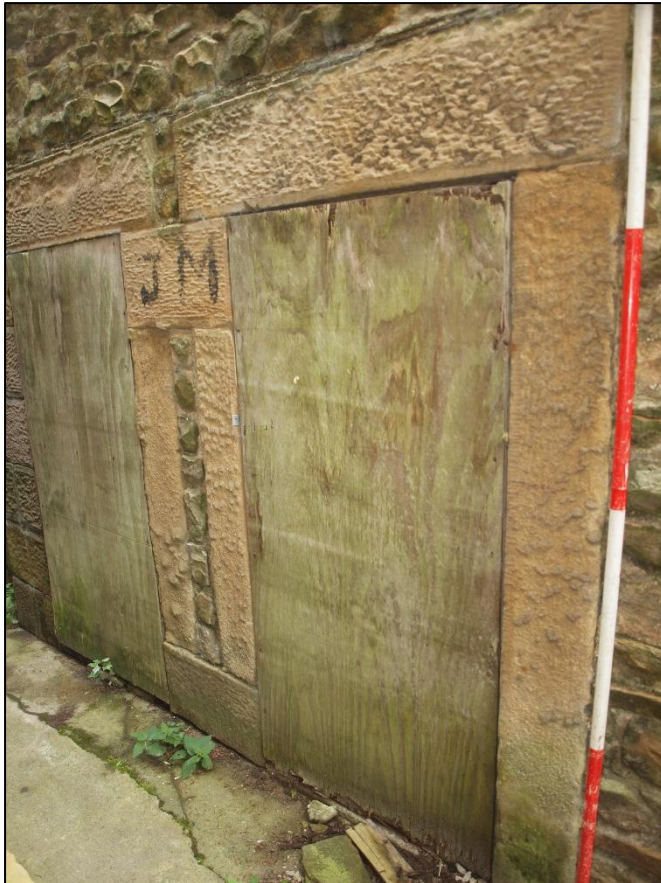
Plate 39: Southern doorway

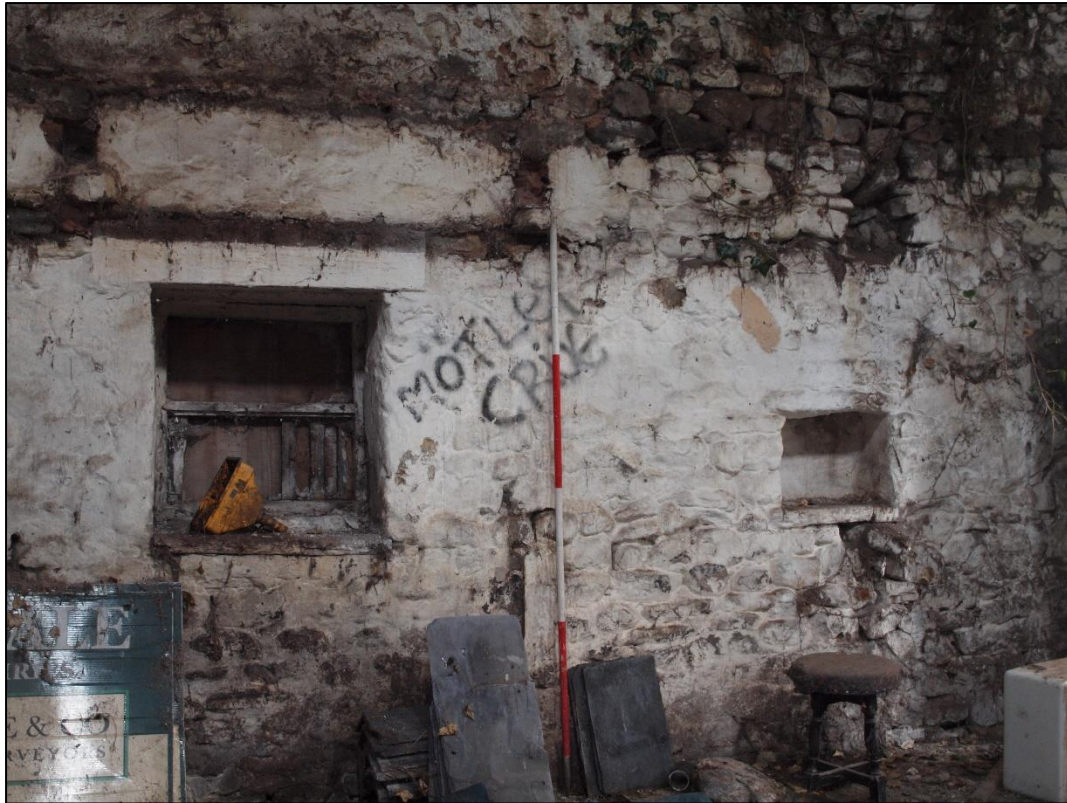
Plate 43: Eastern end of north wall showing window and adjacent niche

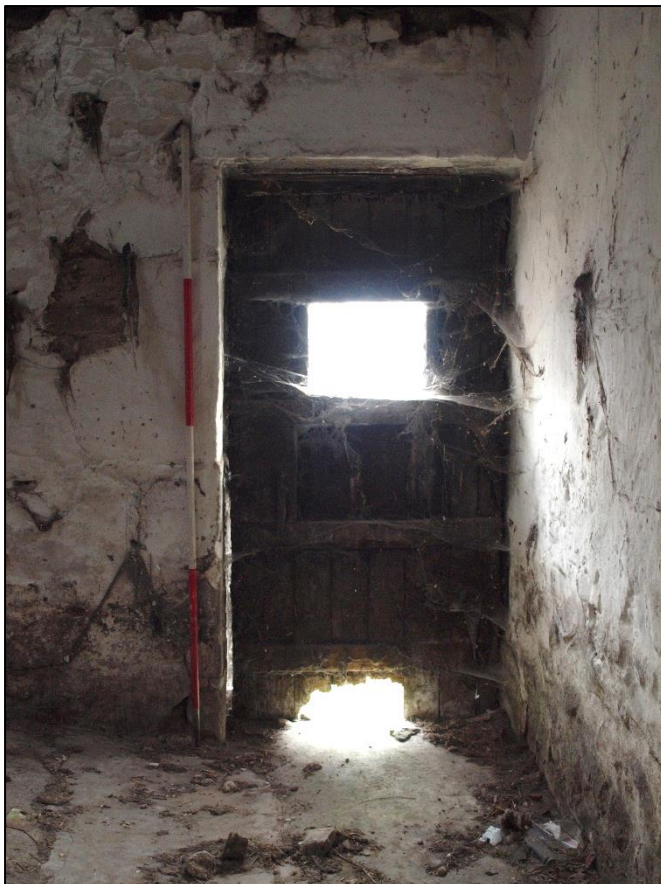
Plate 50: Doorway in south end of east gable

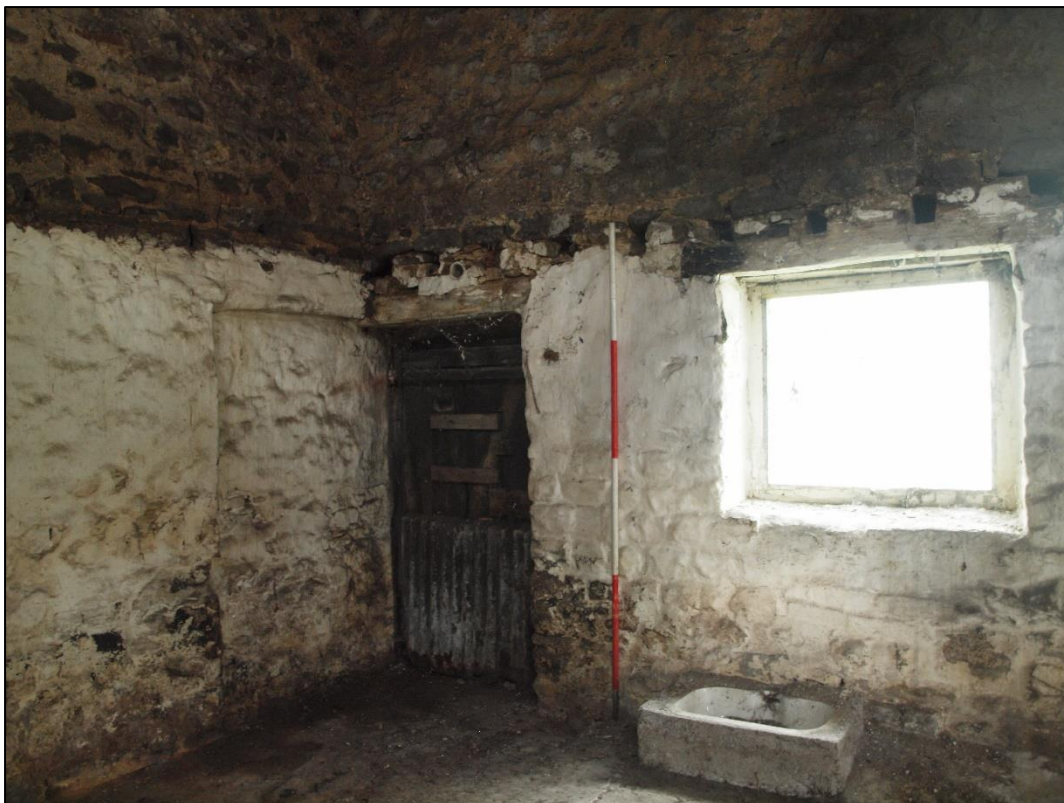
- 6.7 While all of the openings are apparent internally that were visible externally, a few more openings are present here. In the north wall, (plates 56 – 58) to the east of the easternmost window, is a small square lamp hole in the wall, with sandstone cill and lintel. Another lies in the southern wall opposite this. Above the latter is the blocked window, visible only as a straight joint externally. The southern barn door has been blocked internally with concrete block. The western gable shows several features. At the northern end is a recess for the doorway at the western end of the north elevation to open into. To the south of this are a pair of square openings set quite low in the face, suggesting blocked feeding windows. The eastern gable, as noted, is in a very poor condition. In the centre, barely visible through the whitewash is the suggestion of a blocked doorway. No trace of this is visible externally. The southern jamb appears as a single sandstone block. No lintel is present and the northern jamb is suggested by large sandstone blocks.

Plate 56: Western doorway in north wall with recess adjacent

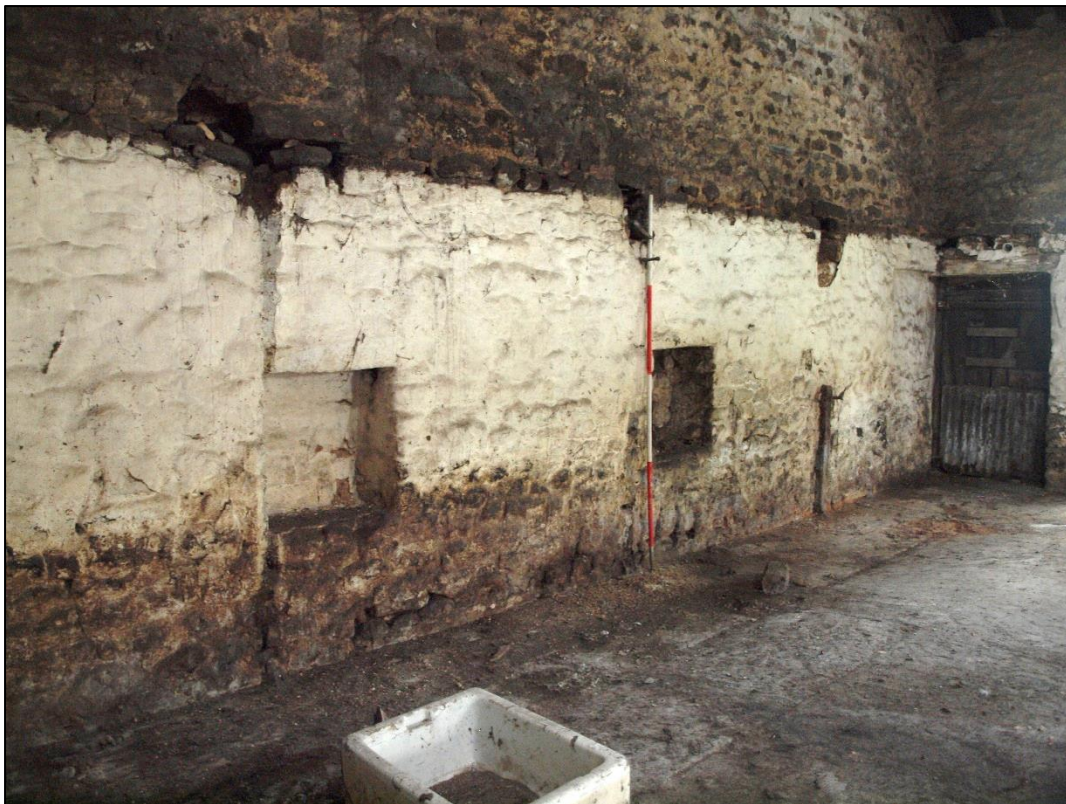
Plate 58: As above

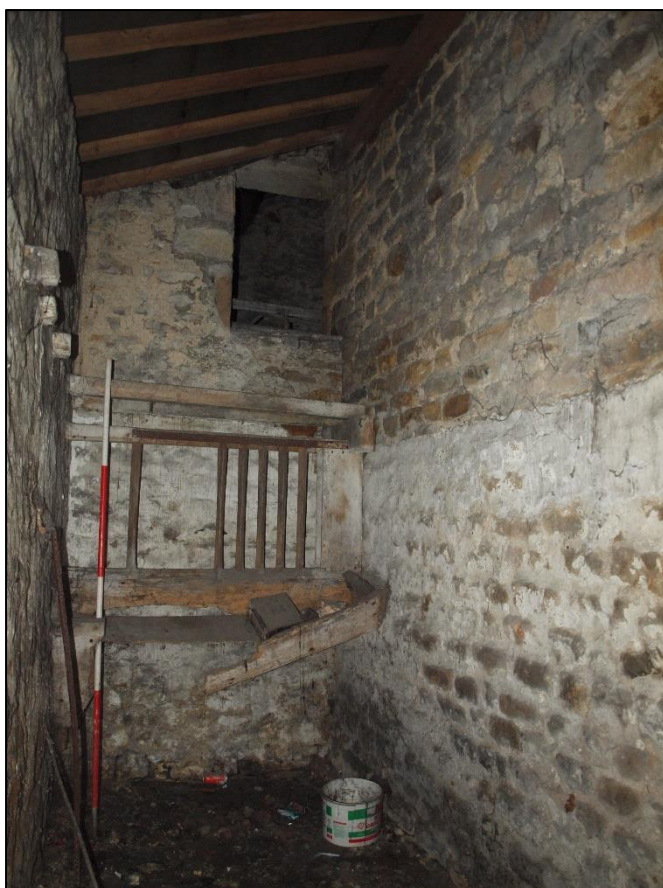
- 6.7 The outshut (plates 64 – 67) is accessed via the doorway in the east elevation. This leads into a small room with concrete floor and a single pitched roof. A timber feeding trough lies in the west wall above which is an opening into the western extension. The walls are whitewashed at ground floor level with bare stone above. In the south wall were small corbels to support a first floor, although none were found in the north wall.

Plate 64: Outshut looking west

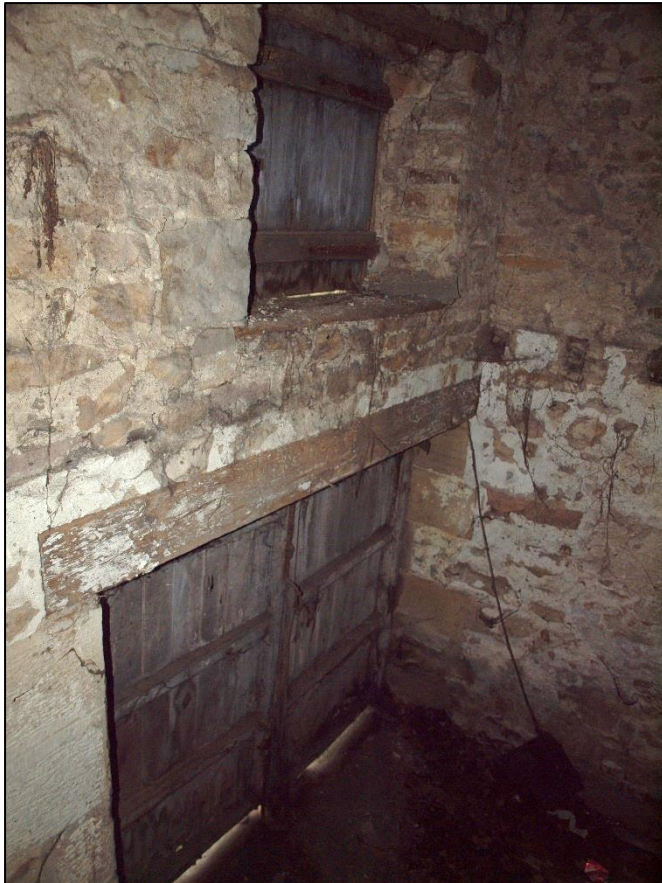
- 6.8 The western extension comprised three separate rooms. The southernmost room (Plates 68 – 75) was accessed via the double doorway in the south elevation. The walls were whitewashed throughout and to the north a brick wall had been inserted. A badly decayed first floor was partially present across the floor with a Jacobs ladder leading up to it. This appears to have been redundant however, the boards present blocking any former hatch. Along the eastern wall a machine cut timber beam ran the length of the room containing timber pegs and metal hooks. To the southern end of this wall, a straight joint of the original corner of the building was present, leading up to the first floor window to the outshut, above which it continued as a rough joint. The first floor was not whitewashed and no openings were apparent in the original gable wall. To the north however, a brick wall rose from ground floor level, with three ventilation holes within it.

Plate 69: Doorway and pitching eye over in south wall

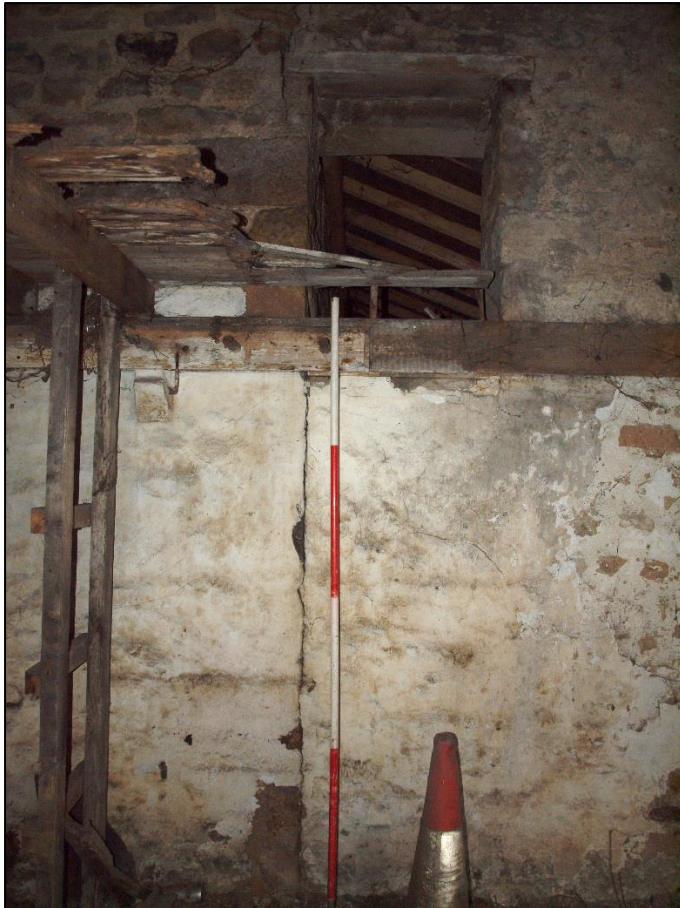
Plate 73: Straight joint of original corner of barn

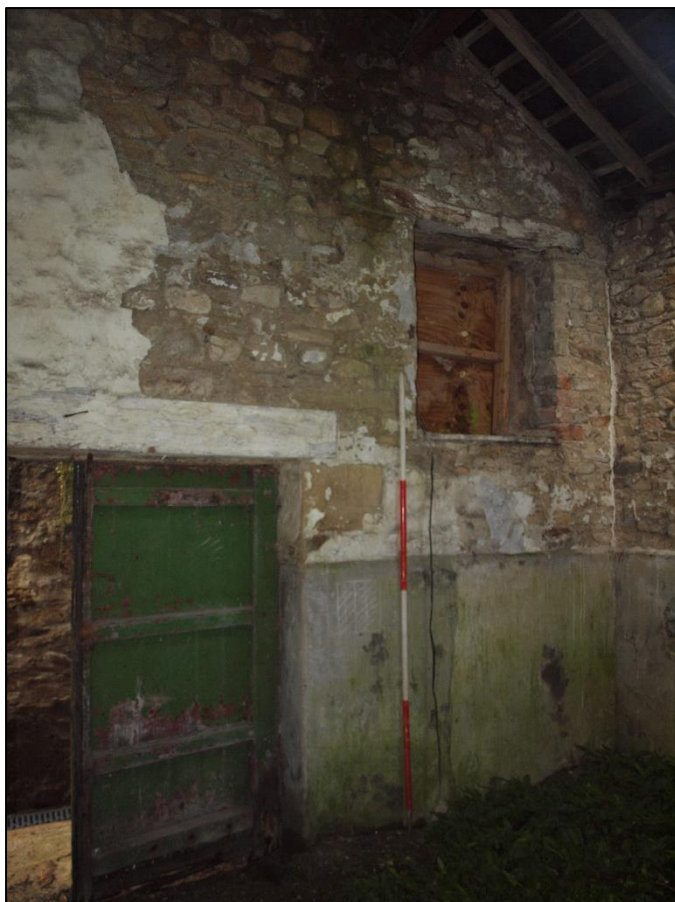
- 6.9 To the north, was a small central room (plates 76 & 77), accessed via the southern and central of the three doorways in the west gable. A further brick wall had been inserted to the north and the scar of a removed brick wall lay in the centre of the room aligned east = west, and separating the two doorways. Only the door to the southern doorway remained, with a timber baton braced door hung internally. The northern room (plates 77 – 80) was accessed via the northern double doorway in the west gable. The lower part of this room was cement rendered with whitewashed stone above. The southern wall was brick, with the three ventilation holes visible at first floor level. No first floor was present here, with no evidence of former joist holes. In the northern stone wall a pair of small niches were present high in the face, although appeared very rough, as if due to decay.

Plate 78: Doorway with pitching eye over in west wall
