**BAT PRESENCE / ABSENCE SURVEY**

**Black Moss Farm**

Elmridge Lane  
Chipping  
Preston  
Lancashire  
PR3 2NY

Date: 9<sup>th</sup> September 2024  
UES reference: UES03941/08

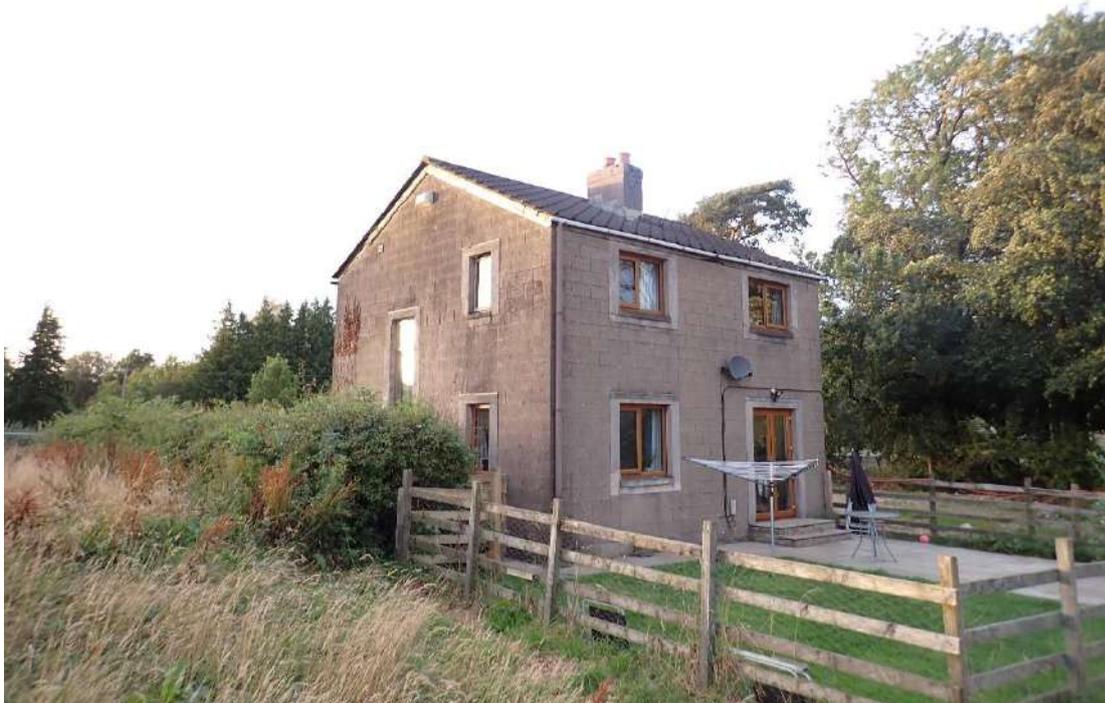
Photograph 1 – View of the southern aspect of Building 1.

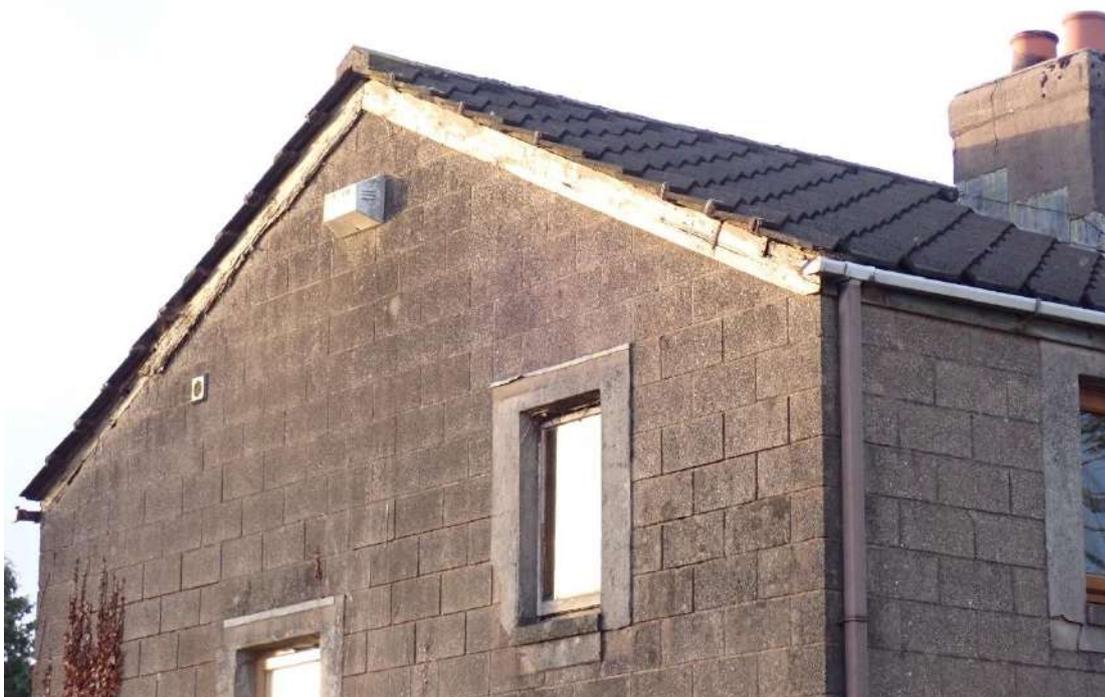
Photograph 2 – View of the pitched roof and western gable end of Building 1.

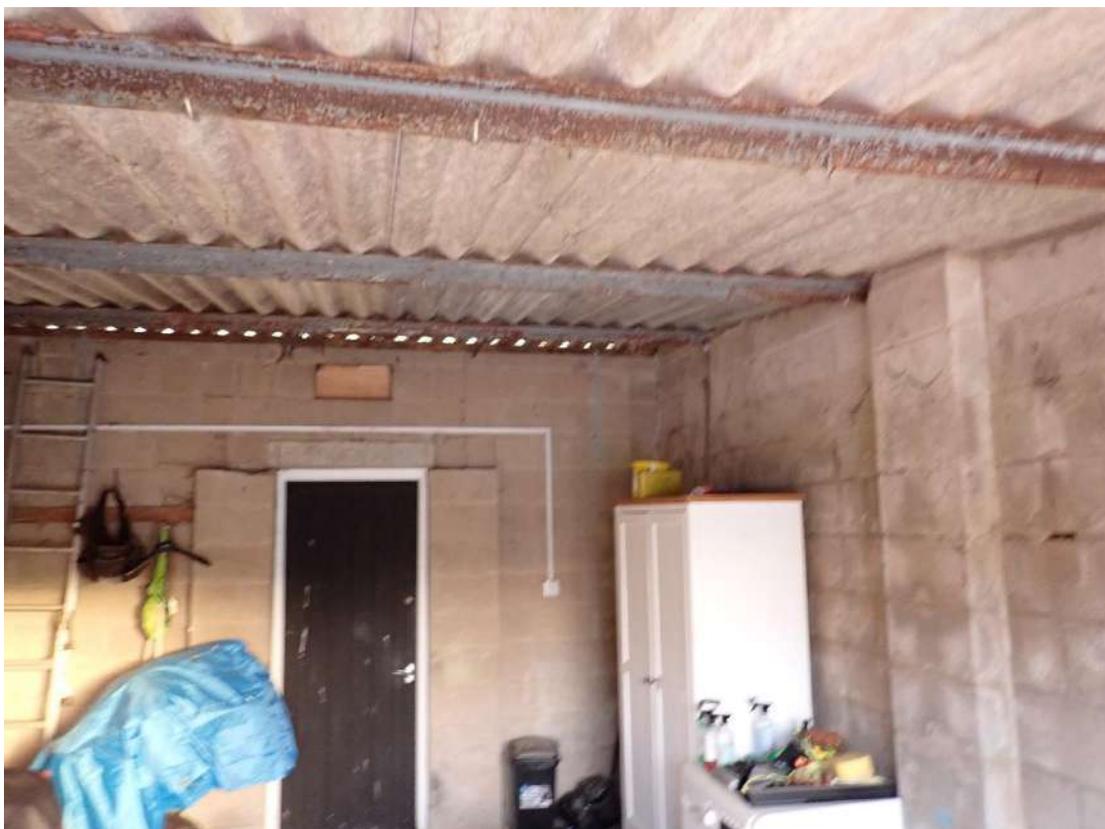
Attached to Building 1 is a breezeblock garage with a lean-to roof (Photograph 7). The garage is constructed from corrugated asbestos with slate barge boards along the eaves. Gaps were identified underneath the fascia boards which may provide a PRF for bats (Photograph 8). Where the lean-to roof connects to Building 1 there is lead flashing which is in good condition (Photograph 9). Nesting swallows *Hirundo rustica* were recorded entering and exiting the garage during the internal building inspection.

Photograph 8 – Internal view of the gaps behind the fascia boards in the garage attached to Building 1.

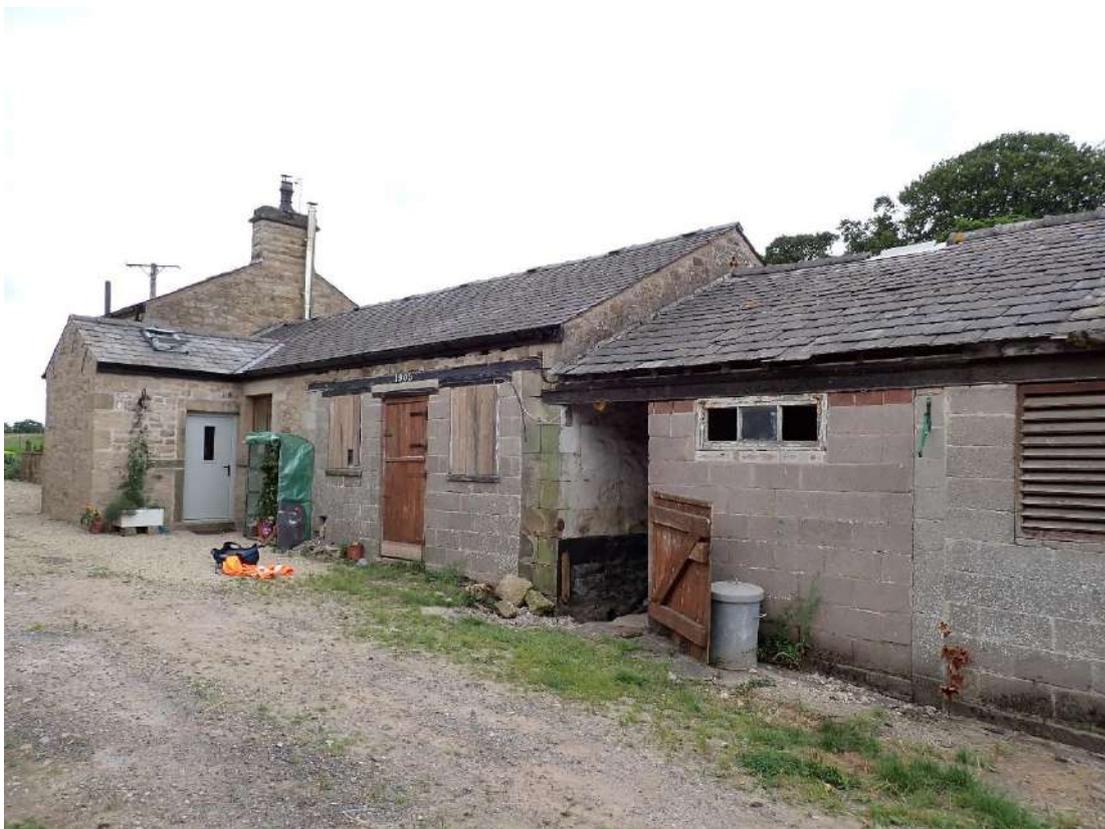
Photograph 10 – View of the pig sty forming the eastern section of Building 2.

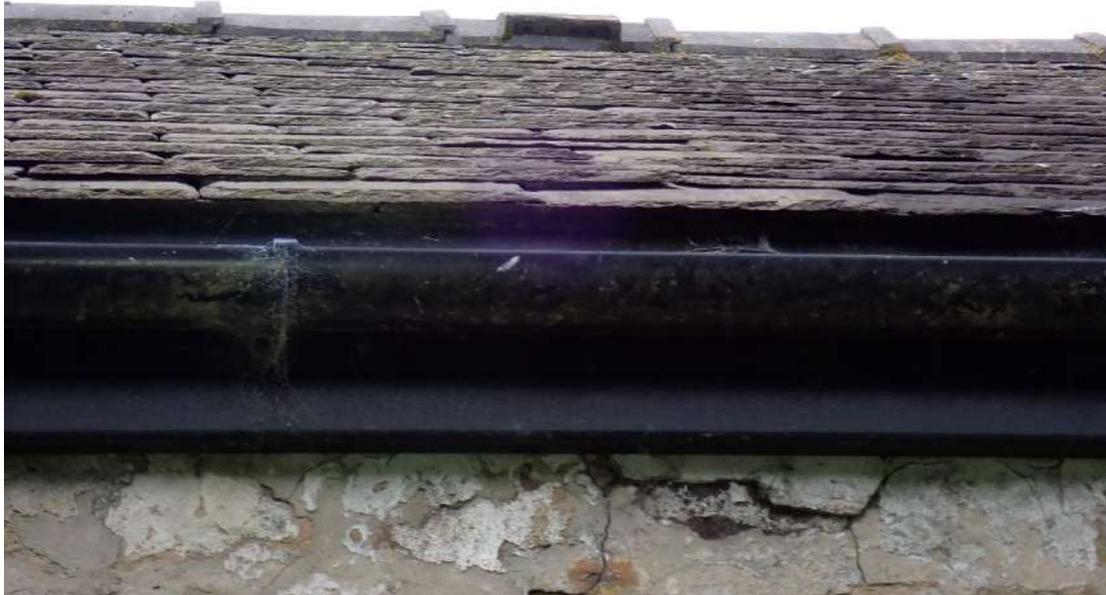
The eastern section of the building is a pigsty (Photograph 10). It has a pitched roof constructed from slate tiles which are raised and missing in places (Photograph 11). Sections of the ridgeline are also missing forming PRFs (Photograph 12). Access points were identified due to the presence of gaps within the mortar along the edges of the roof (Photograph 13).

Photograph 11 – View of PRFs formed from raised roof tiles on the eastern section of Building 2.

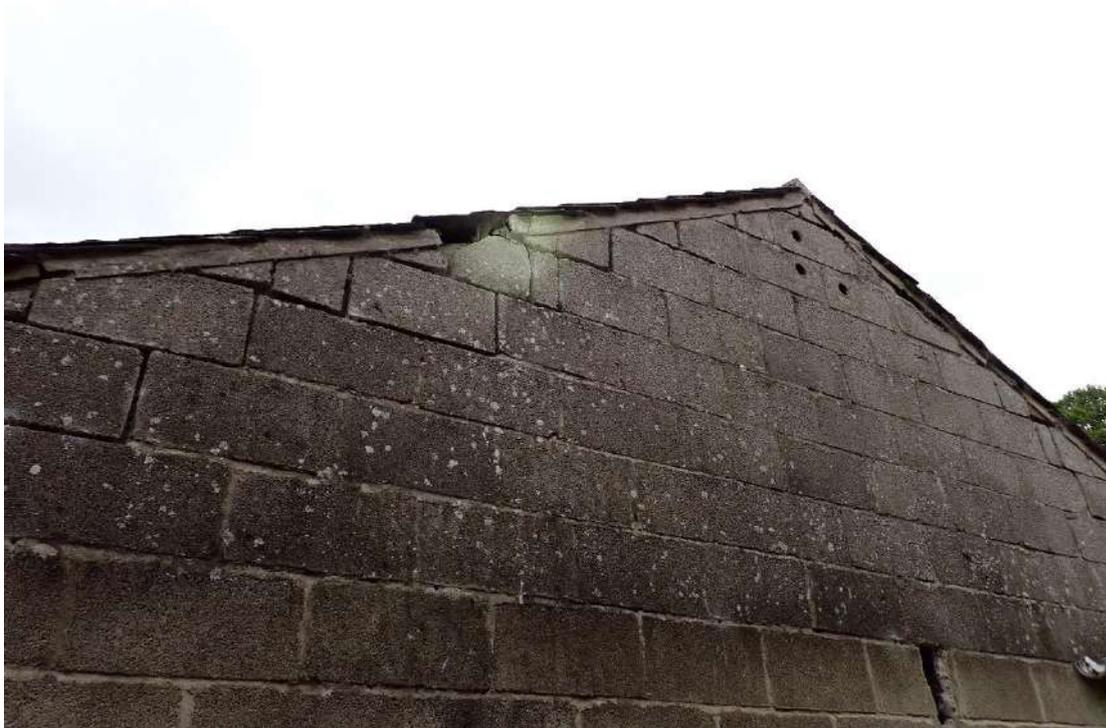
The eaves of the pigsty are comprised of wood and metal joists (Photograph 14). Numerous cavities and access points were found to be associated with the breezeblock walls (Photographs 15 and 16), and the stone-line along the southern eaves of the building (Photograph 17). While some of the windows have been boarded over (Photograph 18), others have been left open and provide free access into the building (Photograph 19). Nesting swallows were recorded entering and exiting the pigsty during the internal building inspection.

Photograph 15 – View of access points into the wall cavities of Building 2 via areas of damaged brickwork at the eastern gable end.

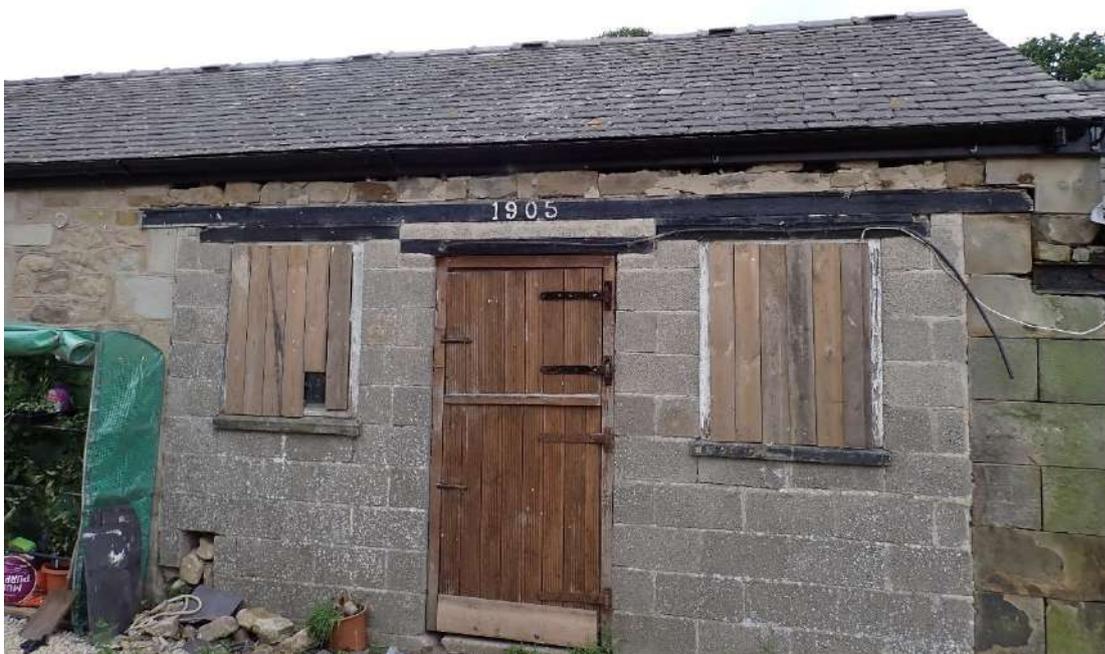
Photograph 18 - View of boarded over windows in on the southern aspect of the eastern section of Building 2.

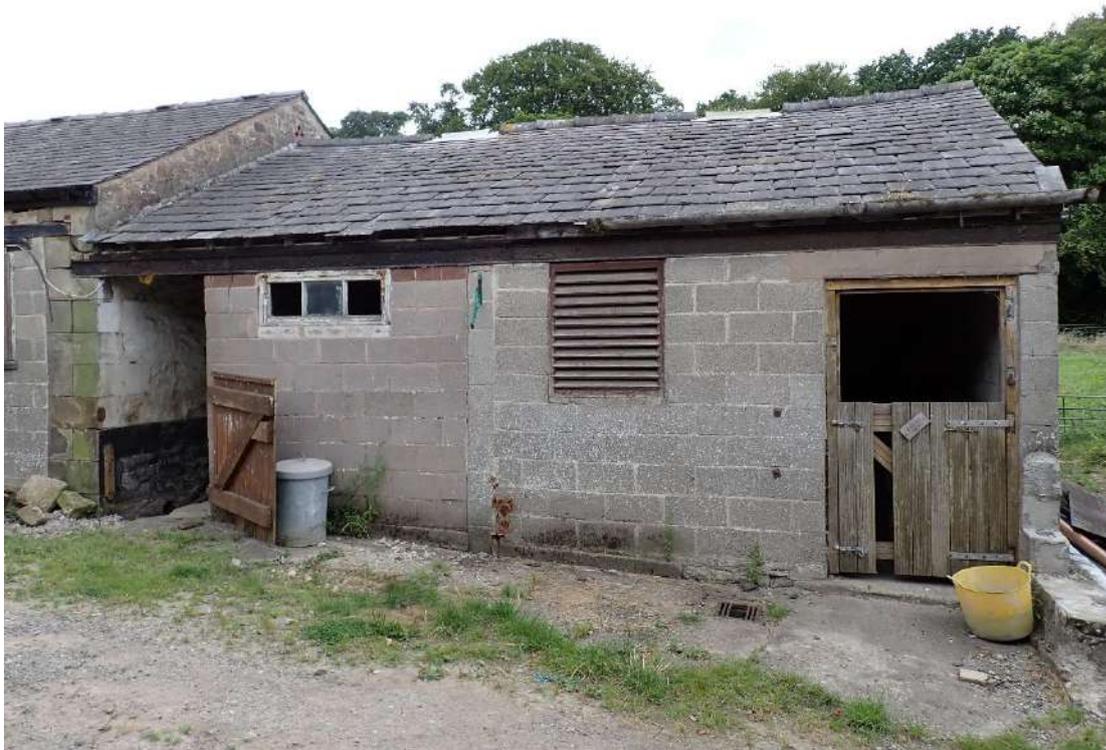
Photograph 19 - View of the open windows allowing access to the interior of the eastern section of Building 2.

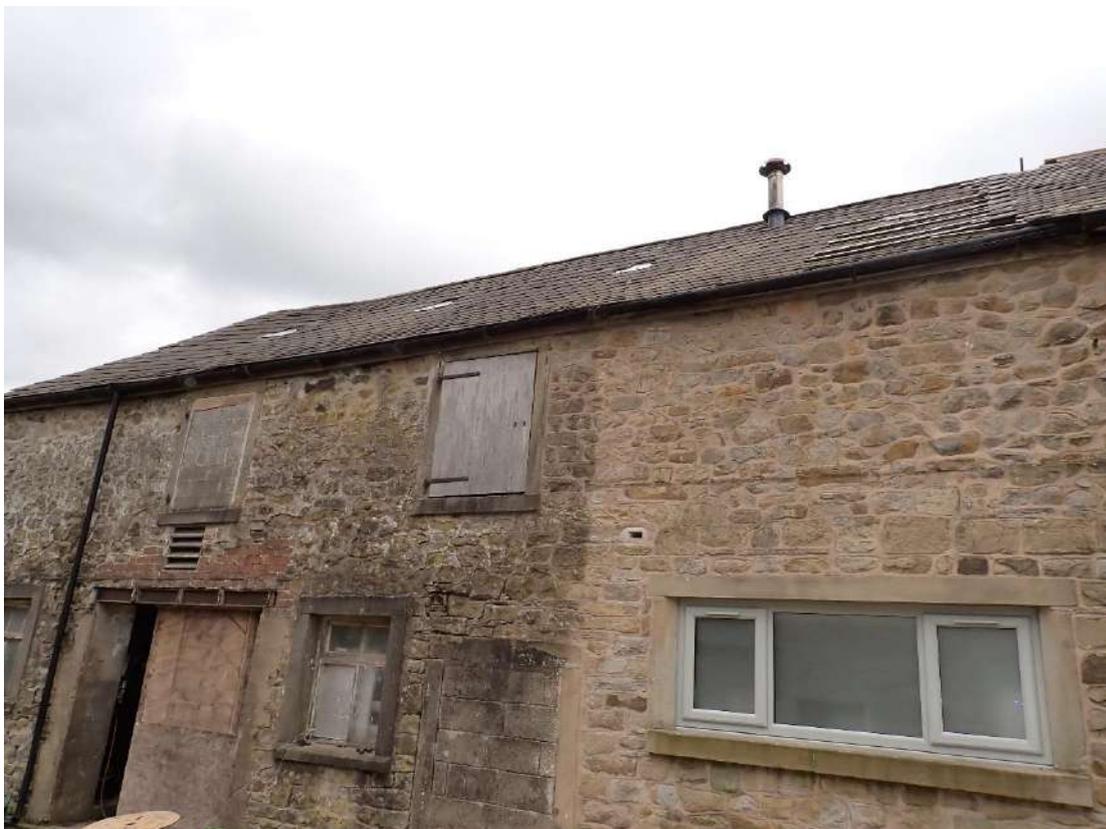
Photograph 20 – View of the northern aspect of Building 3.

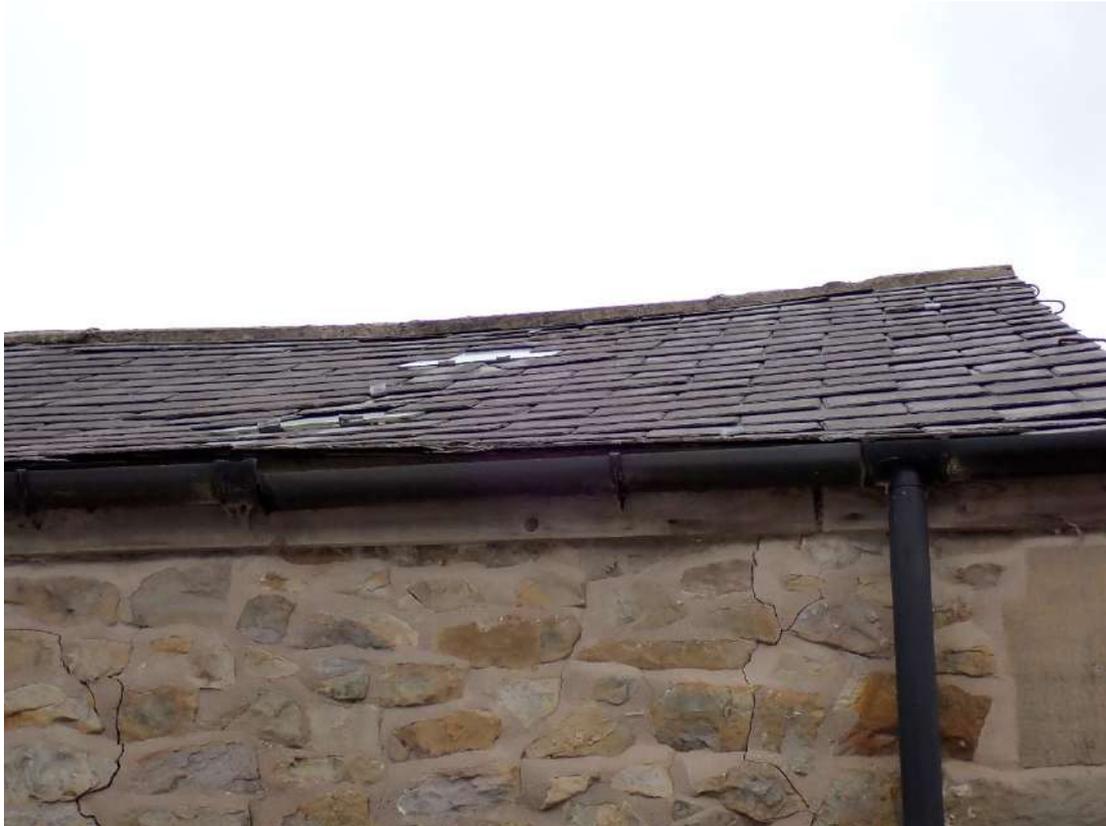
**Building 3** is a combined stone residential farmhouse and barn with a pitched roof constructed from slate tiles (Photograph 20). Some of the tiles are raised and provide PRFs for bats (Photograph 21). There are two stone chimneys which are surrounded by lead flashing where they connect to the roof, and skylights have also been incorporated (Photograph 22).

Photograph 21 - View of the raised tiles on the southern aspect of Building 3, forming PRFs.

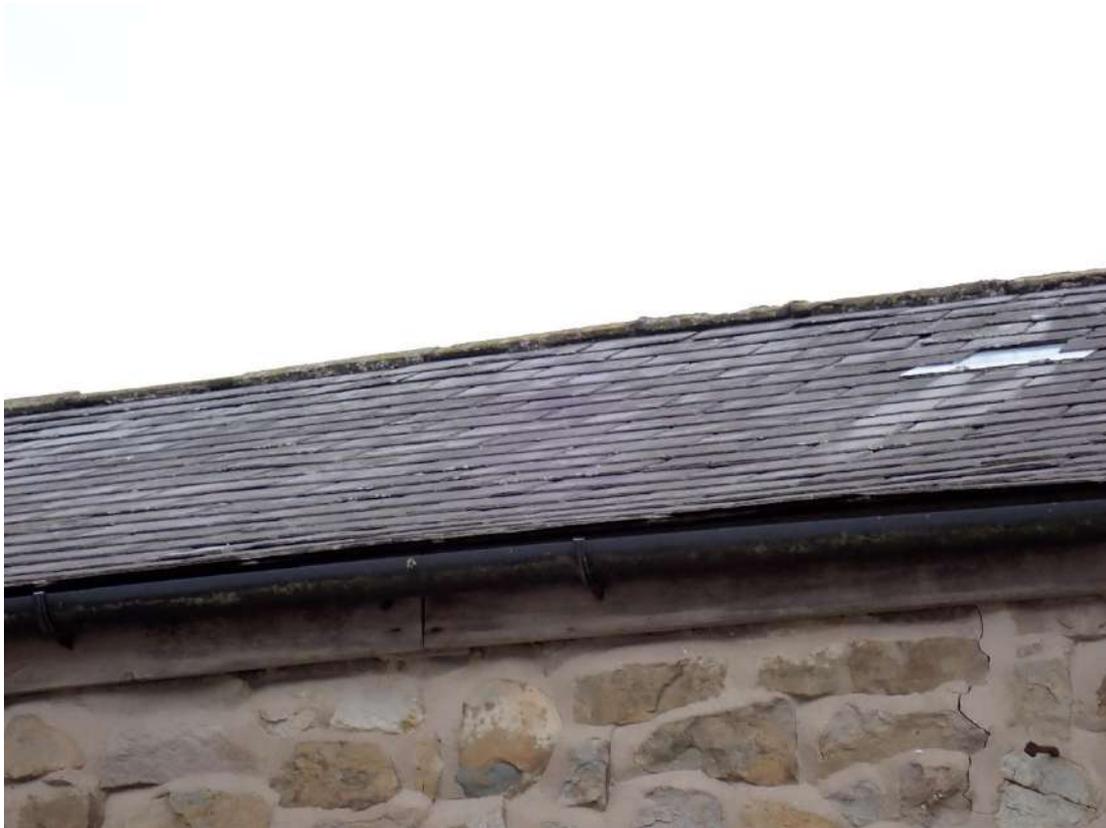
Wooden fascia boards are present along the eaves of the building and the external walls are constructed from stone. Potential access points were identified along the eaves of the building due to the presence of several gaps between the top of the wall plate and fascia boards (Photographs 23, 24 and 25). Four bat droppings were identified on the southern wall, directly below a gap underneath the wooden fascia board which leads into the stonework and onto the top of the wall plate (Photograph 26). The droppings were sent for eDNA analysis and were found to be common pipistrelle (see Appendix 6). The external walls contain several cracks and cavities between the stonework as well as missing mortar (Photograph 27). In addition, there are ventilation holes in the eastern gable end wall (Photographs 28 and 29). All of these features provide numerous PRFs.

Photograph 23 – View of the gaps behind the fascia board on the southern aspect of Building 3.

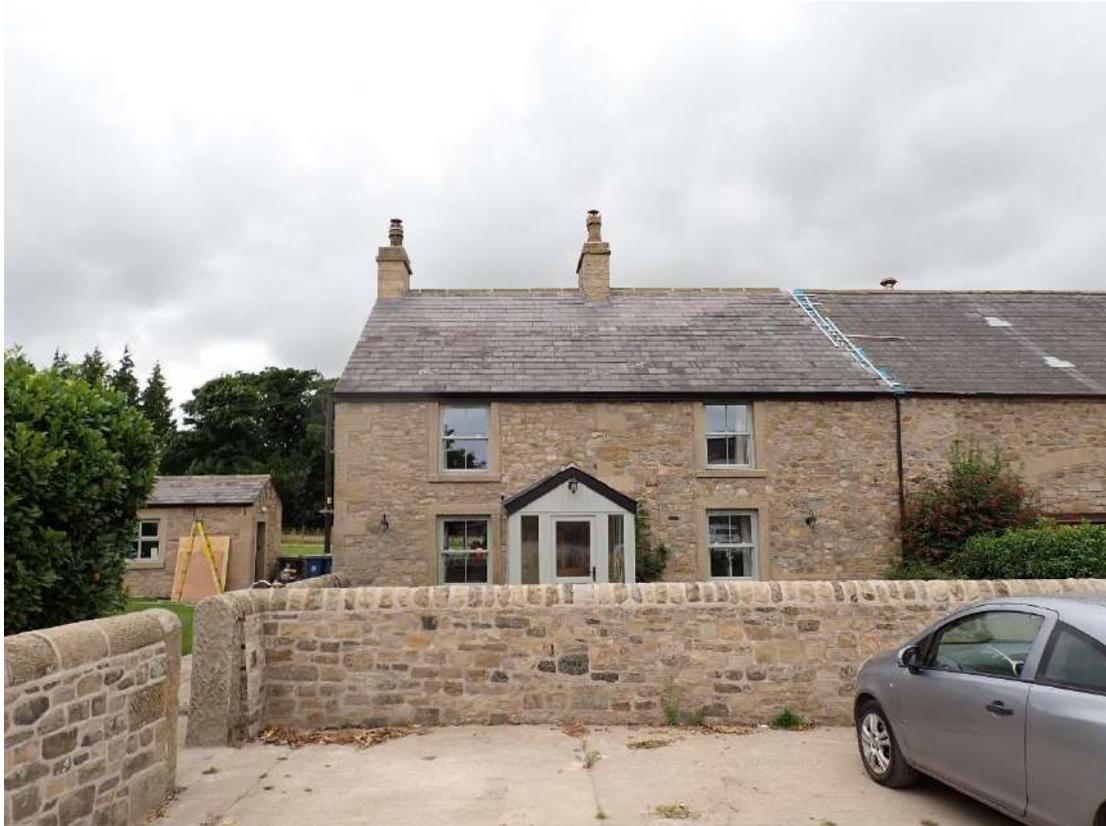
Photograph 31 - View of the porch on the southern aspect of Building 3.

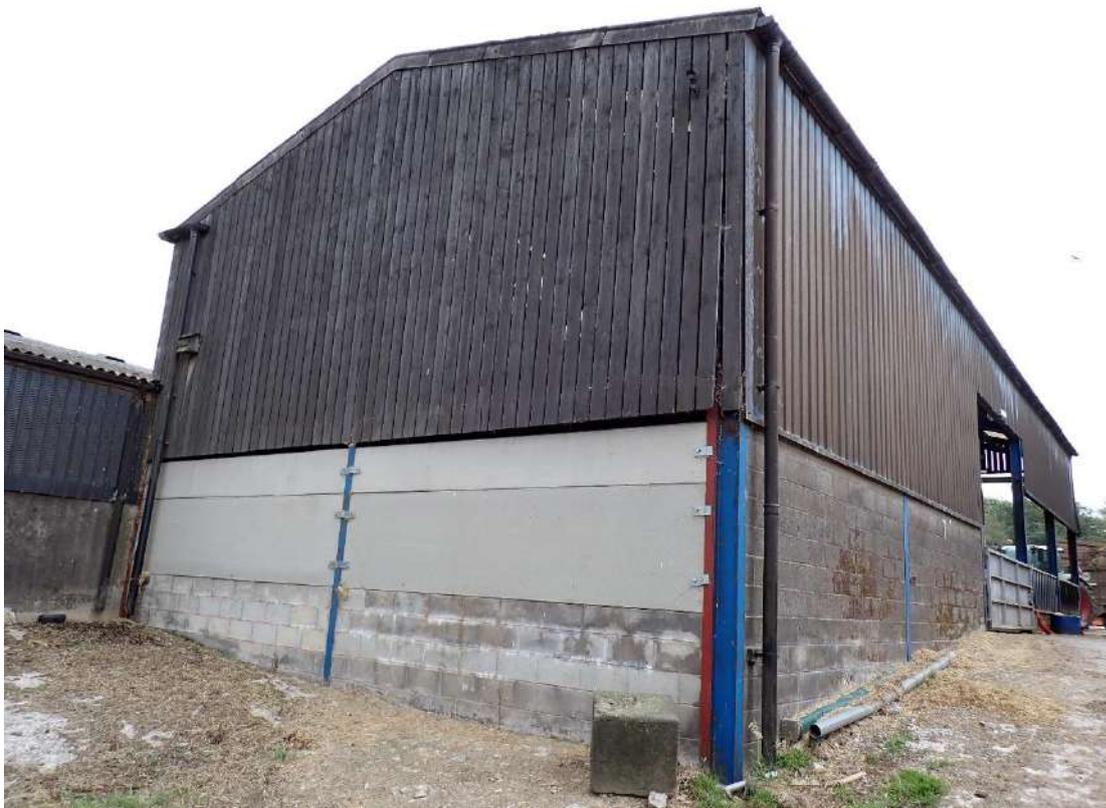
Photograph 32 - View of the gable end of Building 4.

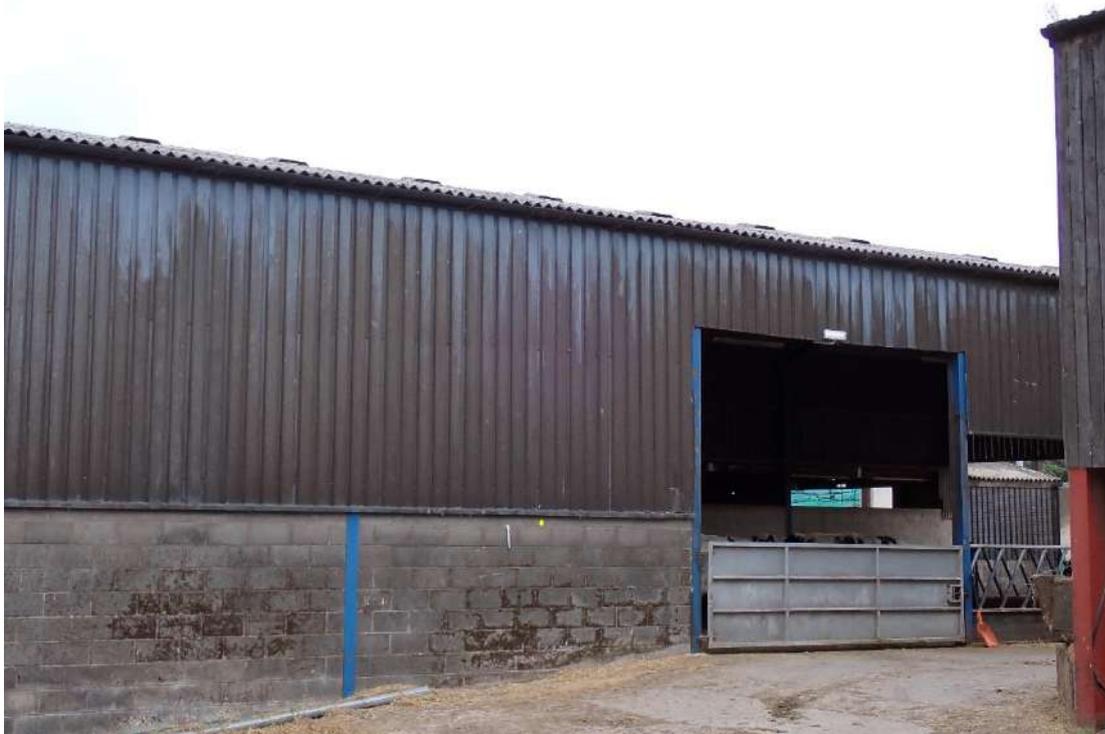
**Building 4** is an agricultural barn with a corrugated asbestos pitched roof (Photograph 32). Several skylights have been incorporated into the roof structure. The upper half of the external walls are constructed from a combination of timber and corrugated metal, whilst the lower half is a combination of breezeblock and concrete. As the building is an agricultural barn, there are large open areas within the external walls which provide direct internal access (Photograph 33). No potential roosting features found during the external inspection of Building 4.

Photograph 33 – View of the side wall of Building 4 showing the large entrance points allowing access into the interior of the building.

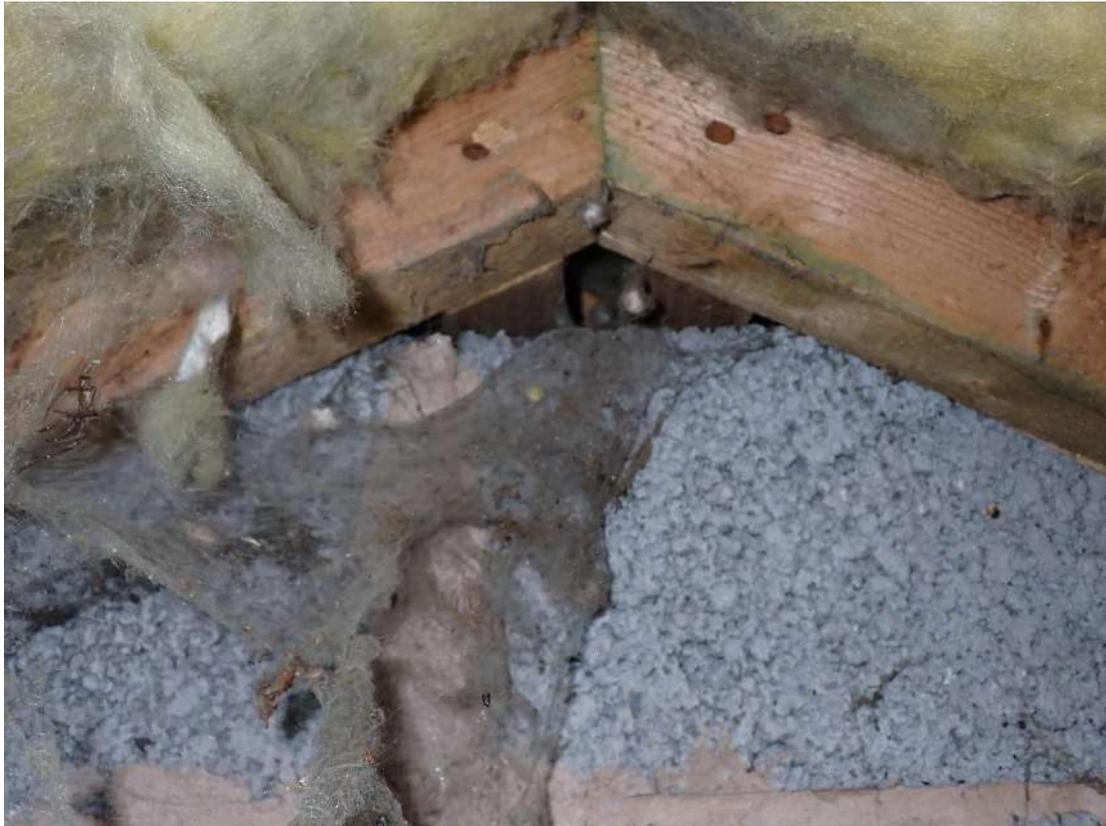
**Building 1** has a single loft space which is approximately 1.25m in height and 4m wide. It has timber rafters and purlins (Photograph 34). Cavities were identified above the western gable end wall which provide a PRF for bats (Photograph 35) and three droppings were identified on the wall during the internal building inspection. Both the roof and floor within the loft space are insulated with mineral wool, and numerous mouse droppings were identified on the floor insulation. The mineral wool also has a large hole in it allowing access to the underside of the roof (Photograph 36).

Photograph 35 - View of the gaps in the interior walls which allow access to the wall cavities.

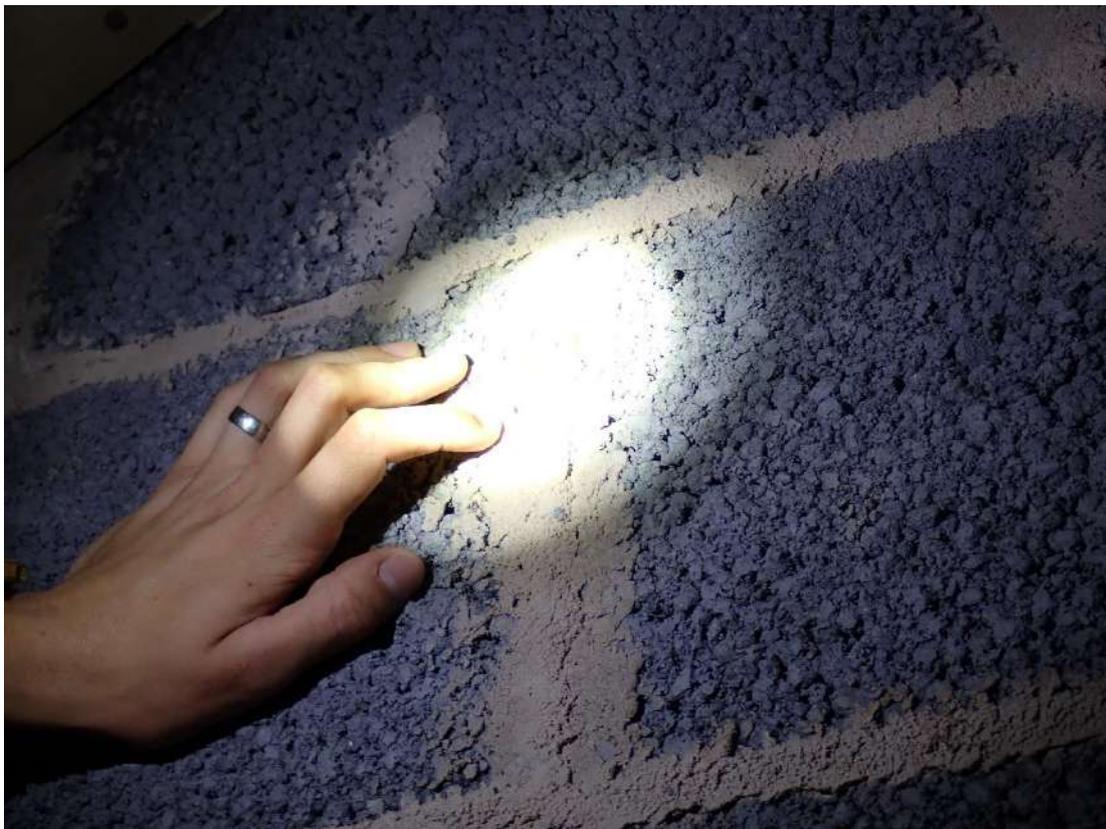
**Building 2** contains a single loft void which is located within the farmhouse and measures approximately 2m in height. The roof is lined with three layers of material: chipboard, insulation and a breathable membrane adjacent to the tiles (Photograph 37). The floor of the loft space has been lined with a chipboard sheeting. Approximately 20 scattered bat droppings and a small number of underwing moth wings were found on the floor and walls at the gable ends (Photographs 38). The bat droppings were sent for eDNA analysis and were found to be common pipistrelle.

Photograph 38 - View of bat droppings located on the walls at the gable ends of loft void of Building 2.

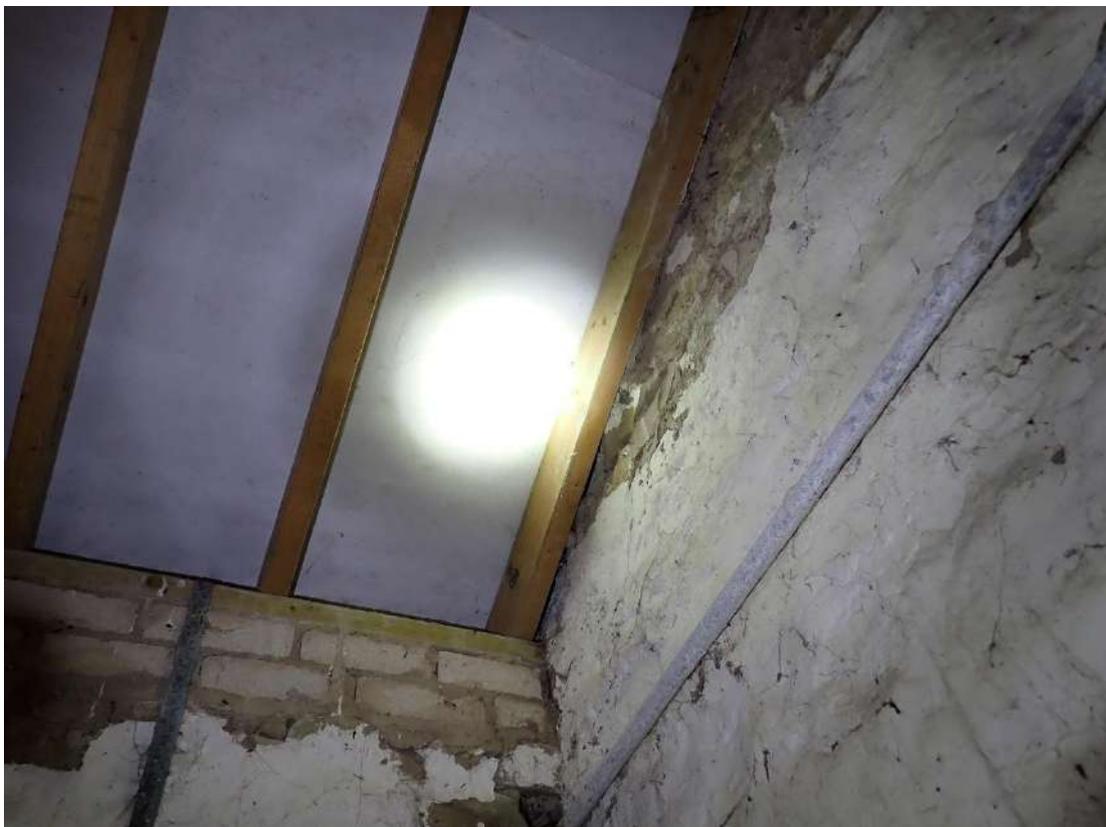
Photograph 40 – View of the PRFs in the gable ends where the timber of the roof ends.

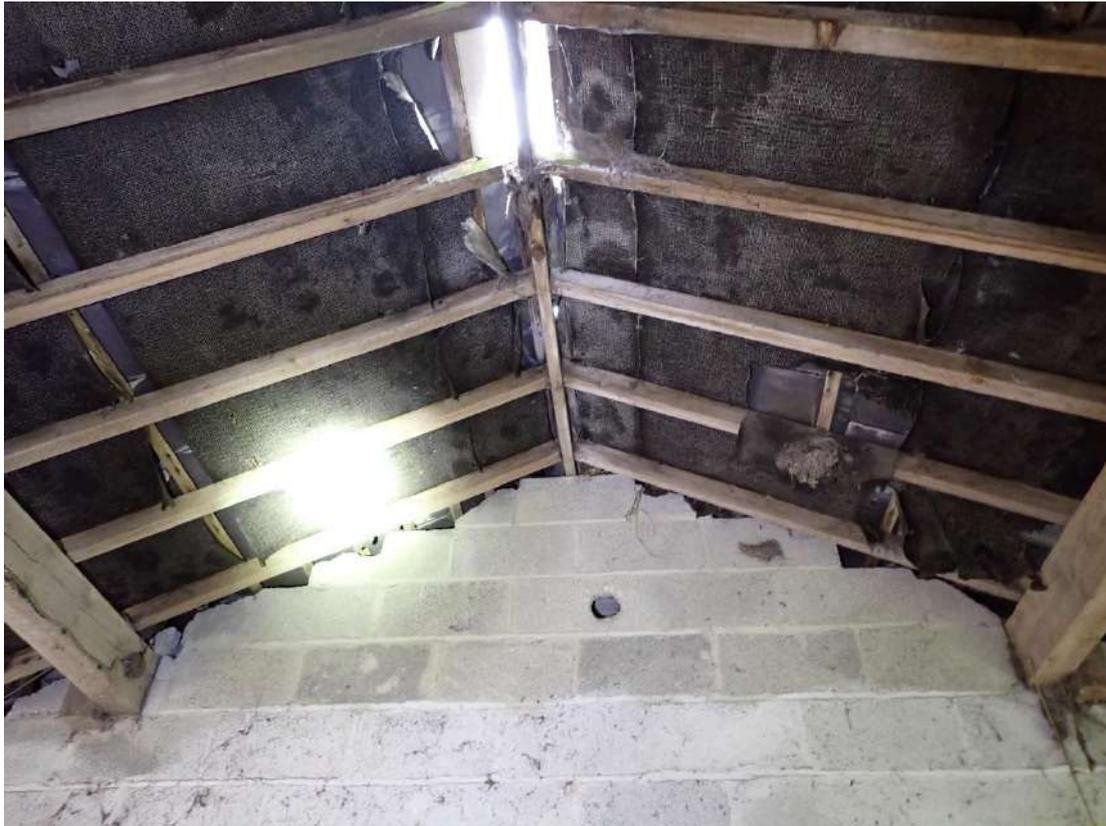
Photograph 43 - View of the damaged section of the bitumen lining of the middle room of the pig styes in Building 2.

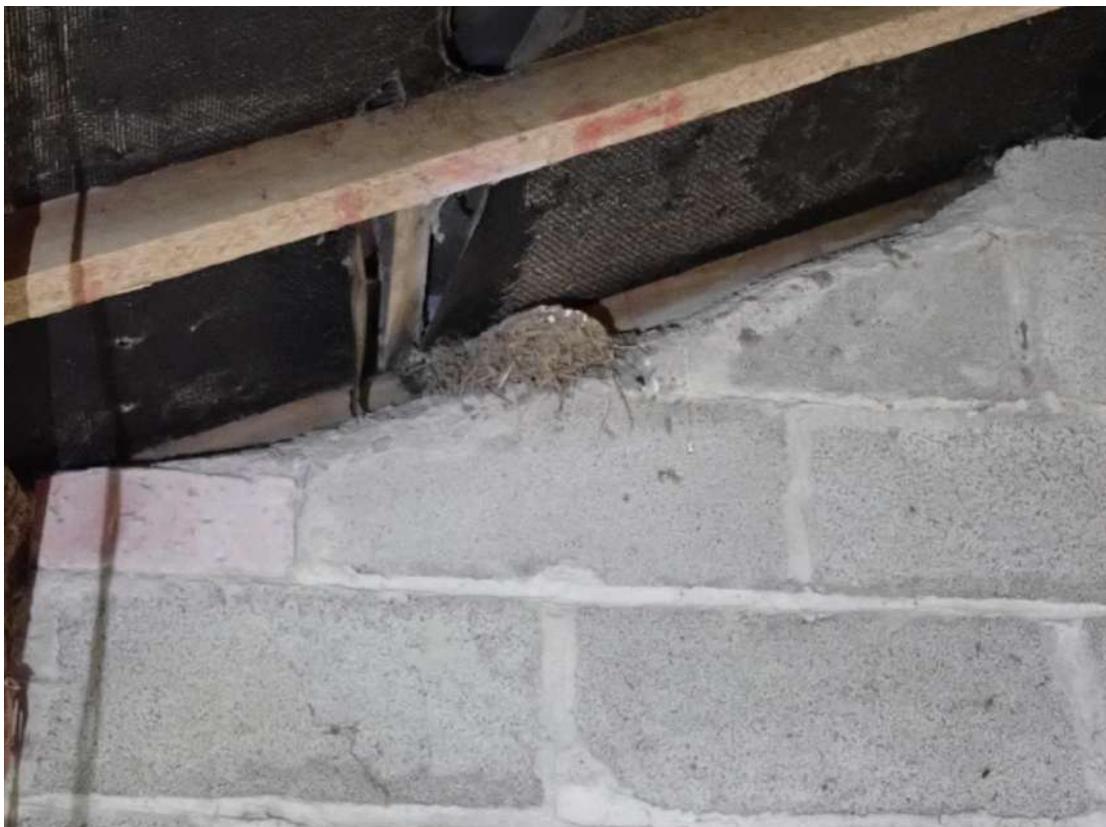
Swallows were recorded nesting within all three rooms of the pigsty (Photograph 50). No bat droppings were identified within the pigsty however, it was difficult to determine due to the many hundreds of swallow droppings and clutter associated with the open working barn.

Photograph 50 – View of the swallow nest located in the pig sty section of Building 2.

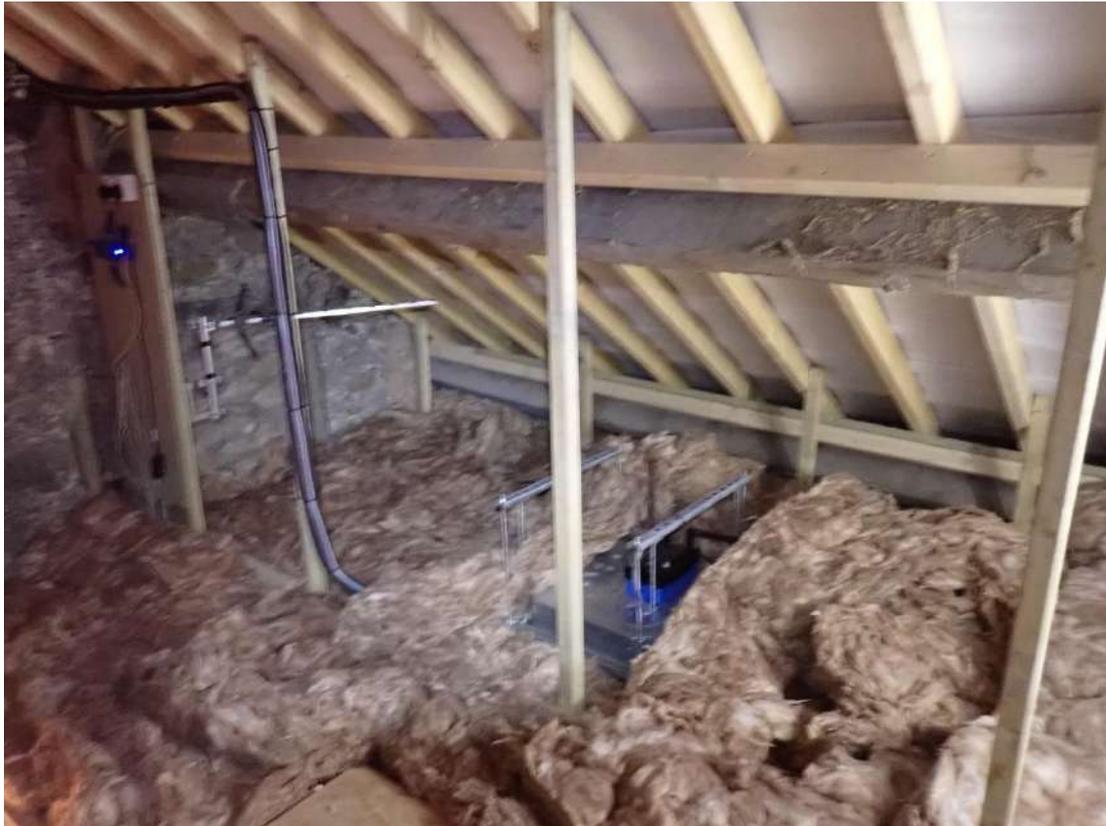
Photograph 51 - View of the internal loft space located within the farmhouse section of Building 3.

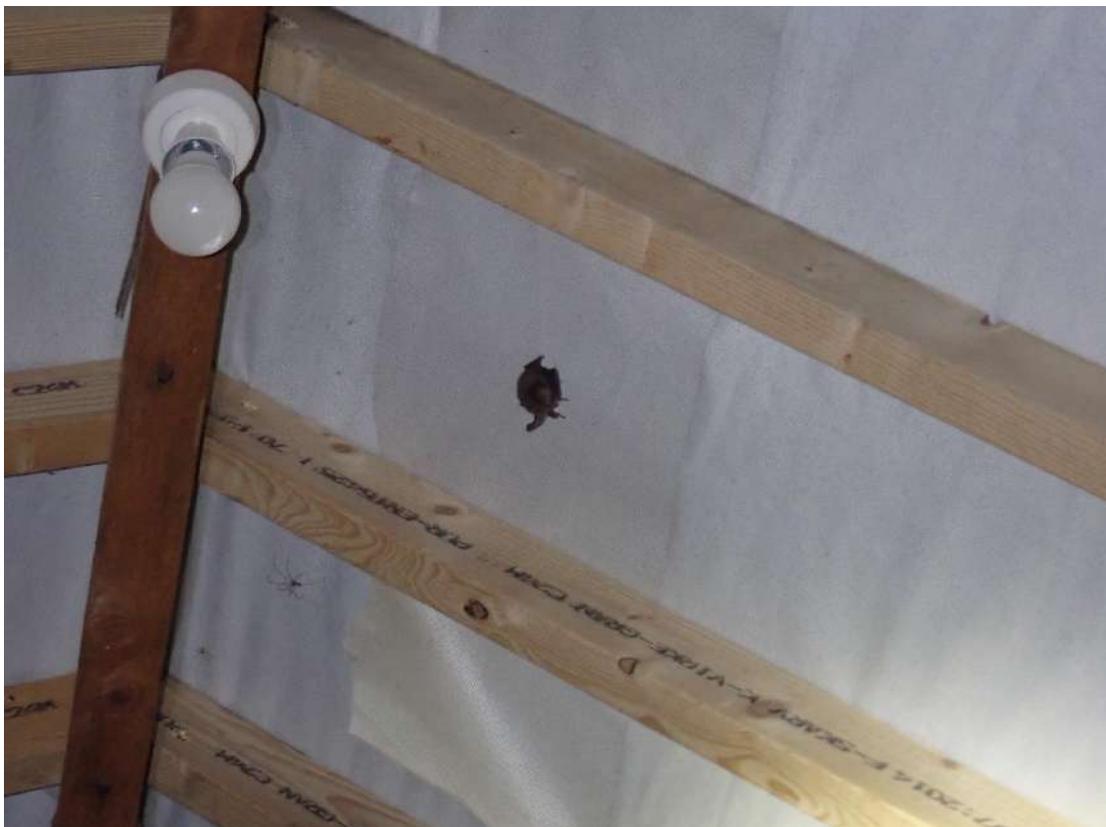
Photograph 52 – View of the brown long-eared bat on the breathable membrane lining the loft in the farmhouse section of Building 3.

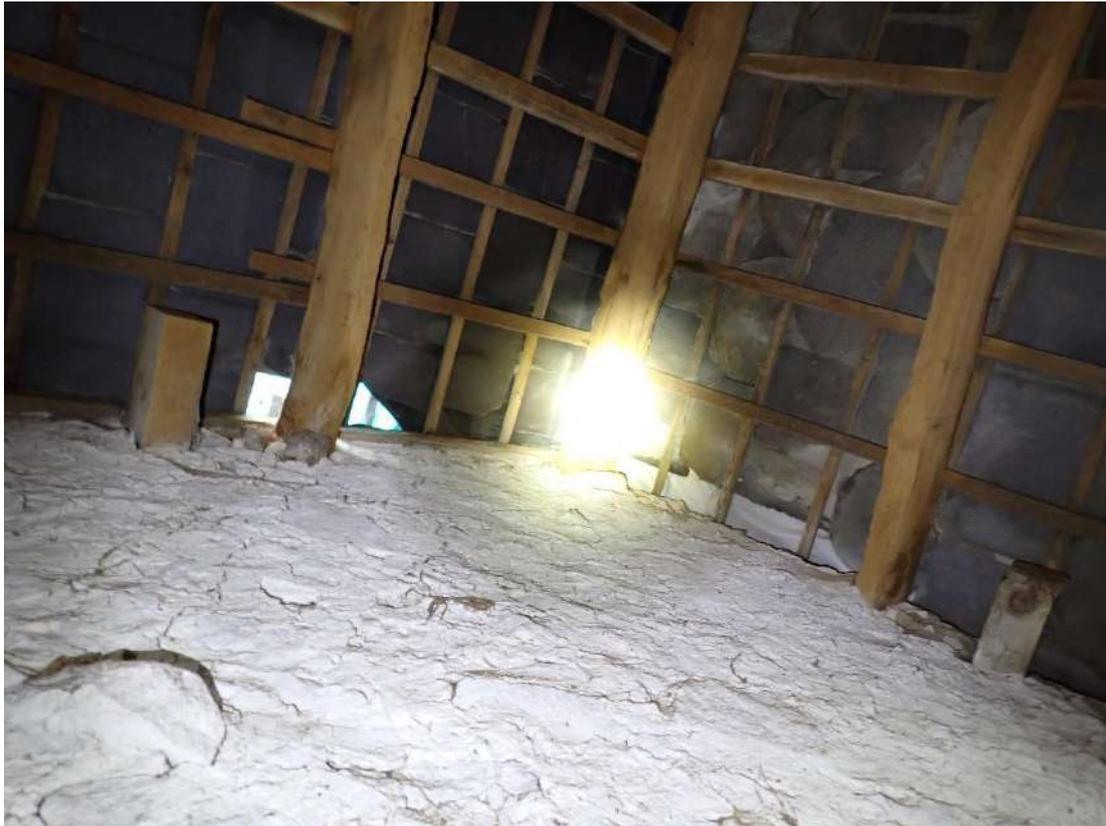
Photograph 57 – View of the underside of the roof of the barn section of Building 3, showing gaps in the tiles and an absence of lining.

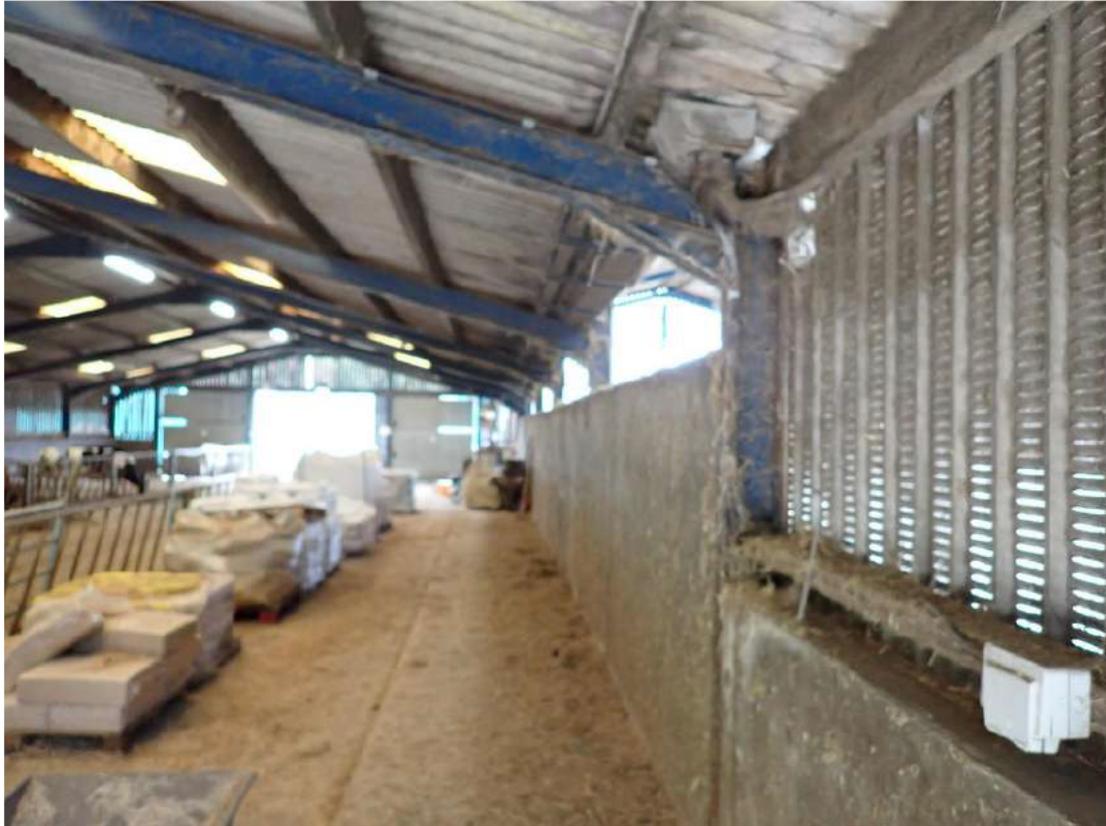
Photograph 67 – View of the interior of Building 4 showing the well lit and exposed conditions inside the building.

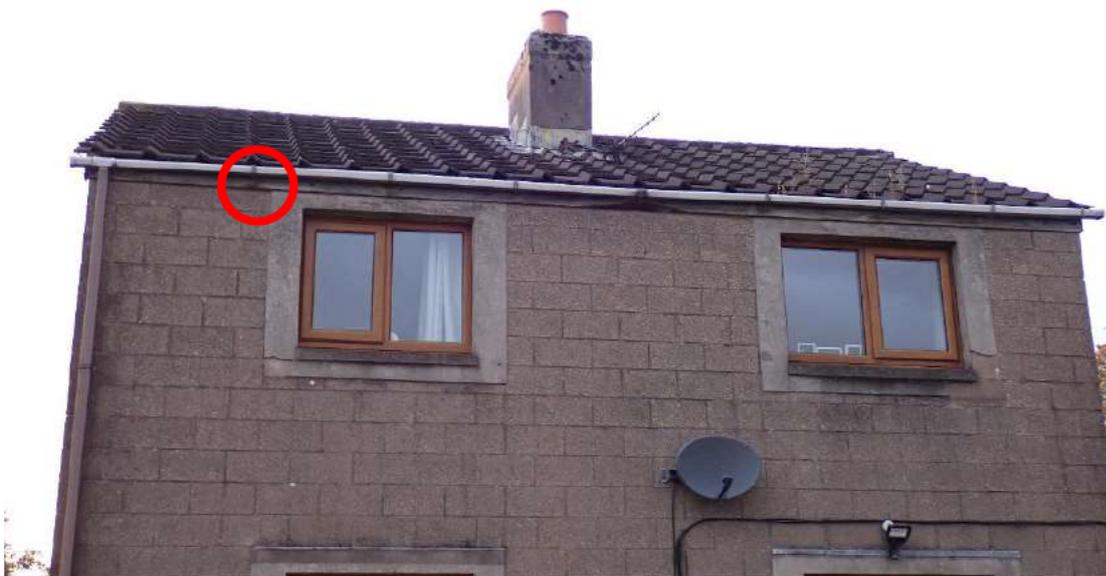
Photograph 68 – View of the southern aspect of Building 1 with Roost 1 circled in red.
