**BAT PRESENCE / ABSENCE SURVEY**

**Black Moss Farm**

Elmridge Lane  
Chipping  
Preston  
Lancashire  
PR3 2NY

Date: 9<sup>th</sup> September 2024  
UES reference: UES03941/08

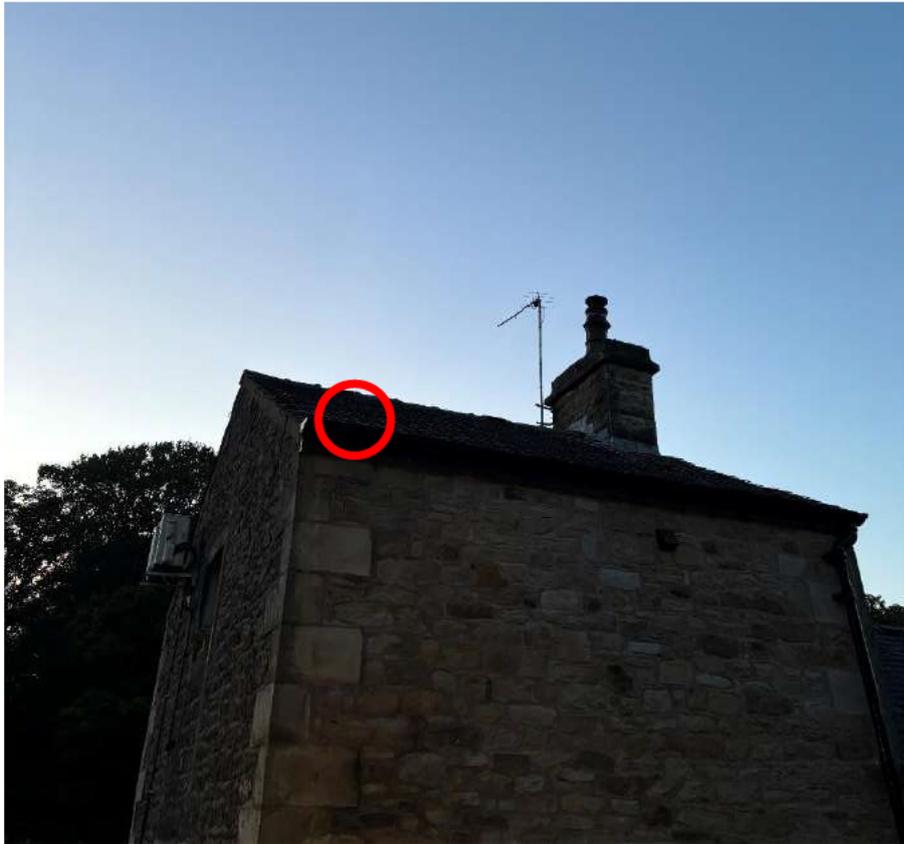
Photograph 69 – View of the entrance to Roost 3 circled in red, located on the western aspect of Building 2.
