Kirk Mill, Chipping, Lancashire

Archaeological Building Investigation

Oxford Archaeology North

August 2013

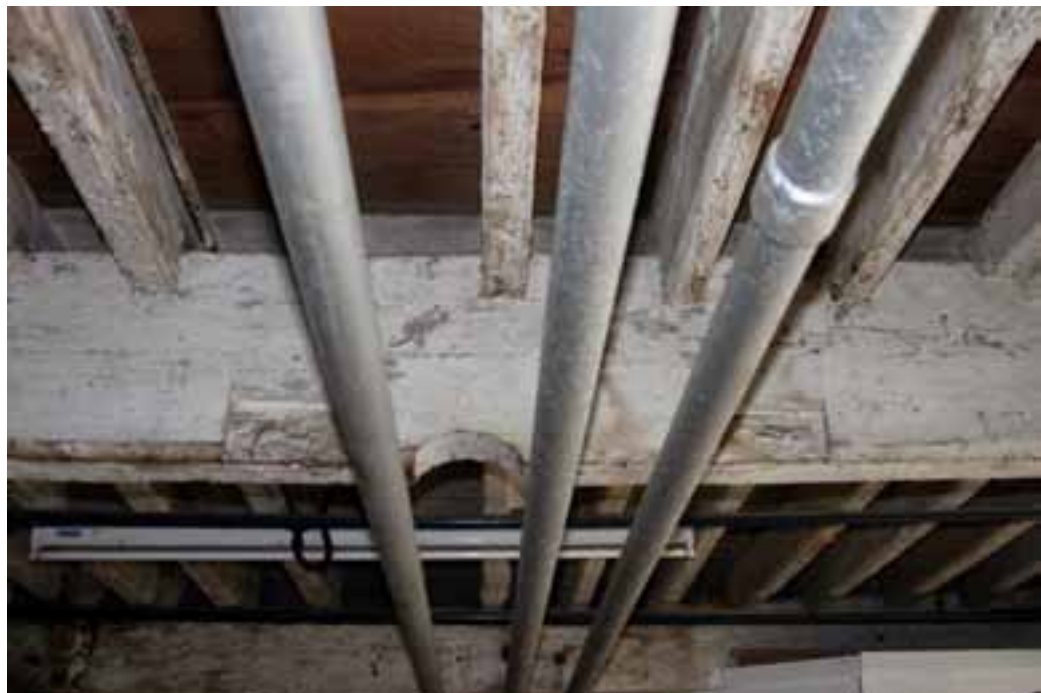
3.3.10 The beams house evidence for three distinct power systems. The earliest was placed in the second bay from the north wall of the original structure and comprised semi-circular cut-outs, presumably for timber shafting (Plate 32). The fourth beam from the west end has the cut-out for this shaft only on its eastern face, whilst the cut-out in the beam to the east is shallow, and offset to the north, suggesting jointing in the shafting. The adjacent beam has no evidence for this shaft, whilst that in the penultimate beam lies significantly to the south, flanked by 8¼ x 4x1½" cut-outs at the base of the western face (Plate 38). In the eastern bay, the cut-out is placed slightly north of the centre line.

Plate 38: Semi-circular cut-out in ceiling beam soffit for original line shafting

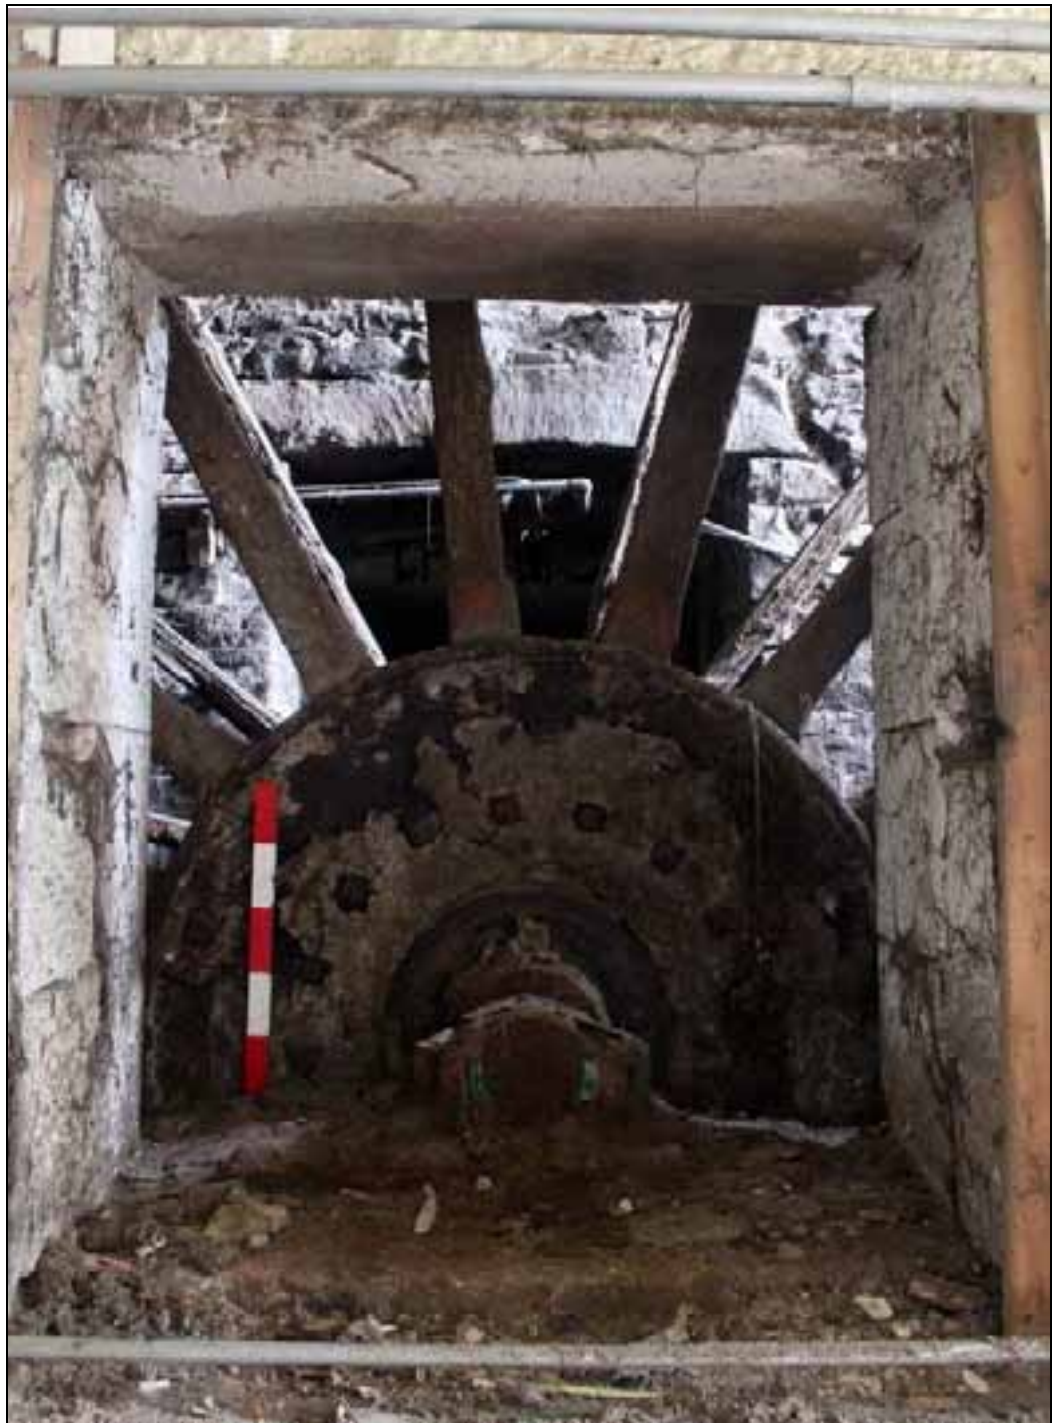
3.3.18 The east wall has a brick-blocked doorway at its southern end, adjacent to a full-height doorway in the south wall, which appears original. The west wall has a corbel at its northern end, placed below beam height in the main structure to the west, but significantly below the rebuilt ceiling within this bay. A 3' 6" x 4' 6" aperture to the south houses the axle of the extant waterwheel, and is of dressed block construction (Plate 46). The 5¼" diameter iron axle has a phosphorus bronze lining to its mounting, the top plate of which has been removed (Plate 46).

Plate 46: Waterwheel axle

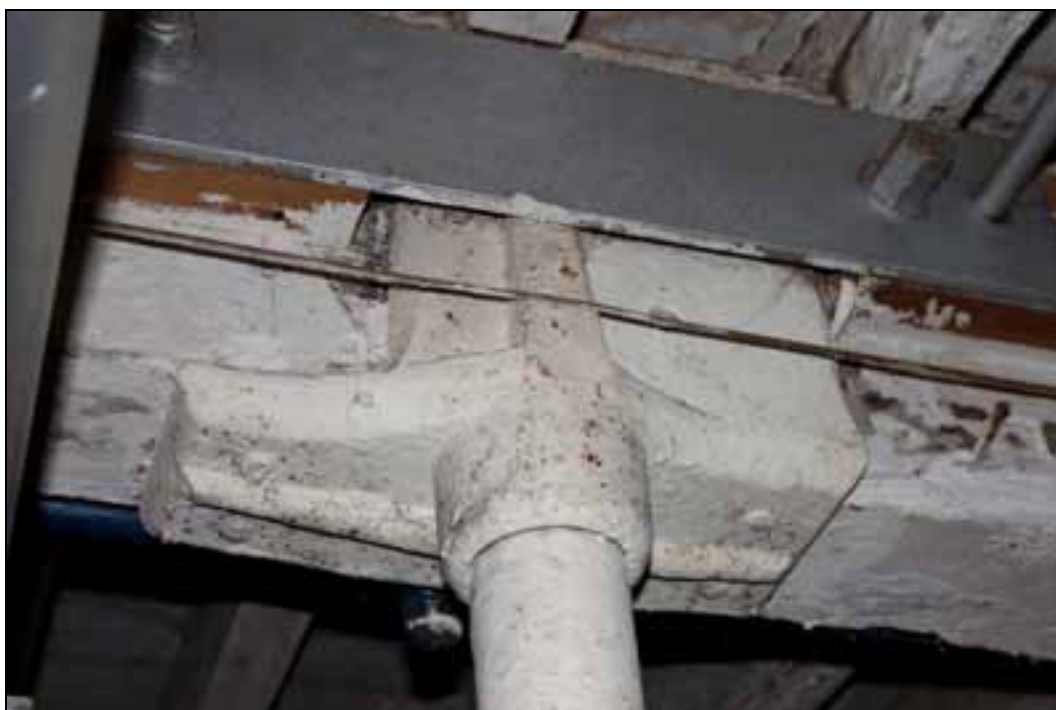
- 3.3.23 All beams have narrow cast-iron columns placed below the scarf joint, with that below the fifth beam having an L-section head plate, offsetting the column to the western side of the beam (Plate 53). Many of the other columns have significant lean, particularly the eastern three bays (Plate 54). The flooring of the main mill at first-floor level comprises 5½" and 4½" north/south-aligned boards.

Plate 53: L-section column head plate

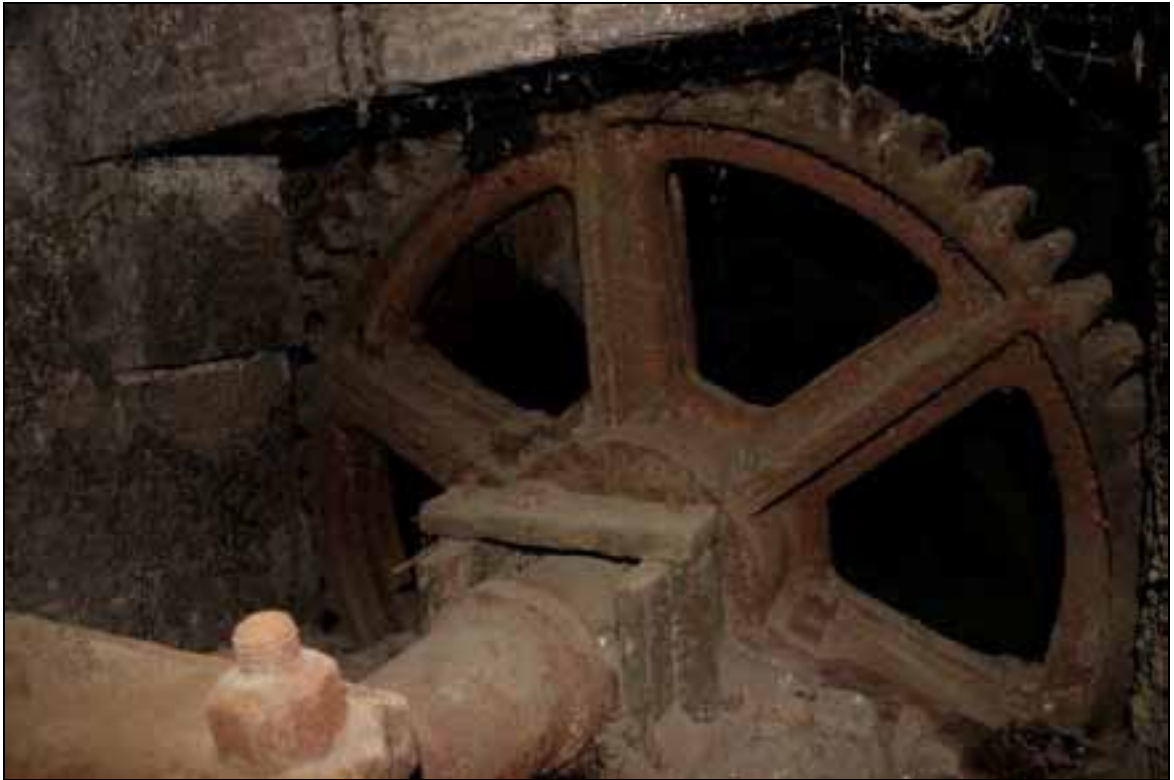
Plate 65: Axle and bearing of pinion wheel

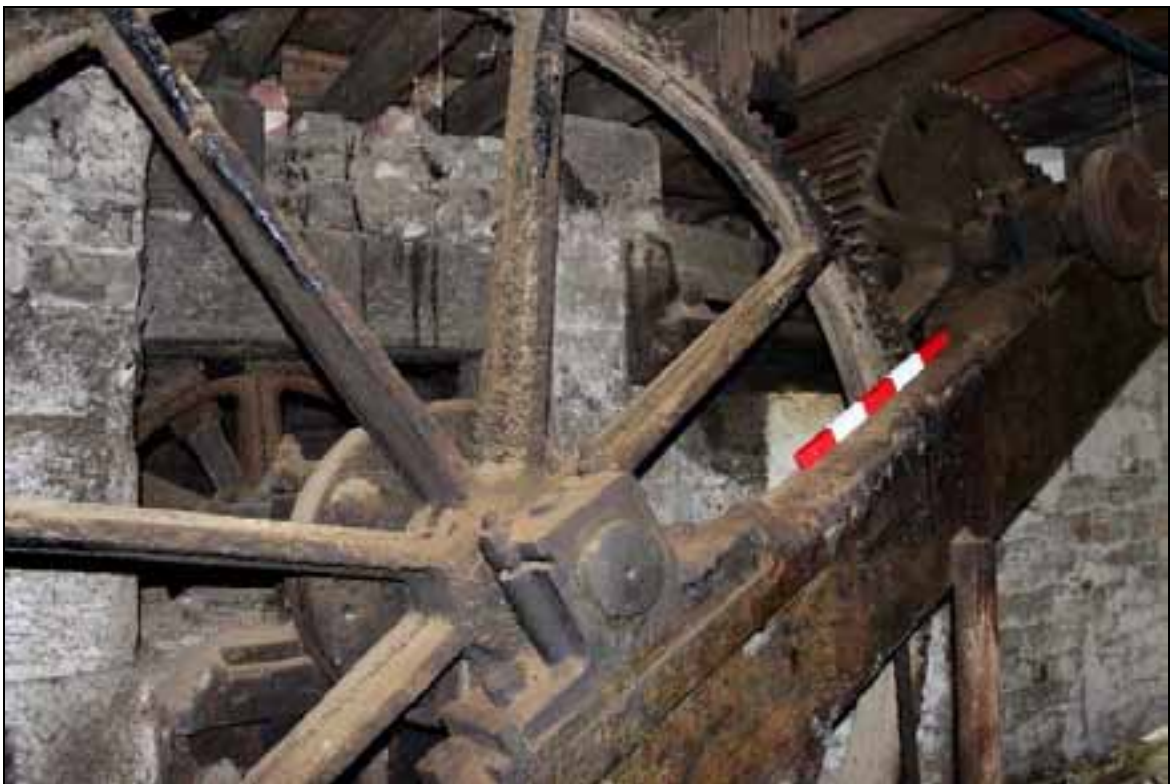
Plate 66: 8' gearing wheel on pinion wheel axle

- 3.3.29 A shaft driven by the 2' wheel extended immediately below the ceiling beam towards the spinning room to the west, and terminated in what appears to have been a clutch plate, almost adjacent to the gear wheel (Plates 66 and 67). The great difference in size between the two wheels would have given a massive increase in the rotational speed of the line shaft, in comparison with that of the primary motion shaft, which again rotated at a much greater speed than the waterwheel itself. The clutch afforded the ability to disconnect the waterwheel gearing from the primary motion shaft, allowing it to be powered by the supplementary steam engine.

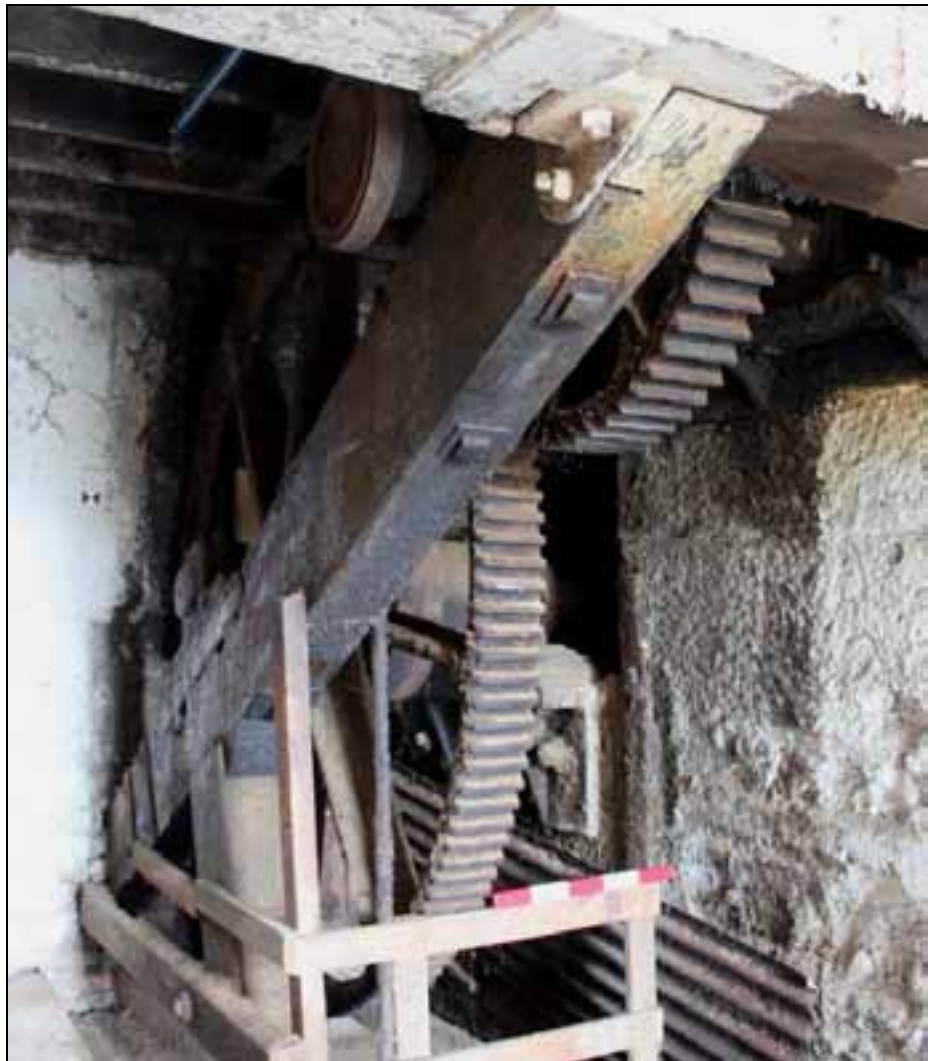
Plate 67: Gearing driven by pinion wheel, with clutch-plate on drive shaft

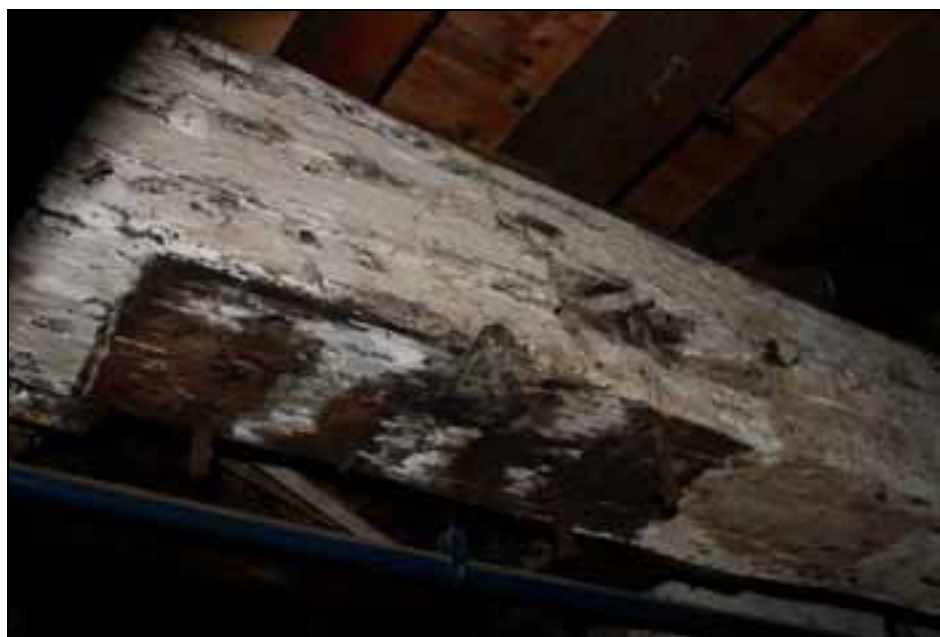
Plate 68: Compression scar and bolts associated with vertical shaft from steam engine

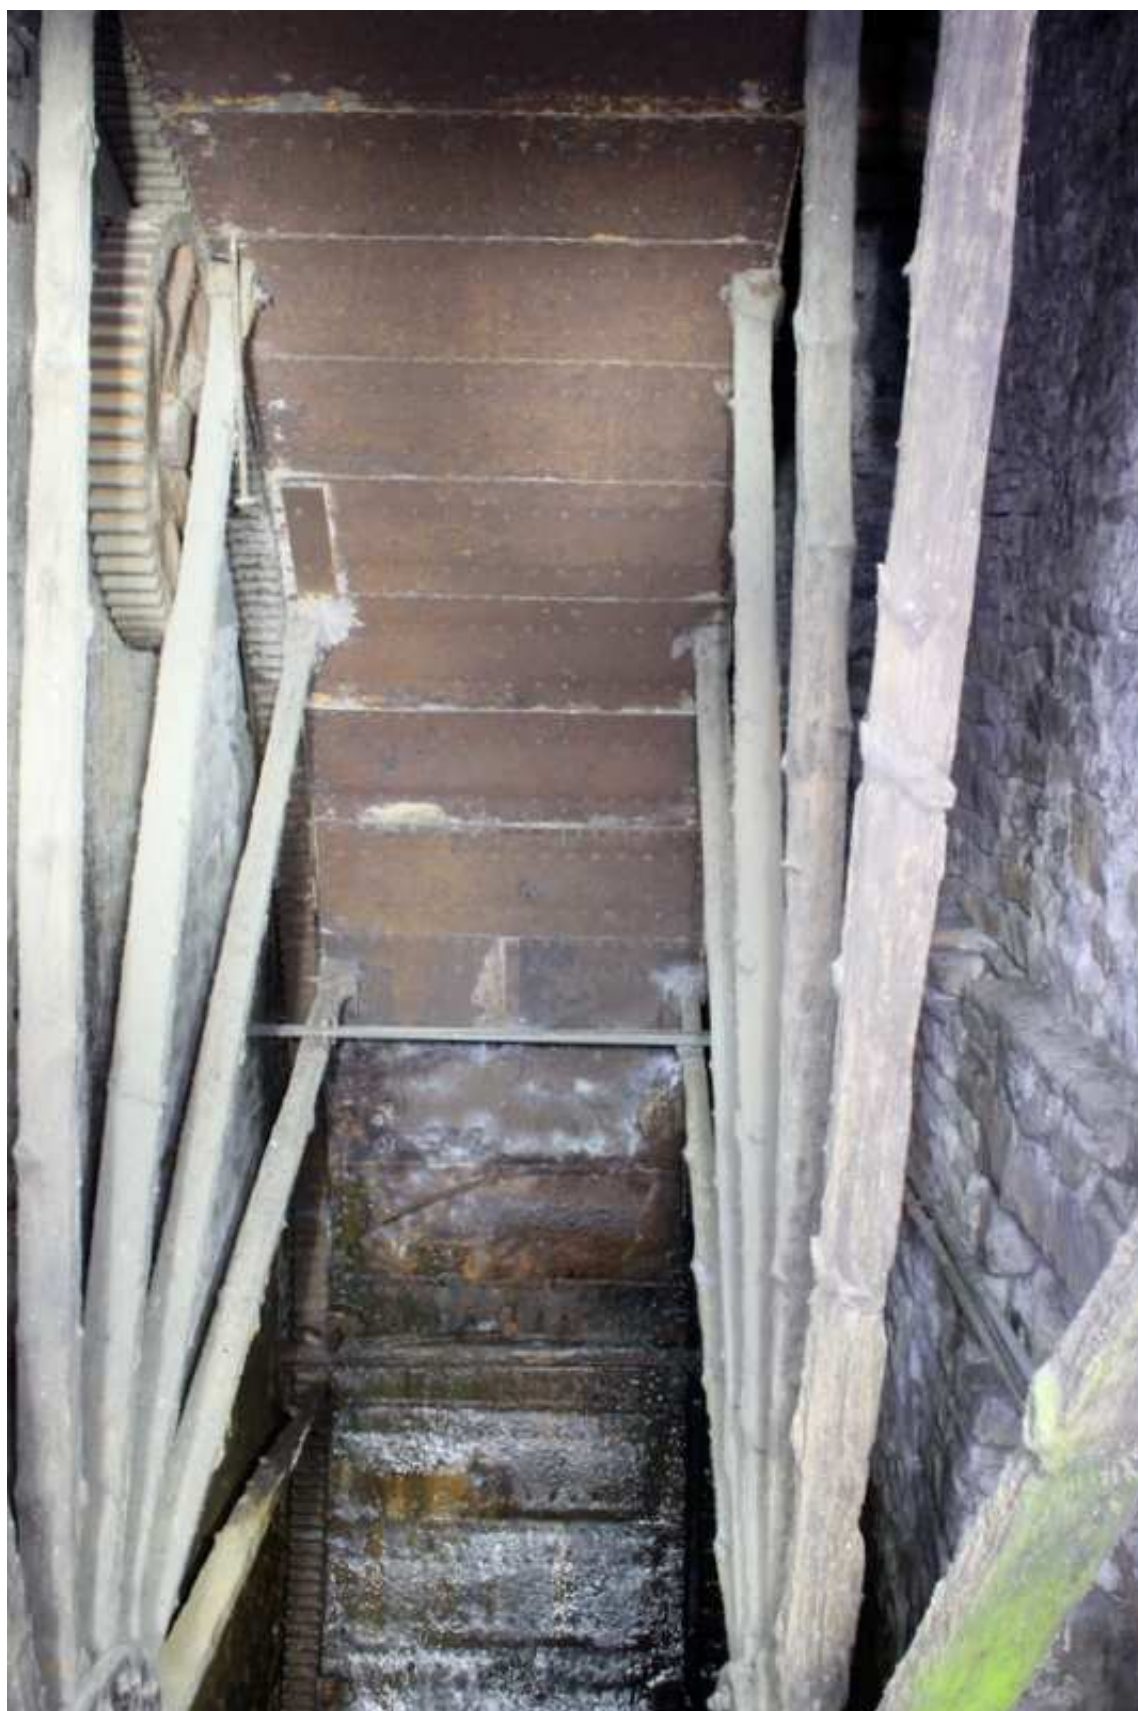
- 3.3.32 The current waterwheel is the full height of the ground and first floors, and almost the full 7' width of the bay in which it is housed (Plates 69 and 70). This represents an extension to the original mill, with this waterwheel probably being erected whilst an original waterwheel continued to function in the adjacent bay to the west. The high breast-shot wheel has cast-iron rims housing metal sheet elbow-buckets (Plate 71), supported by slender timber spokes socketed into a small diameter cast-iron hub (Plates 69 and 70).

Plate 69: Extant waterwheel with slender timber spokes

- 3.3.33 The east wall of the wheel pit diminishes in thickness to each floor level, consistent with that of an external wall (Plate 69). Quoin stones on the edge of an infilled aperture at the north end of the east wall, just below ceiling level (Plate 72), appear to represent the southern jamb of a doorway affording access to the waterwheel, prior to the construction of an extension on its eastern side. A concrete bridge with doorways either end, inserted across the southern side of waterwheel bay, cuts the waterwheel, rendering it unusable, but provided access between the original mill, and a later extension to the east of the waterwheel, and was inserted after 1933, when the waterwheel became redundant.

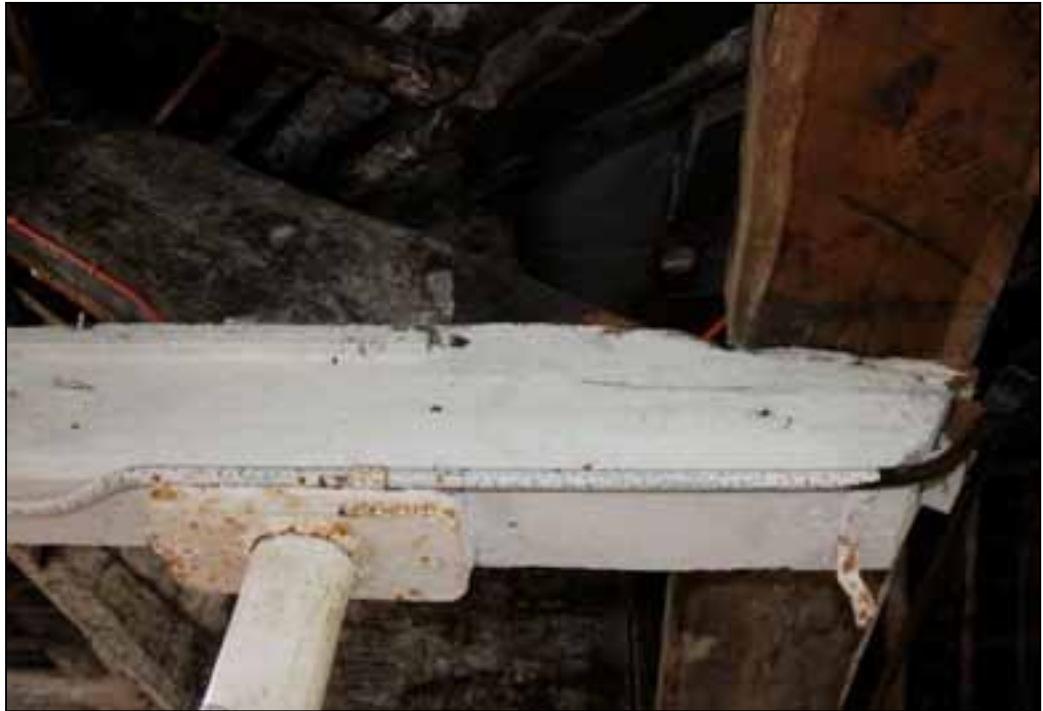
Plate 79: Plain column capital, second floor

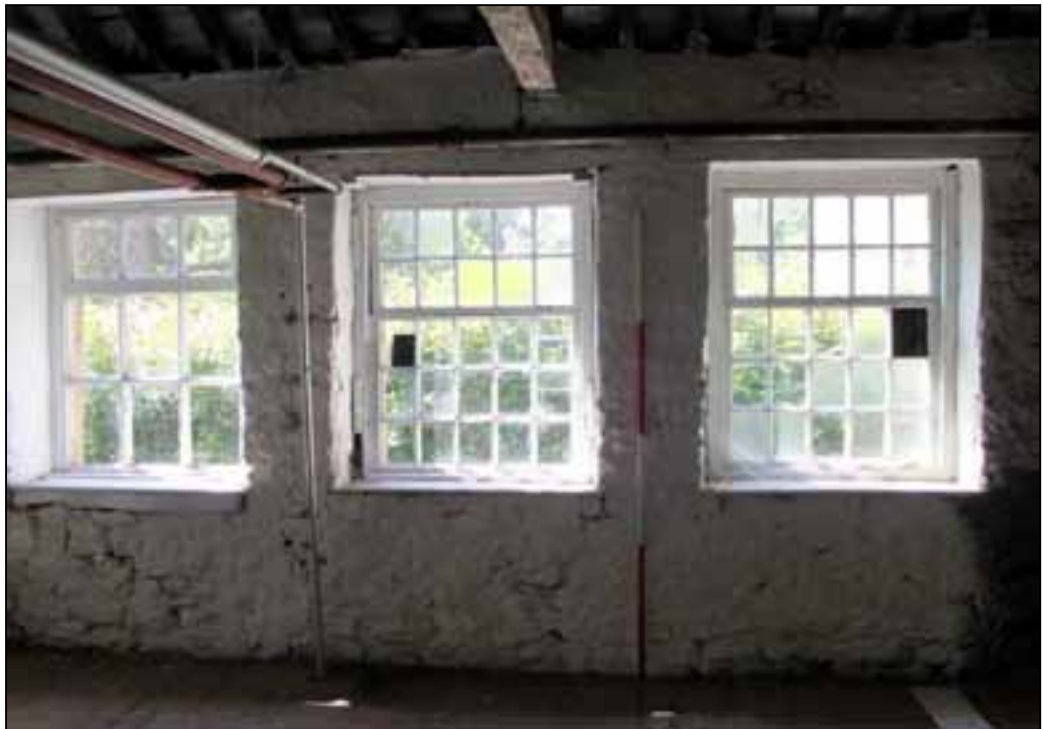
3.3.38 Windows were similar to those on the floors below, with the exception of those in the north wall, which matched those elsewhere, rather than extending to wall-head height (Plate 78). Many housed nine-light, top-vent windows, although some timber 25-light vertical sash windows also survived (Plate 80).

Plate 80: Second-floor windows

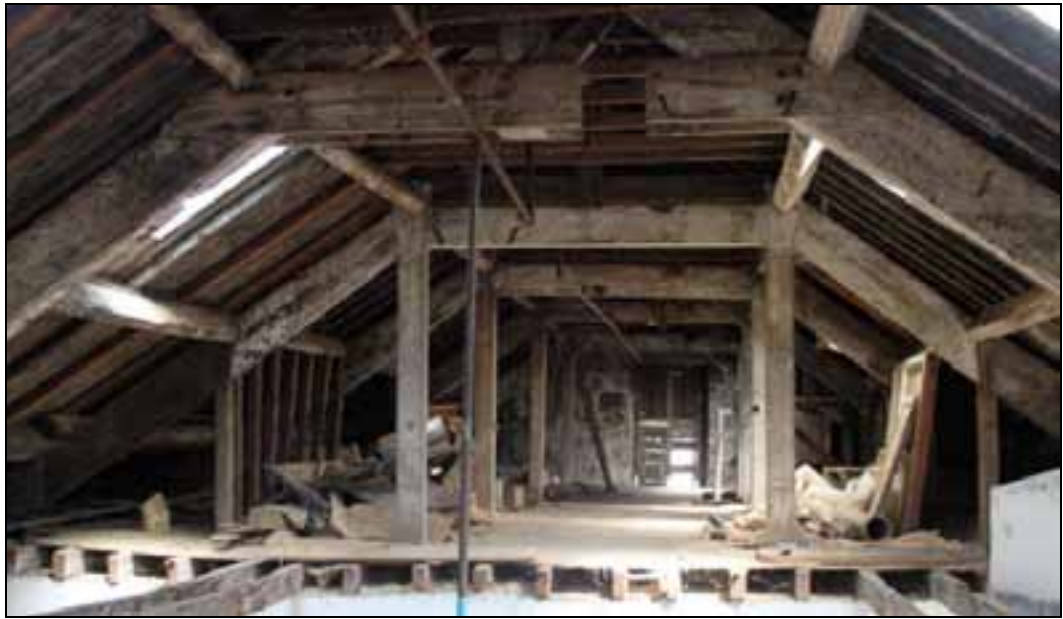
3.3.47 The roof structure above the engine and wheel houses differed from the main roof, comprising two queen post trusses (Plate 94), with jowled feet (Plate 95) and each post carrying the upper of two rectangular-section purlins to each pitch. Posts below the lower purlin do not form part of the truss, but instead form studs for a former partition to the eaves (Plate 94), which appears to have been a relatively recent addition, and certainly post-dates the extension of the mill to the east, as it is also present within this part of the roof.

Plate 94: Queen post trusses above engine and wheel houses

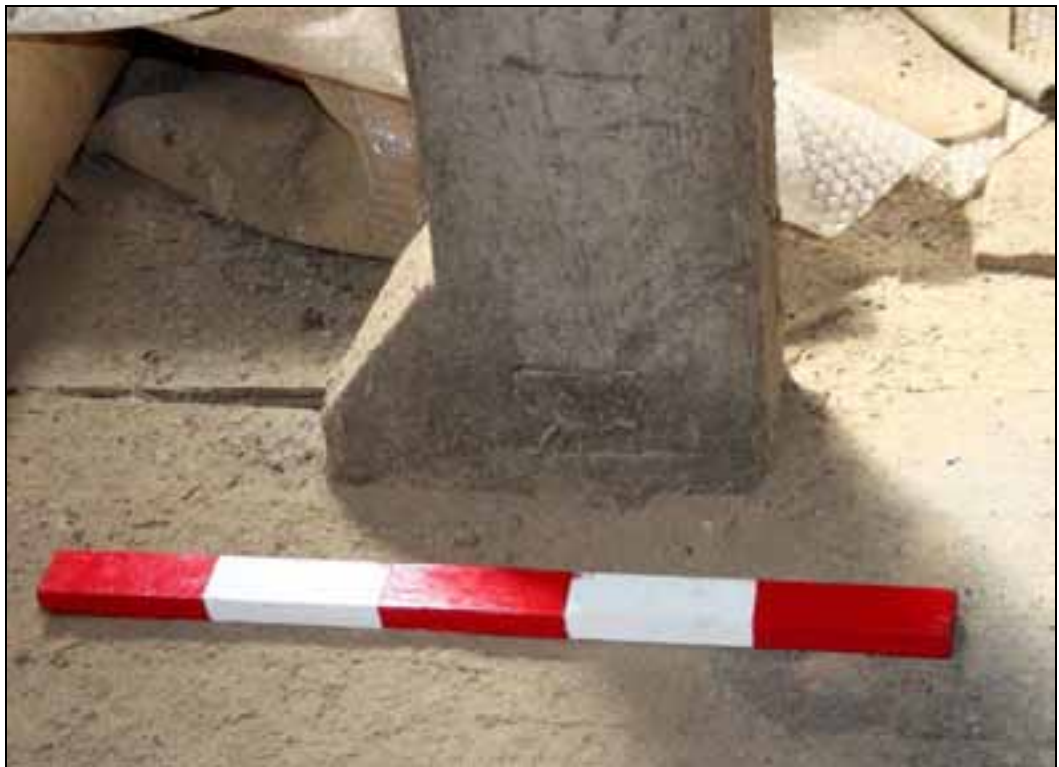
Plate 95: Jowled foot of queen post
